Interceptor Condition Assessment and Rehabilitation Program

Environment Committee

February 11, 2014

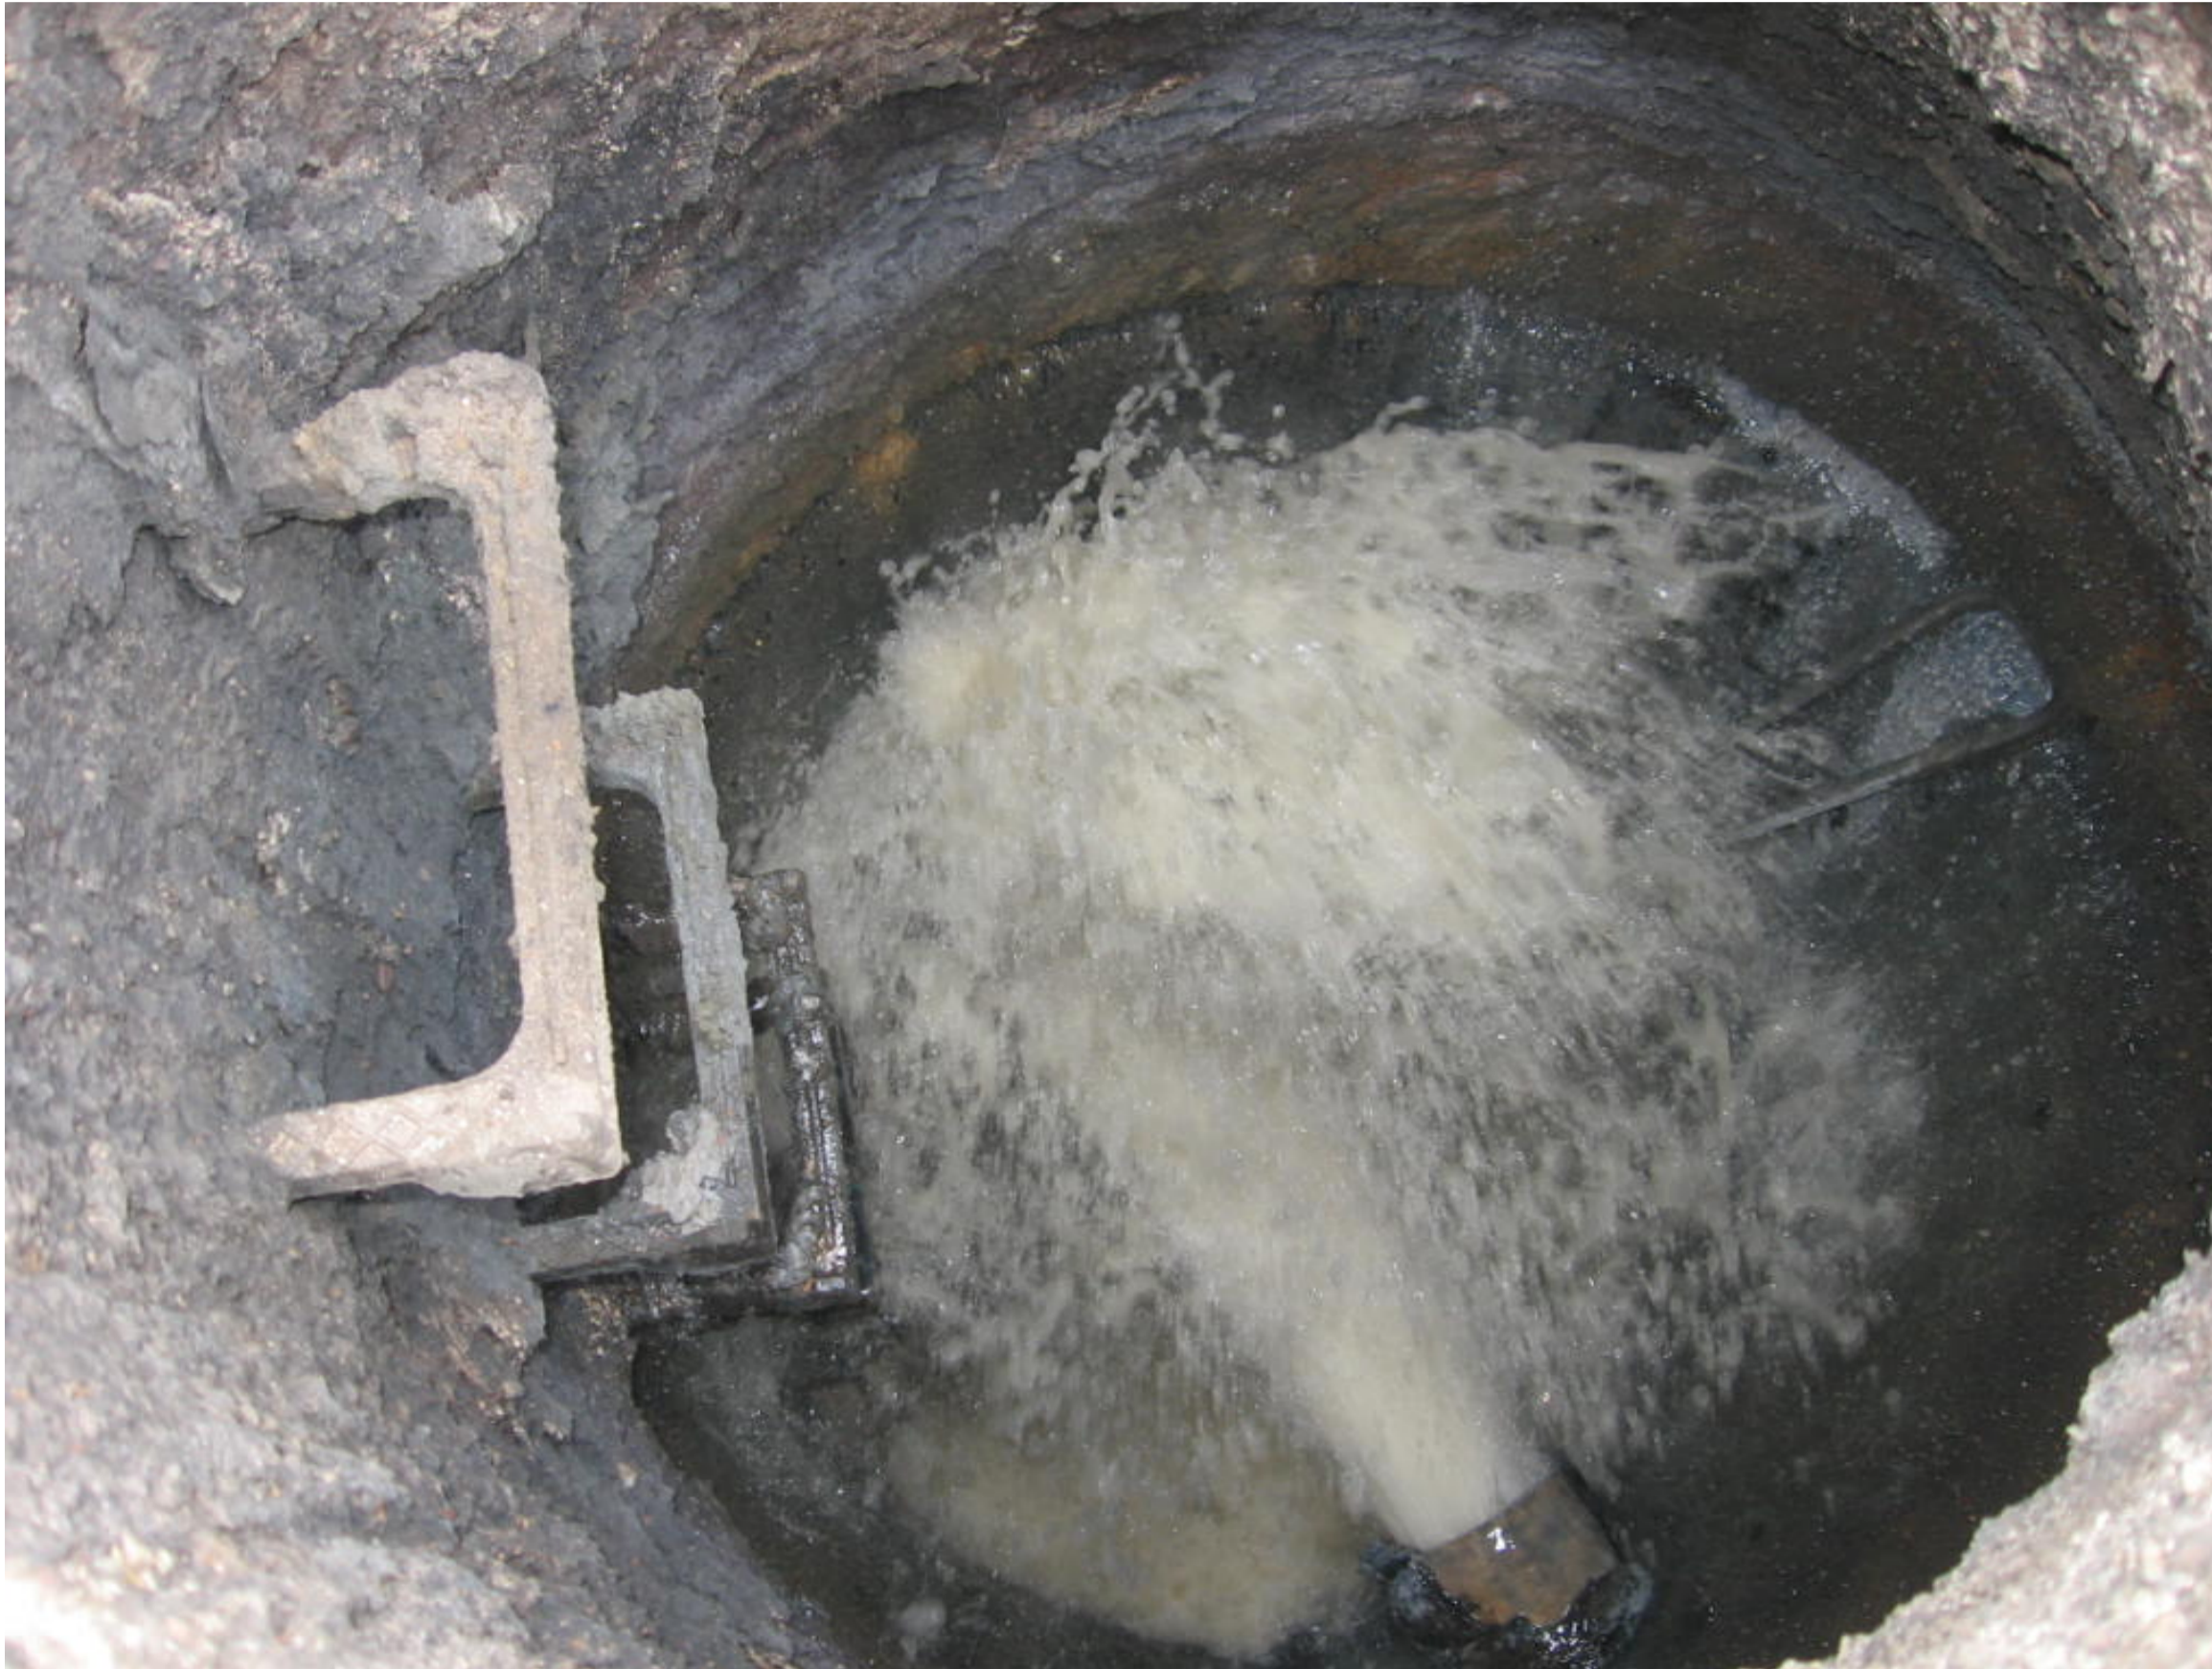
Corrosion Damage Found at FM Discharge Structure

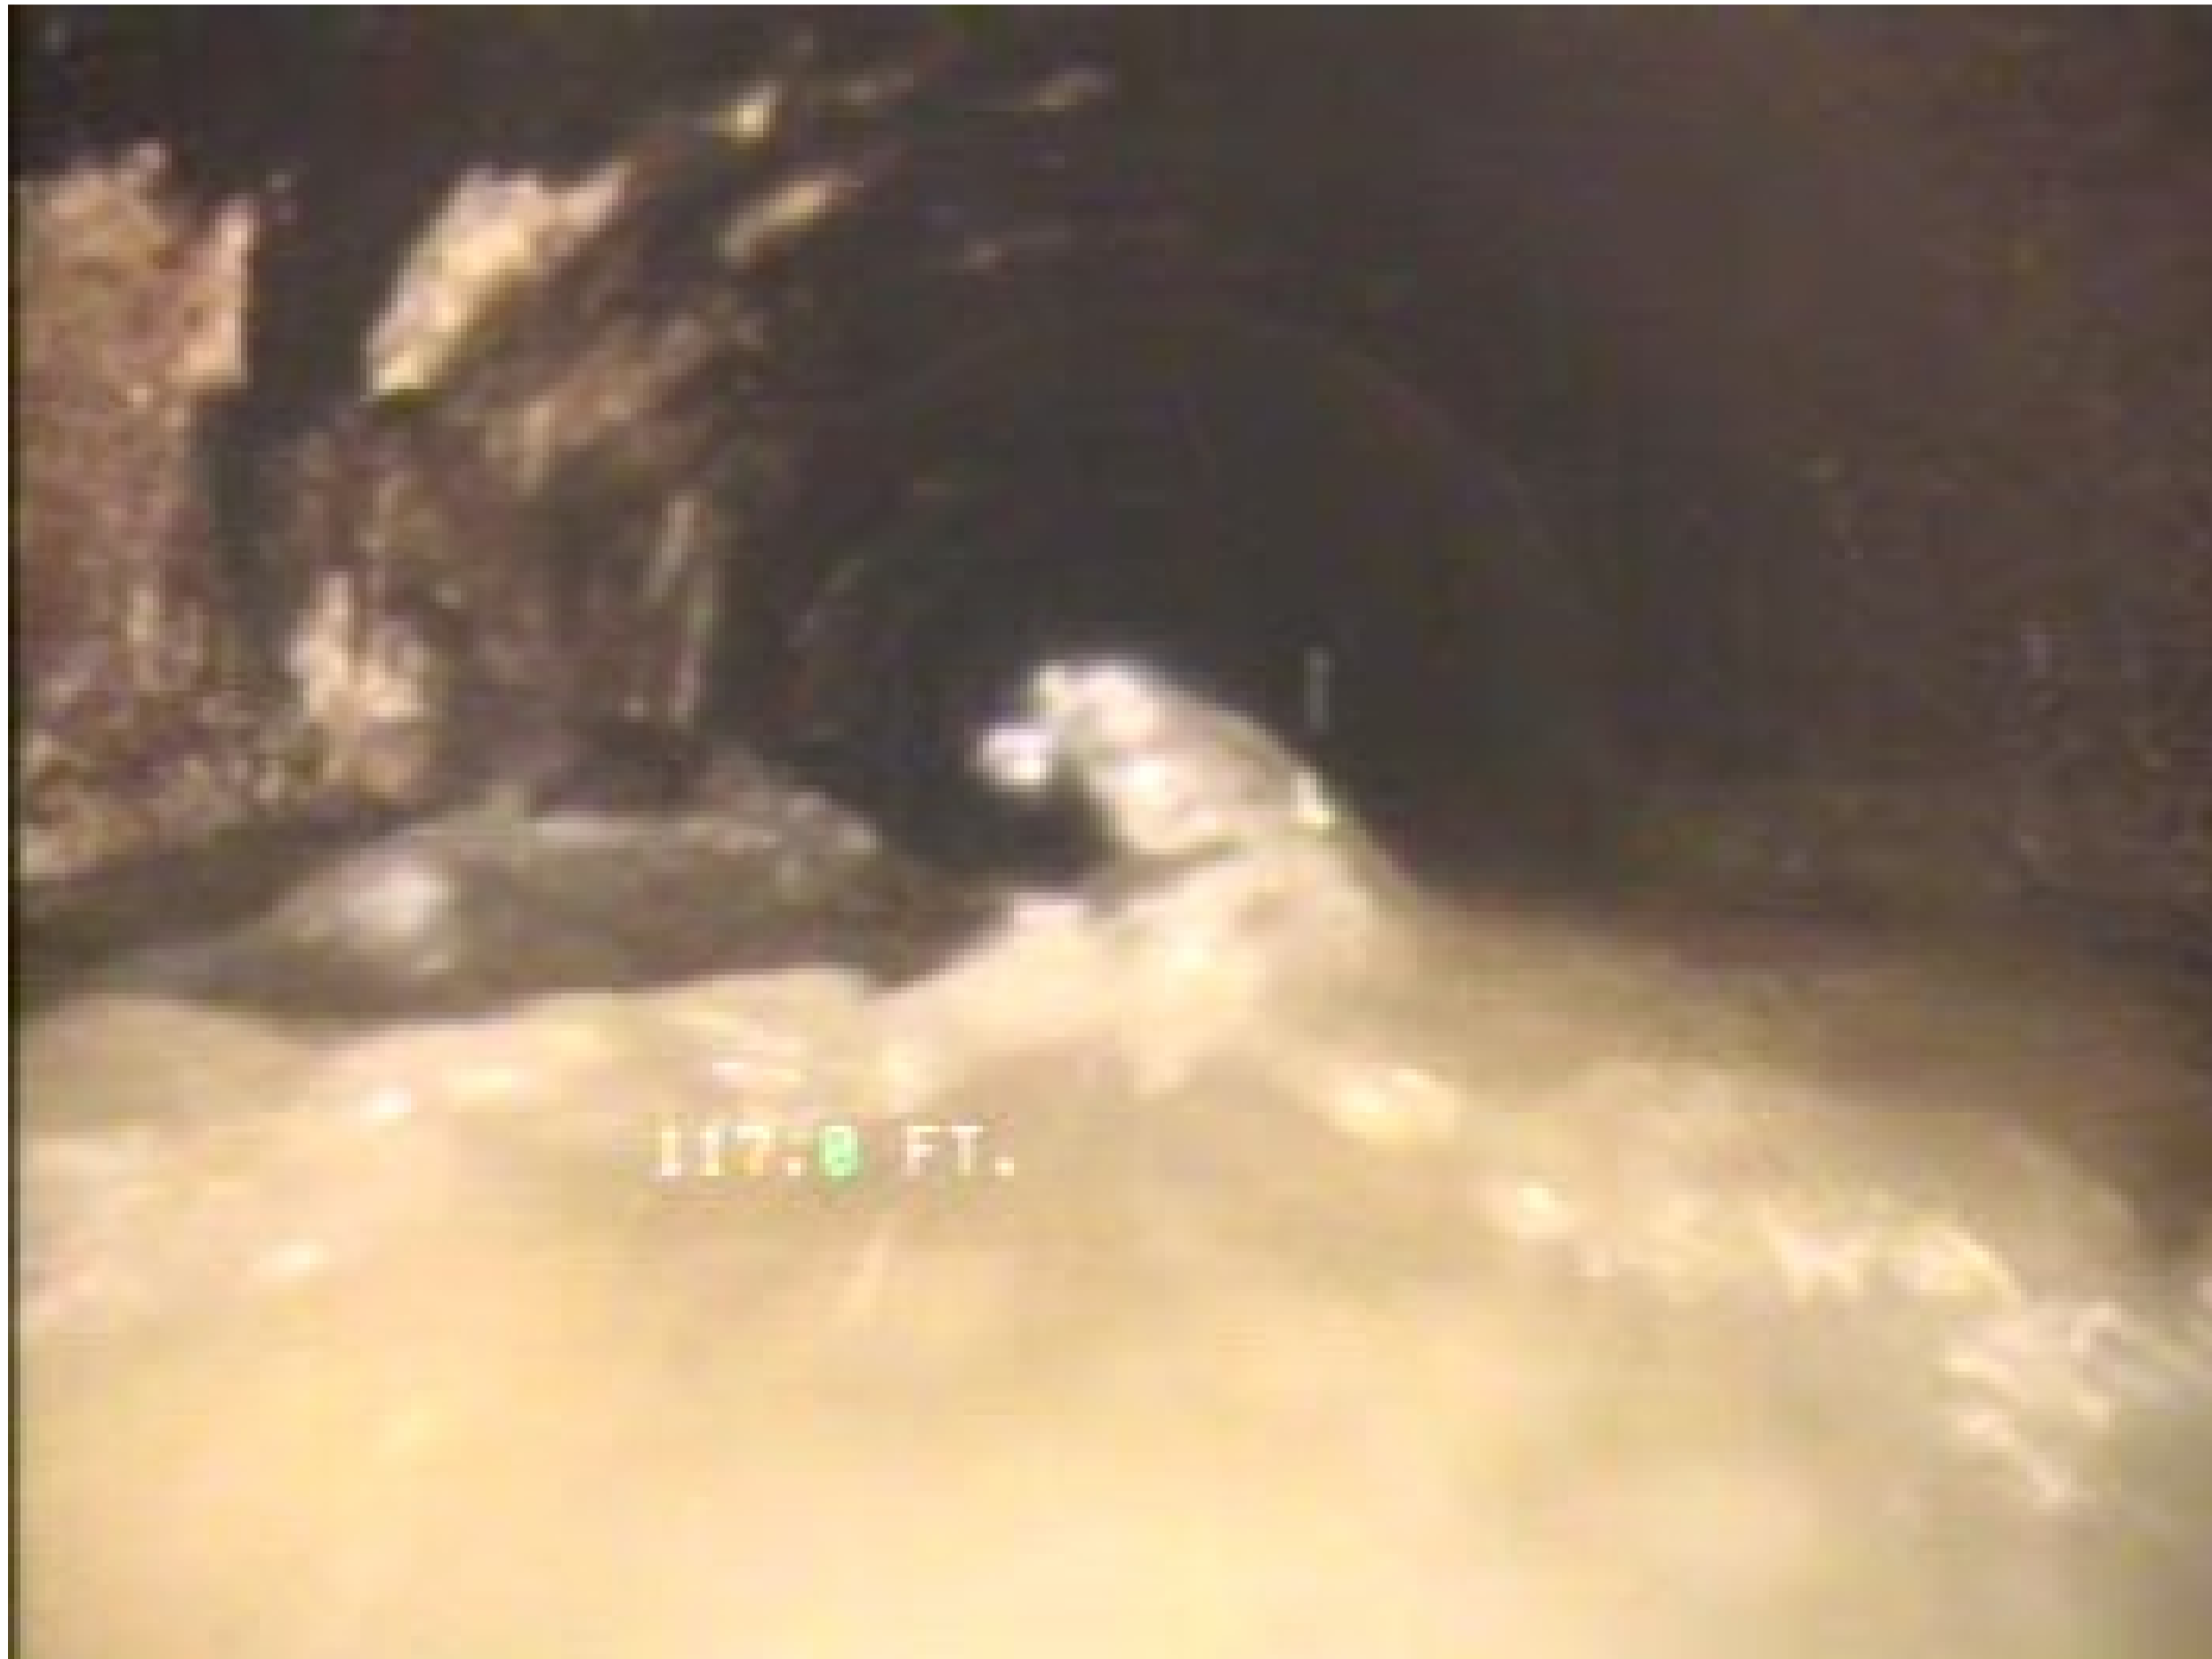
Corrosion Damage Found at Highly Sloped Concrete Pipe

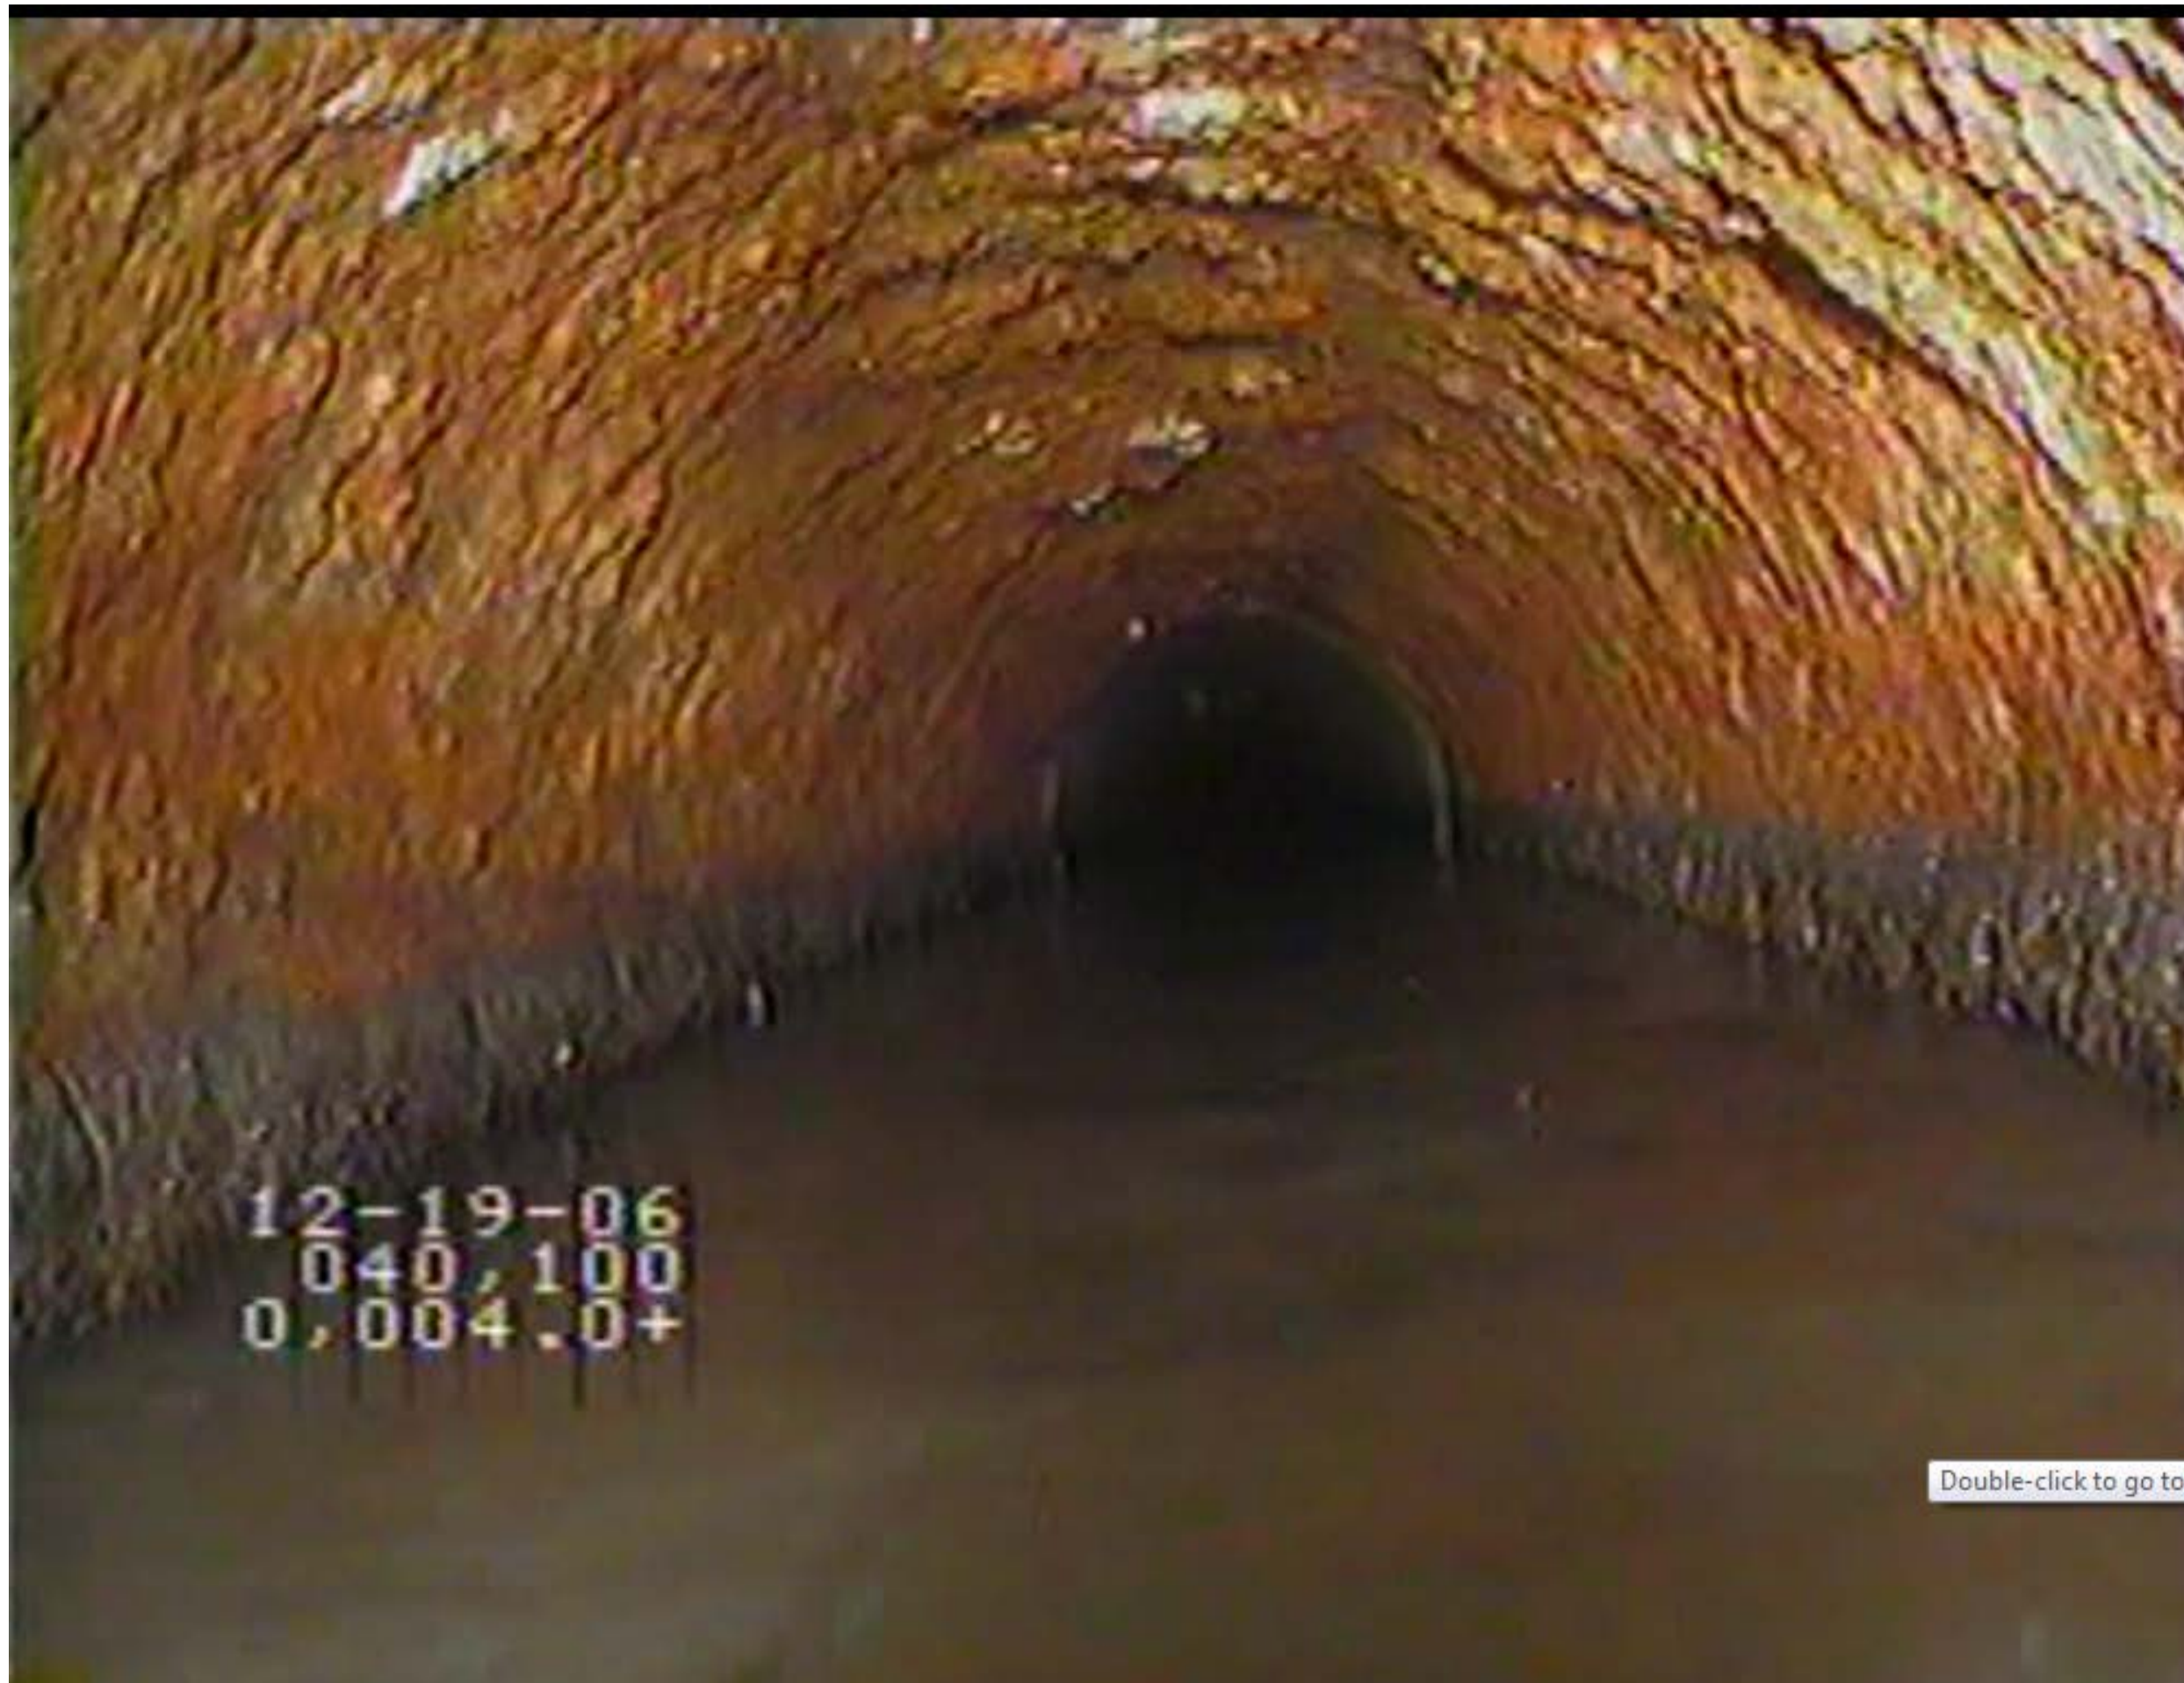
Corrosion Damage Metal Pipe

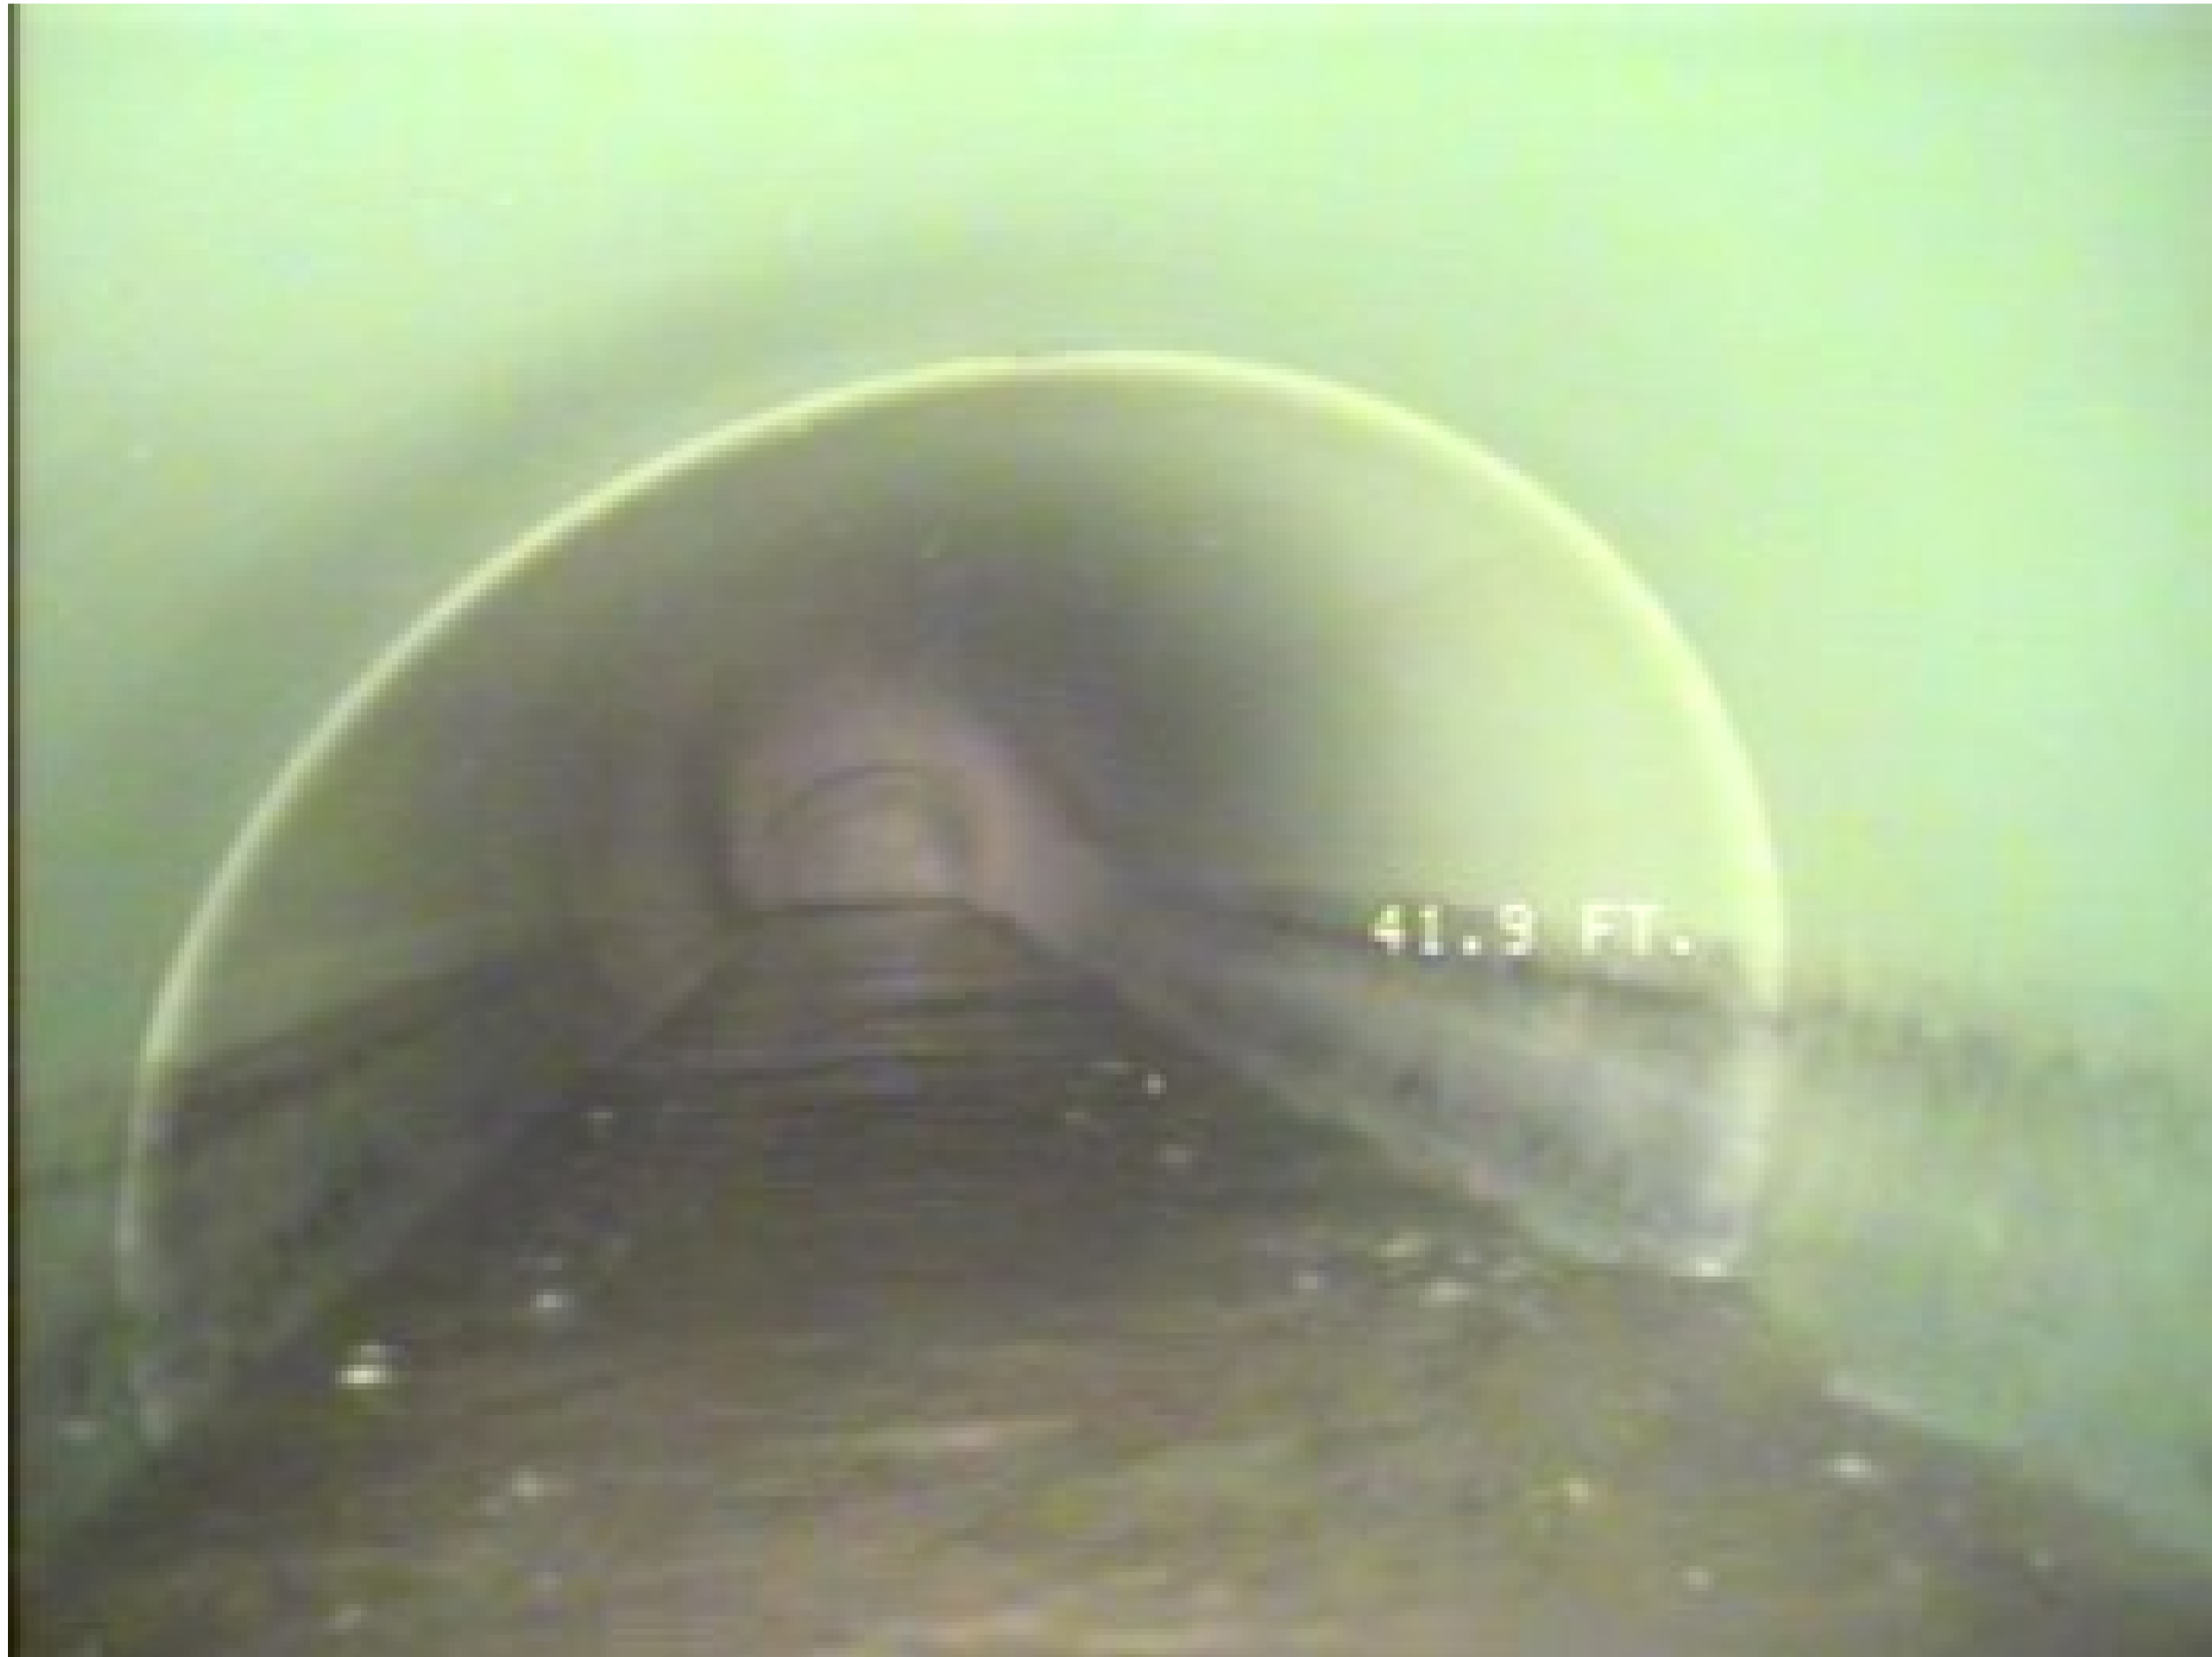
Overly Deflected PVC Pipe

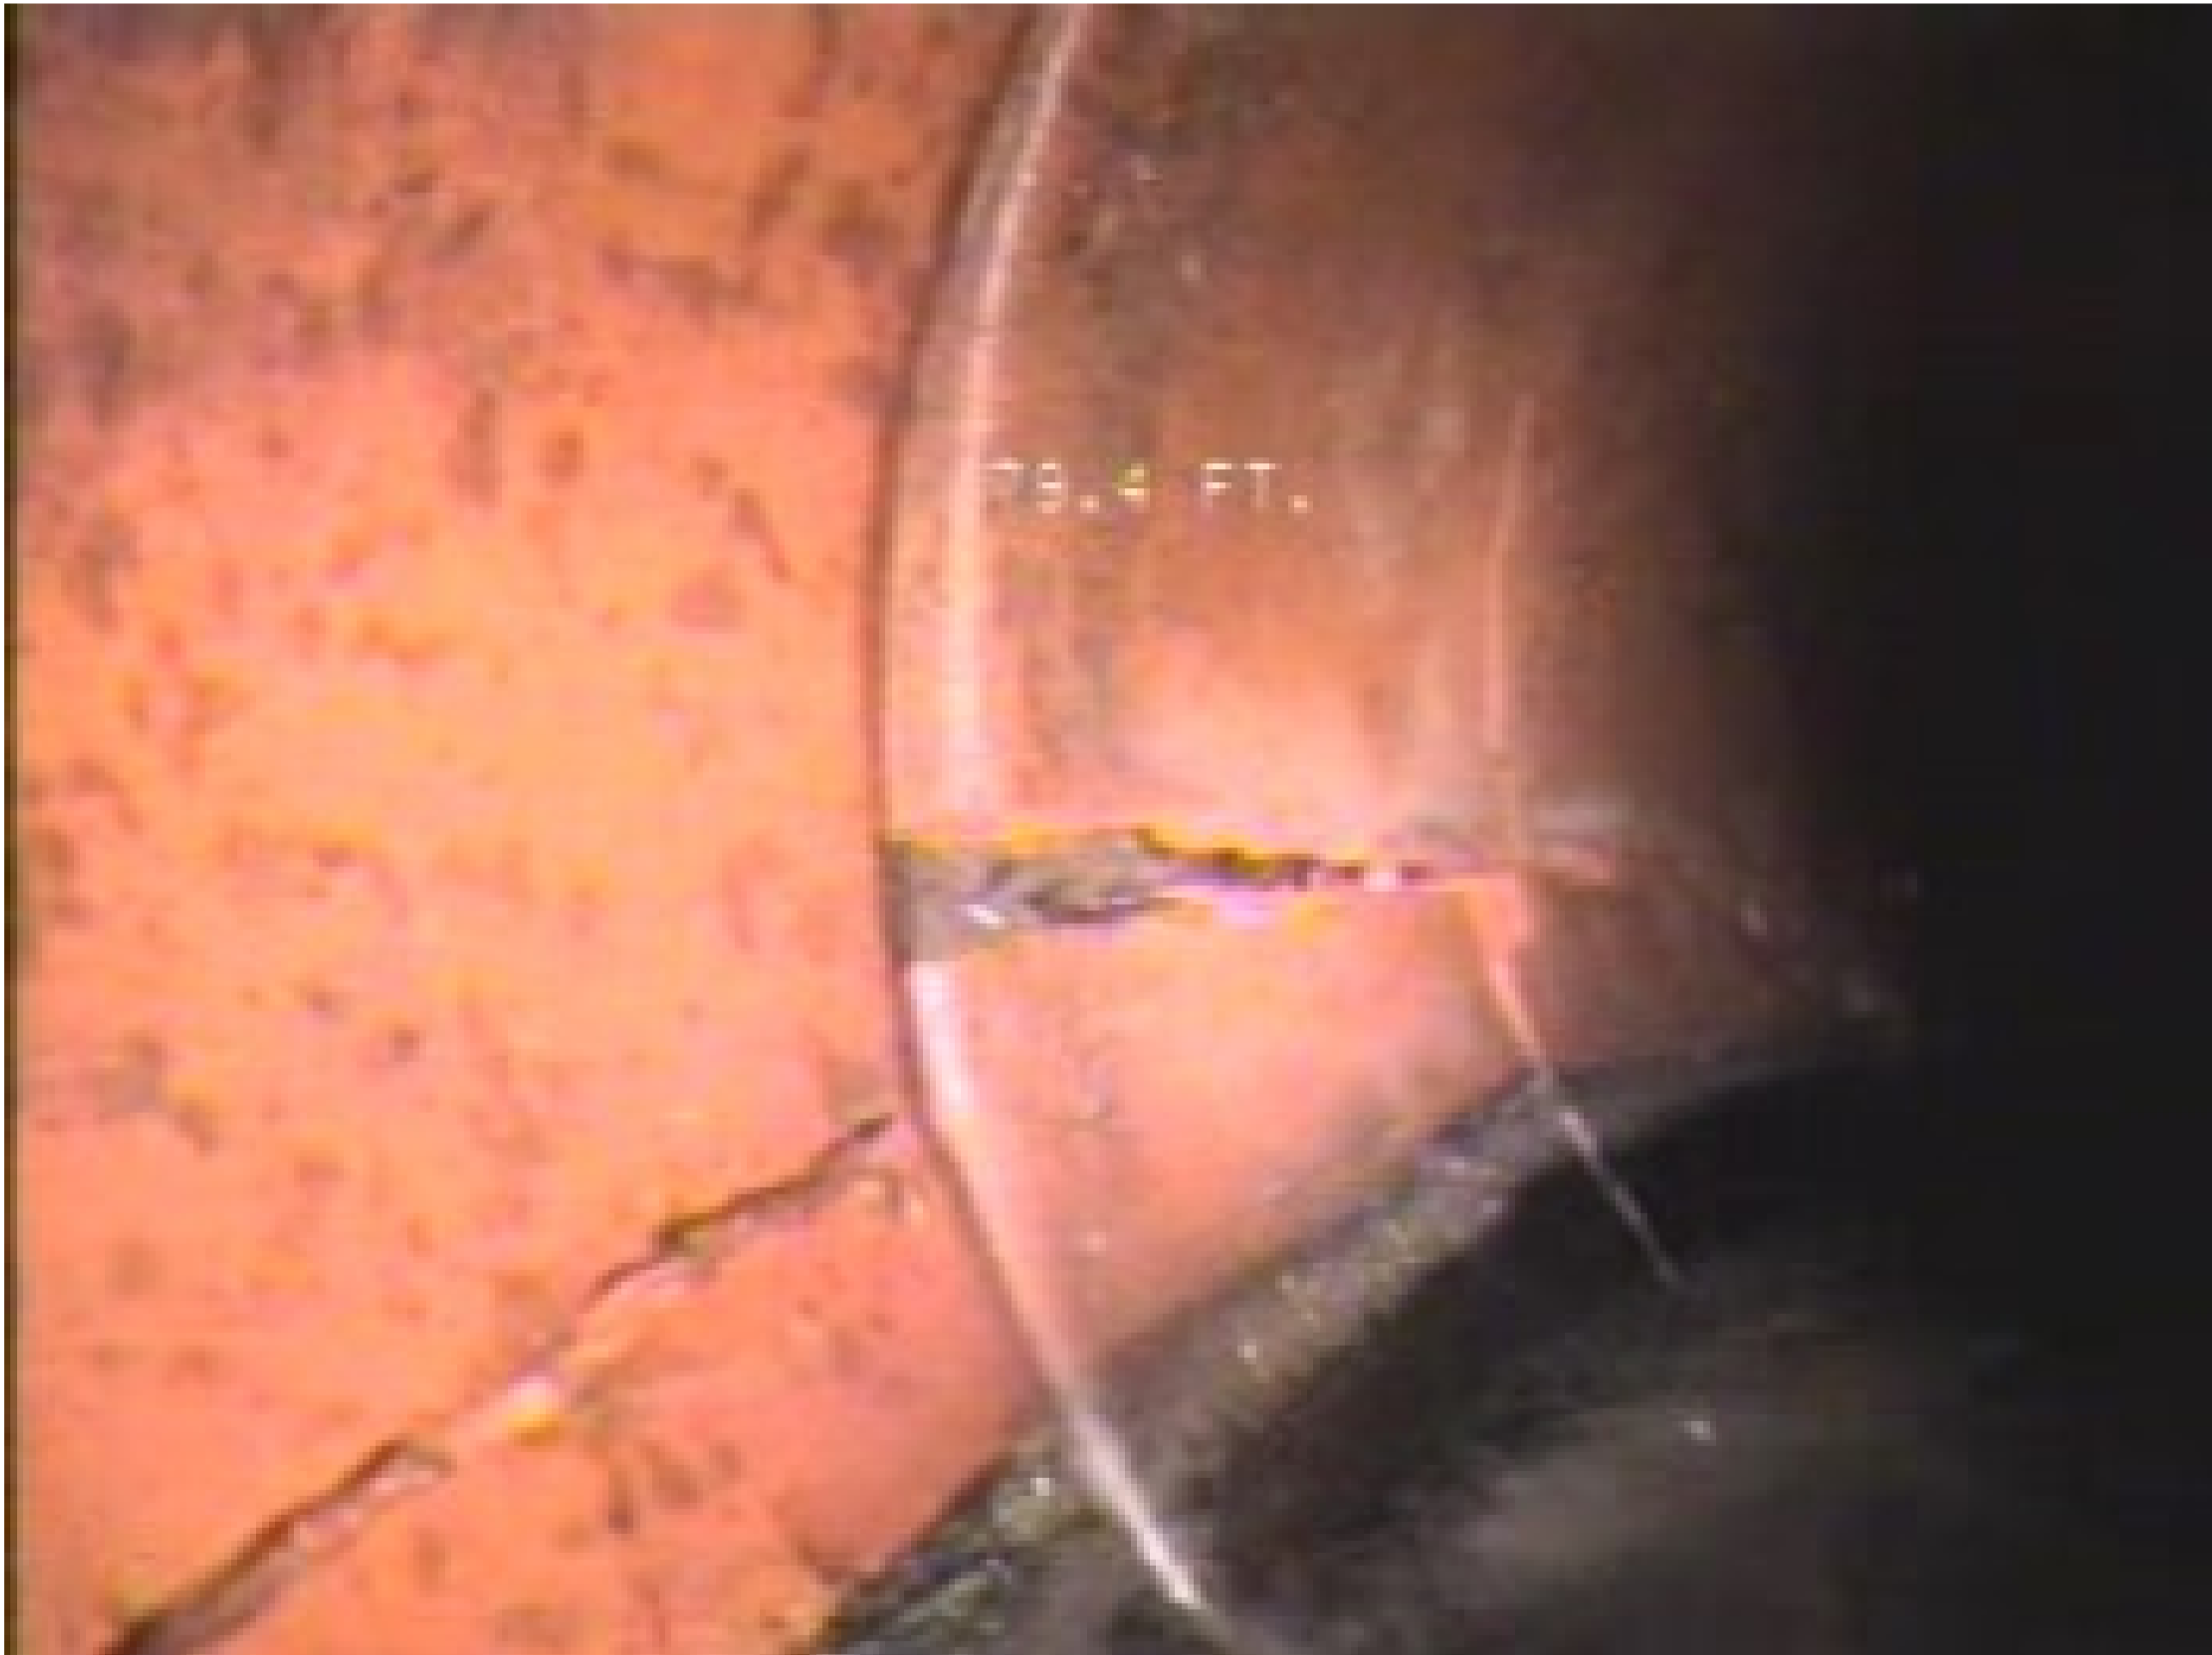
Subsidence in Poor Soils
