Declaration of Emergency for Repair of Rosemount Interceptor 7112 and 9208

Environment Committee: July 23, 2019

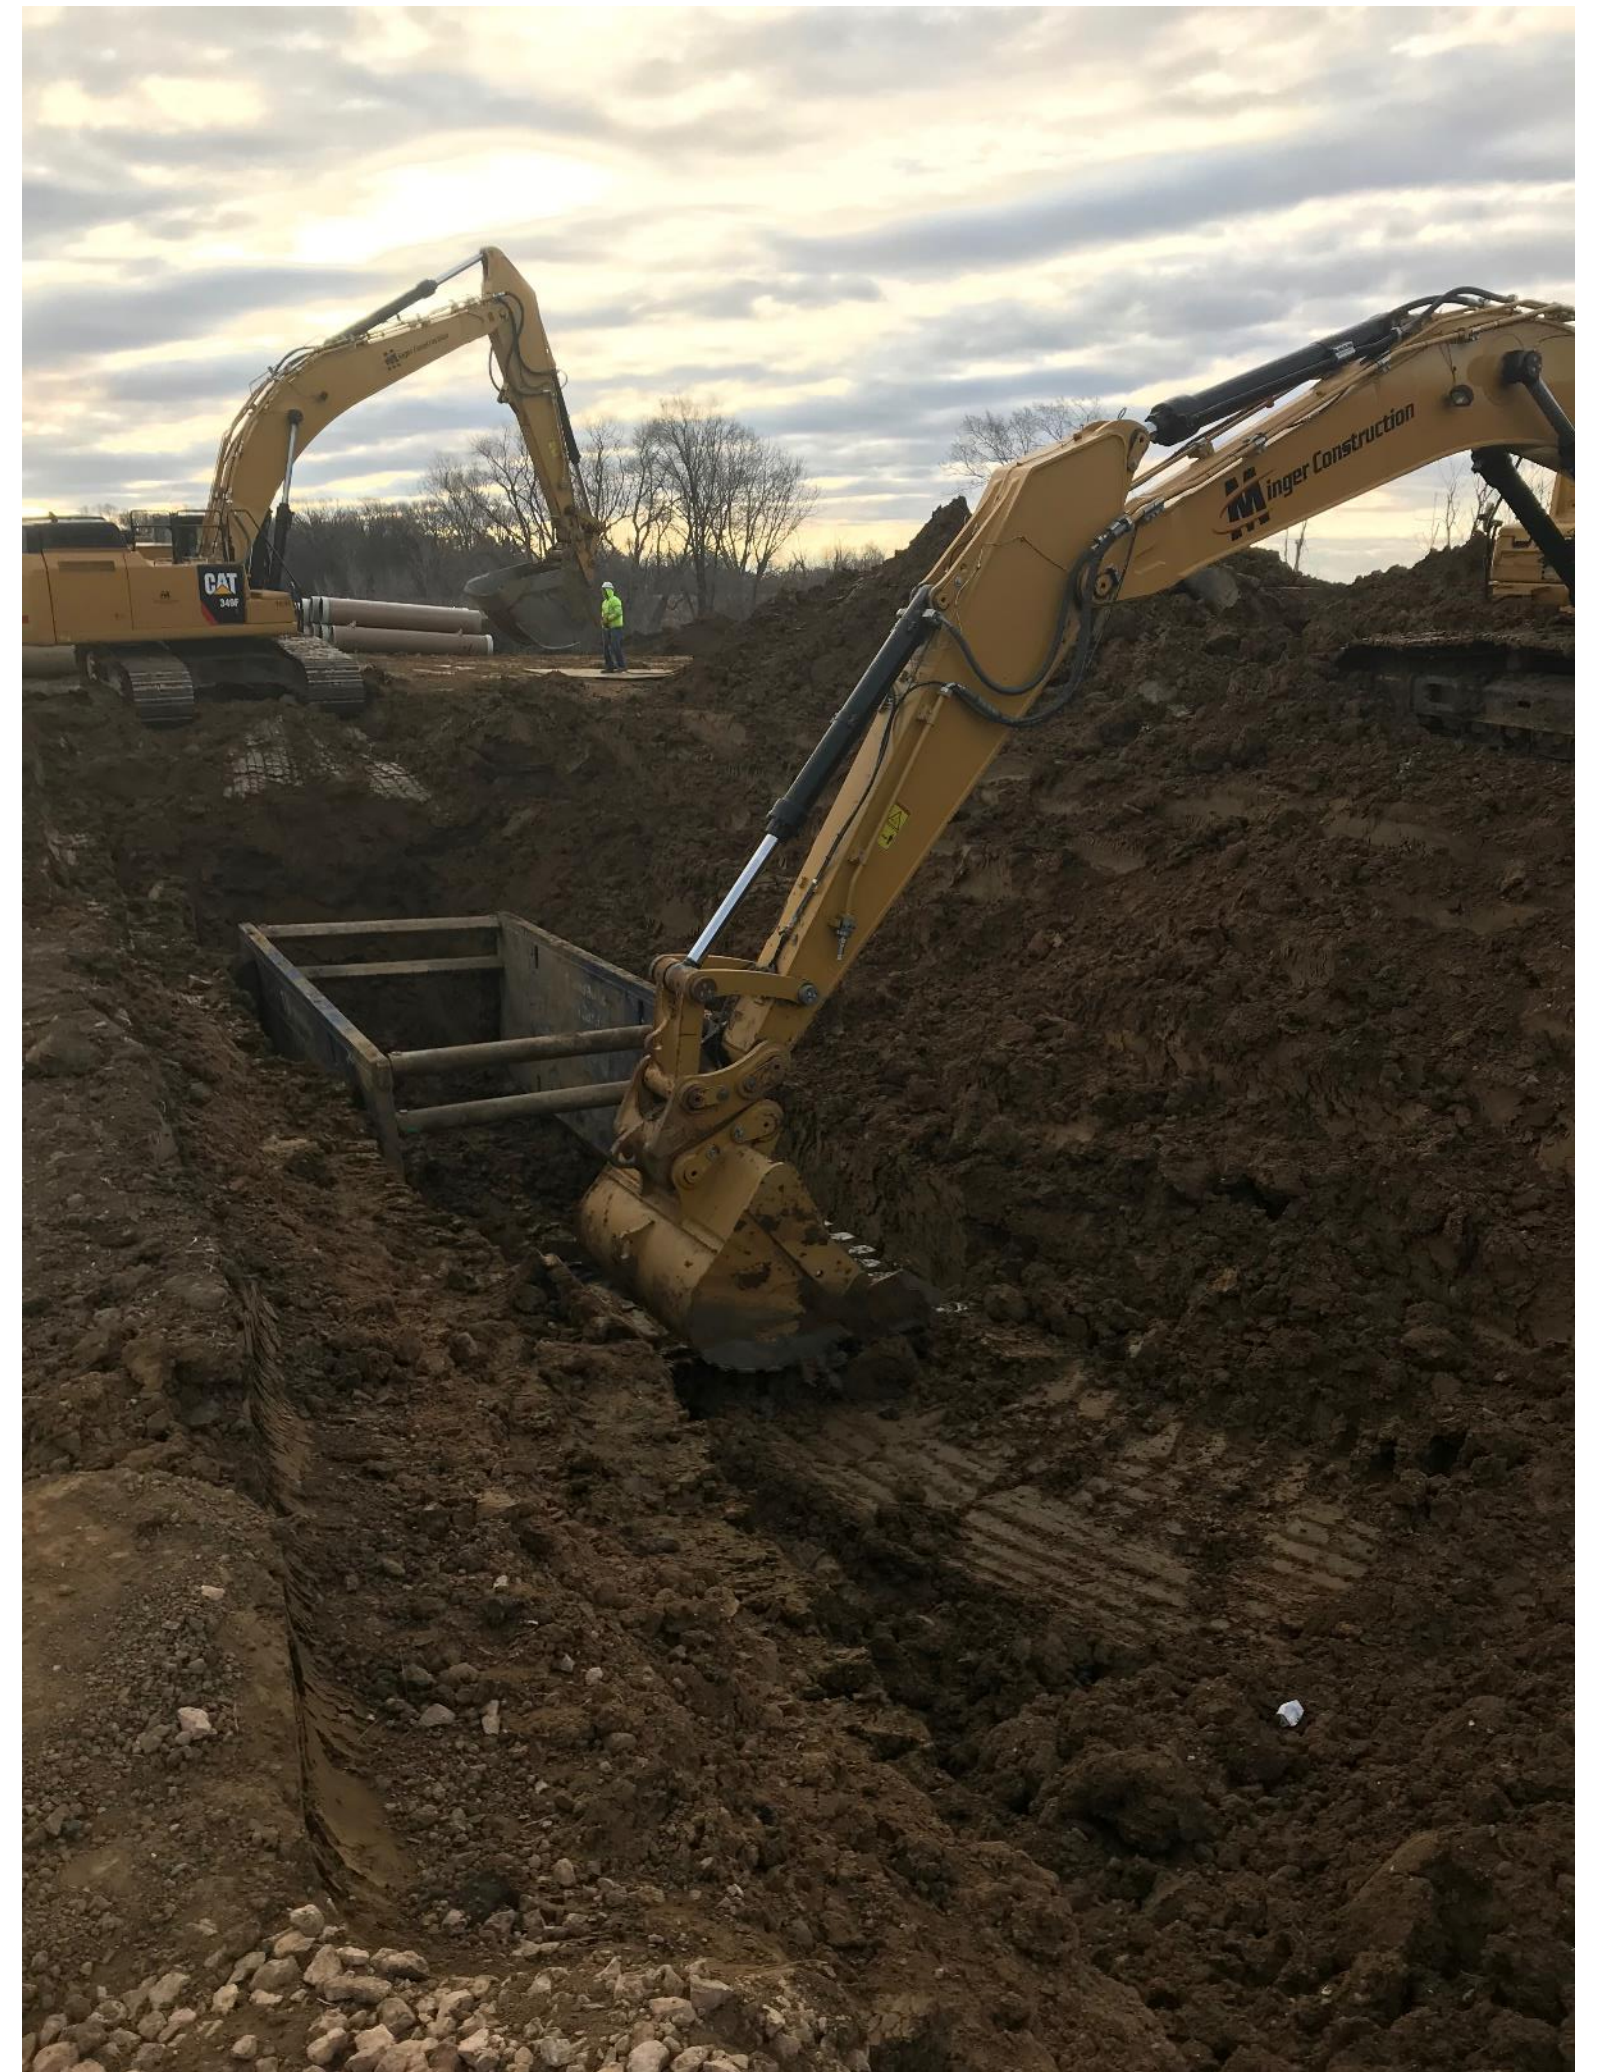
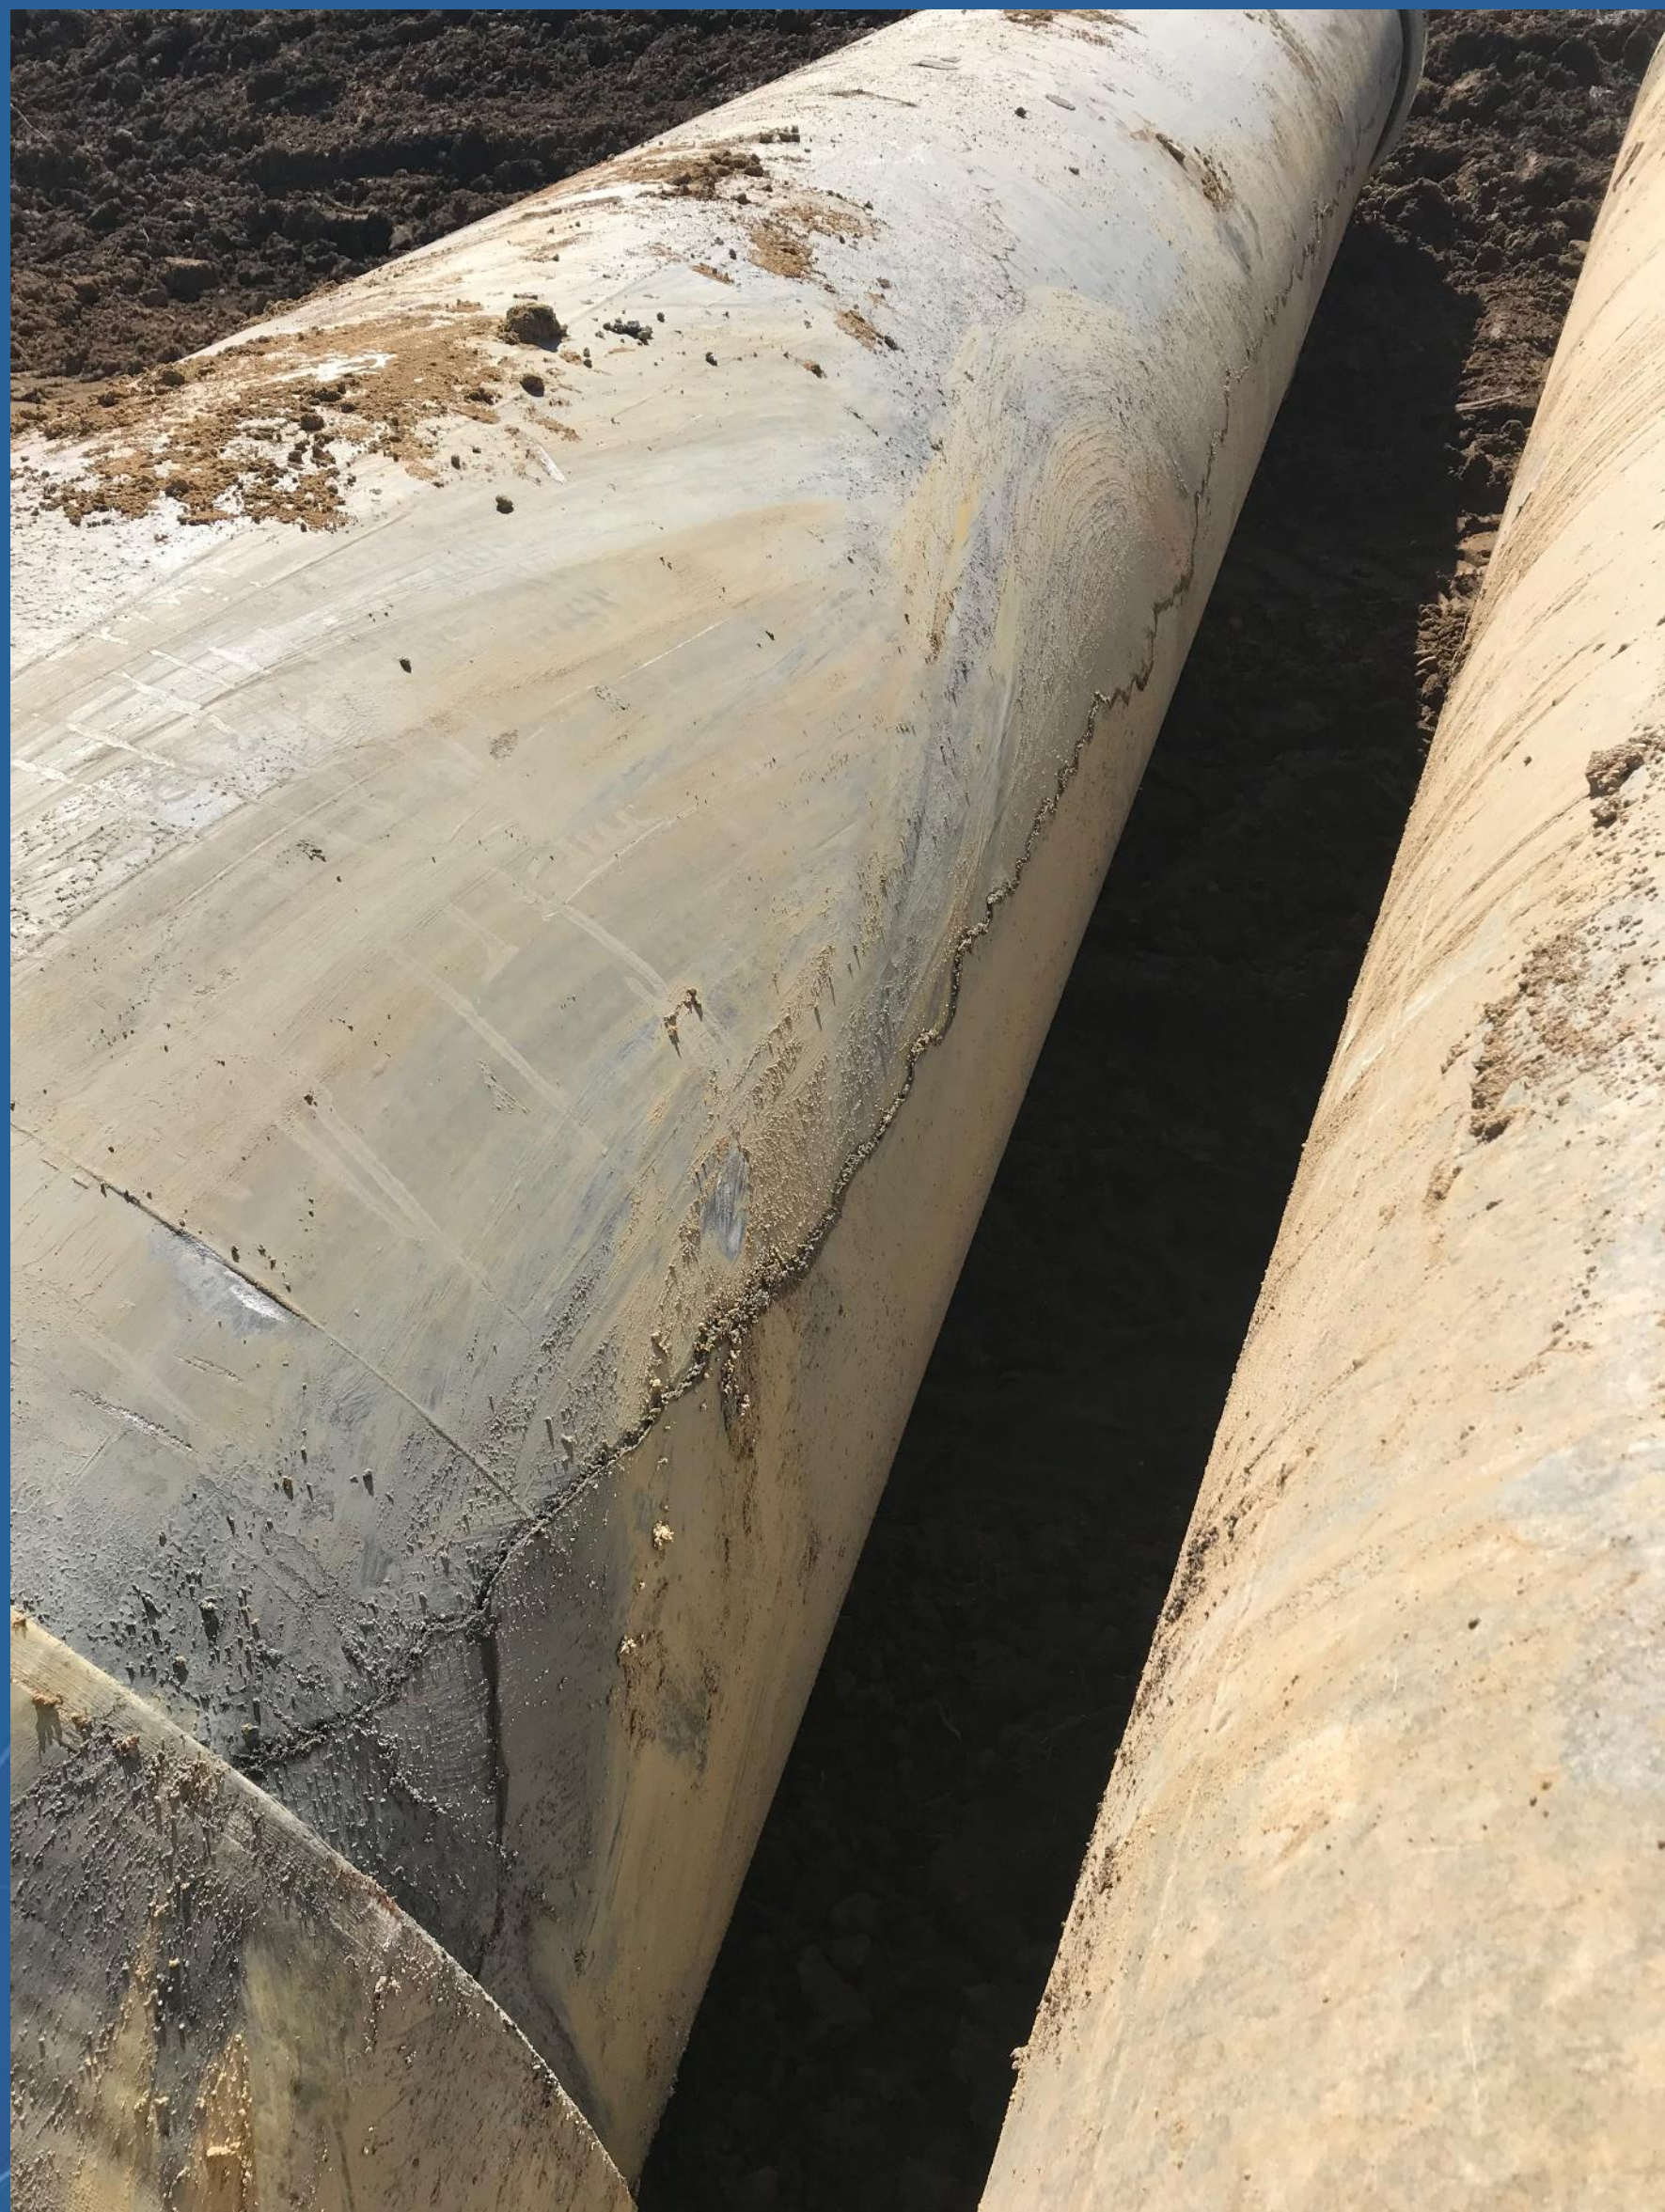
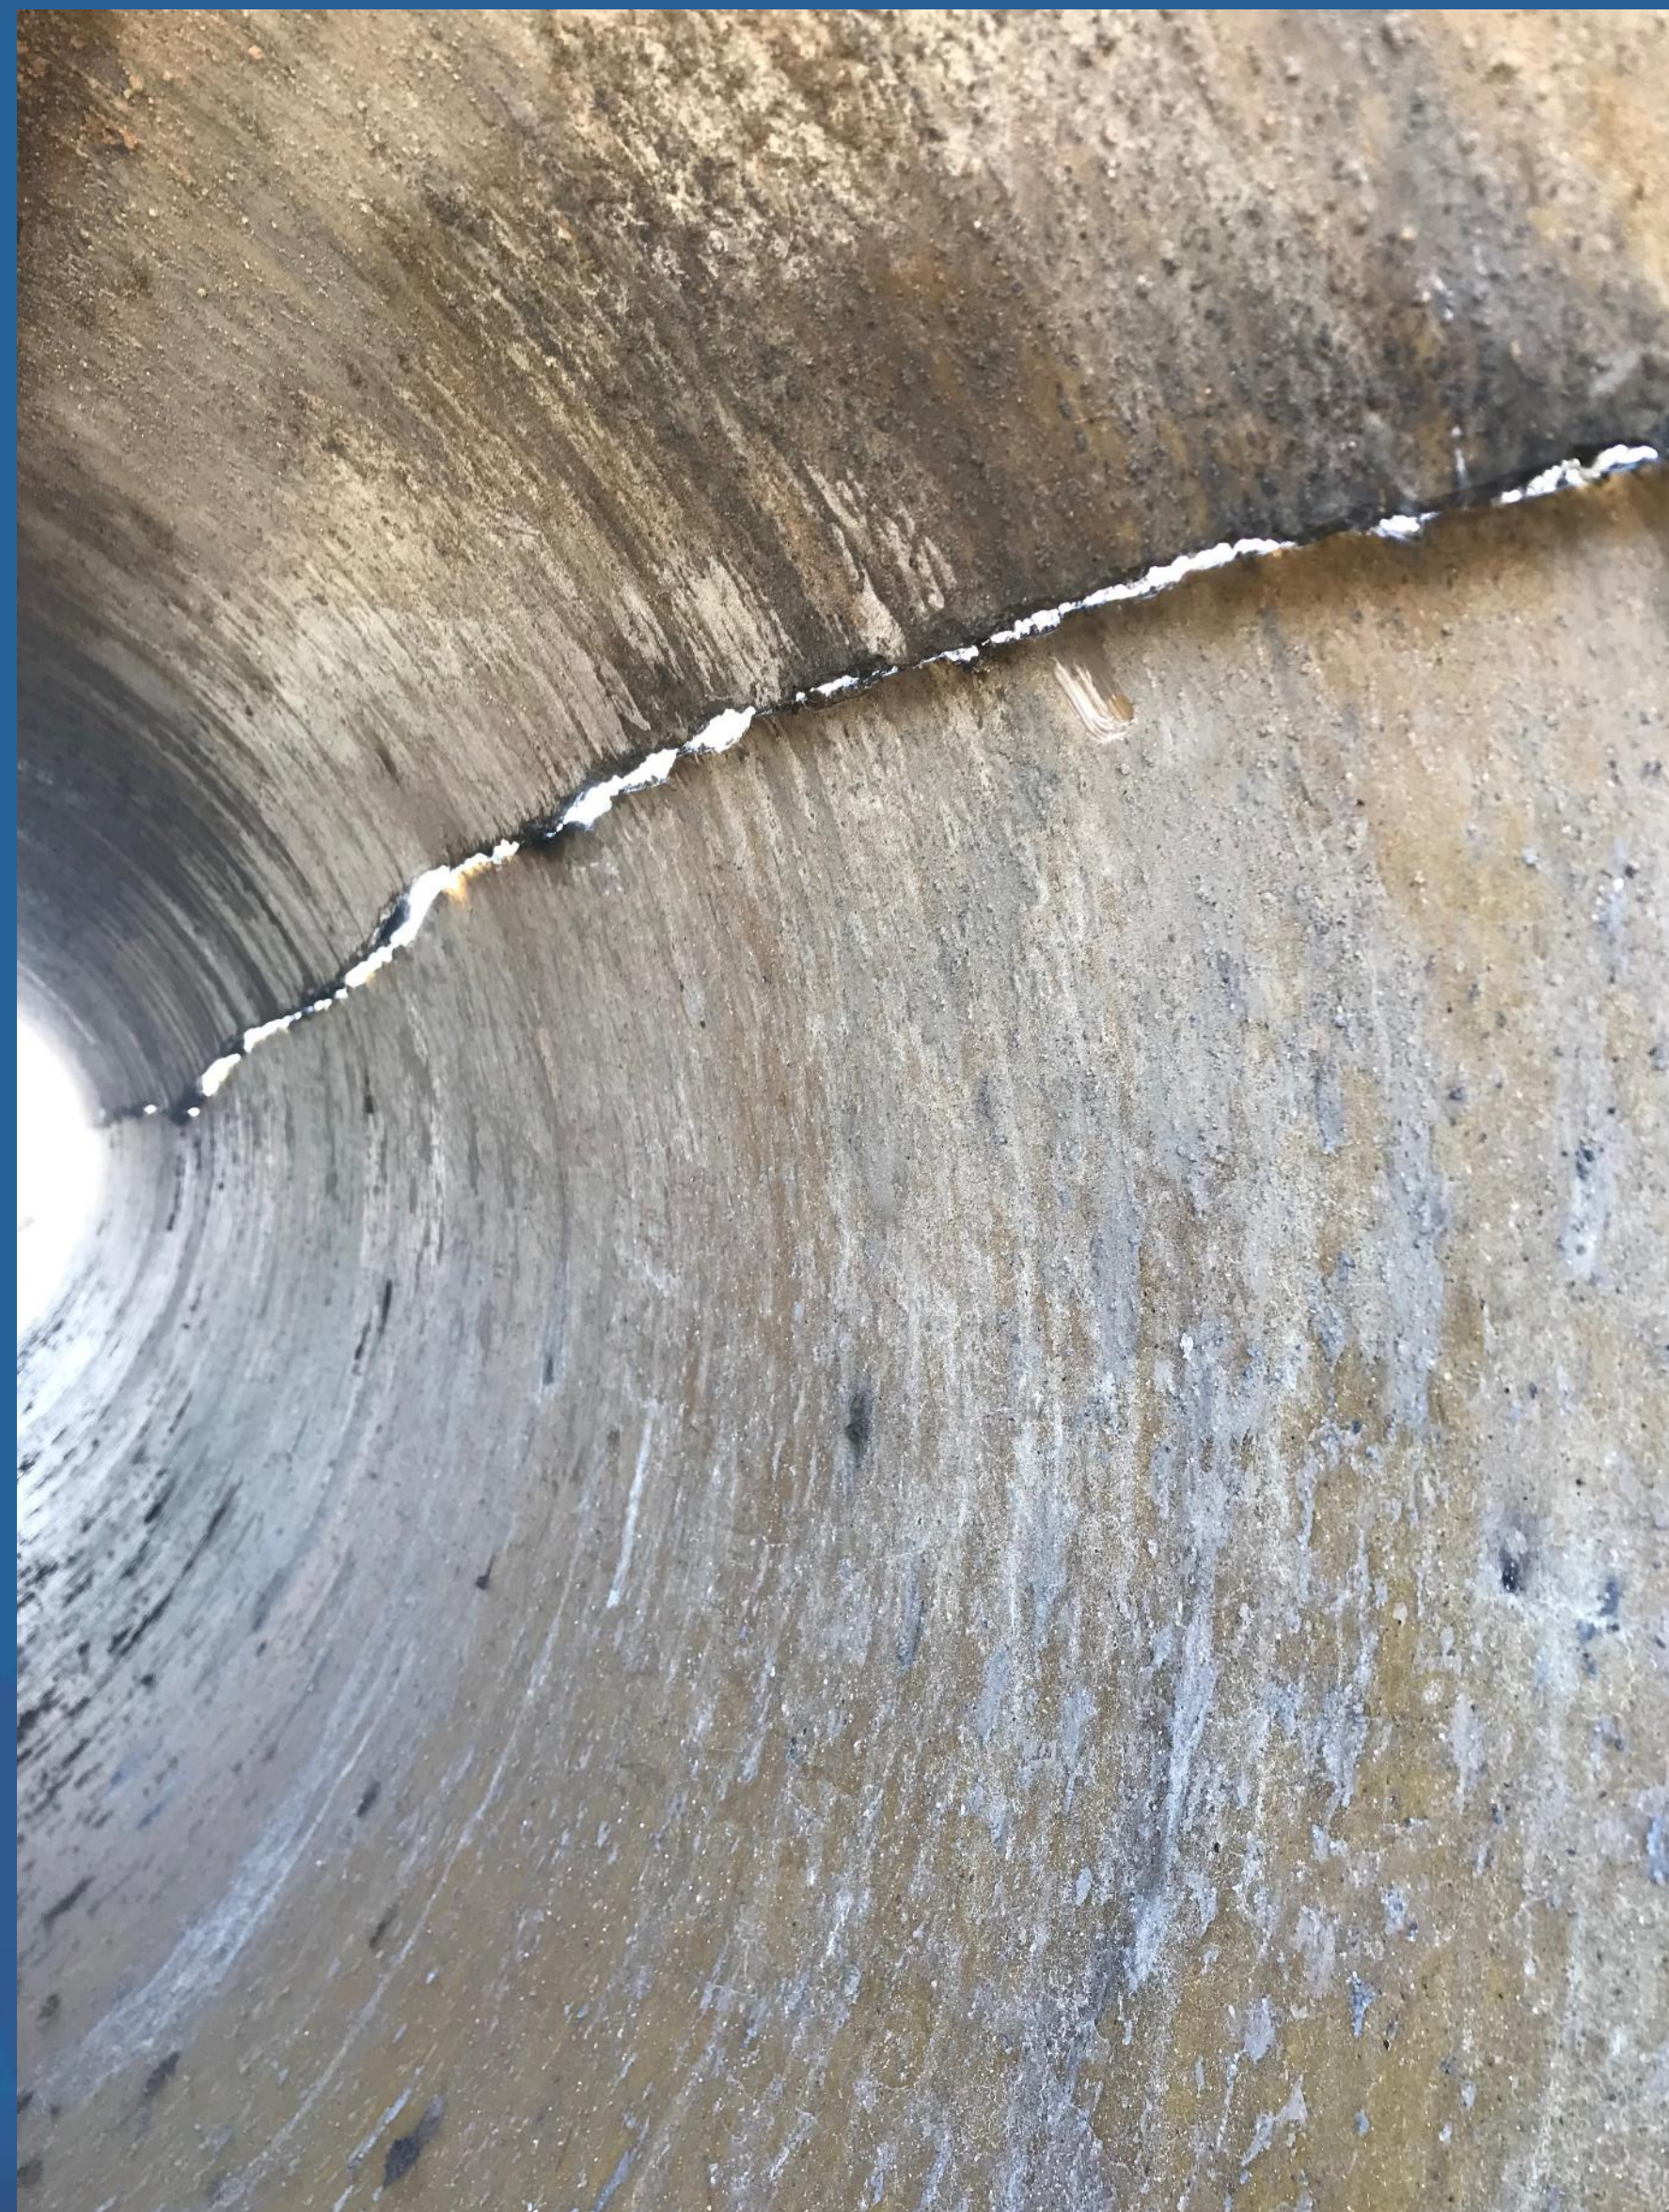
9208 Cracked Pipe

- During the removal, sand was found in the rock backfill surrounding the sewer pipe
- Trench materials and backfill around the pipe were saturated with water
- 5 of the 20-foot HOBAS pipe sections were cracked longitudinally the entire length of the pipe

- Sand migration into the backfill can cause the trench walls to collapse away from the pipe
- The wet trench conditions during the initial installation may have further compromised the trench structure
- Inadequate pipe bedding material surrounding the pipe can lead to pipe failure
