# Information Item: Minneapolis Pipe-In-Pipe Repairs

Environment Committee

May 10, 2022

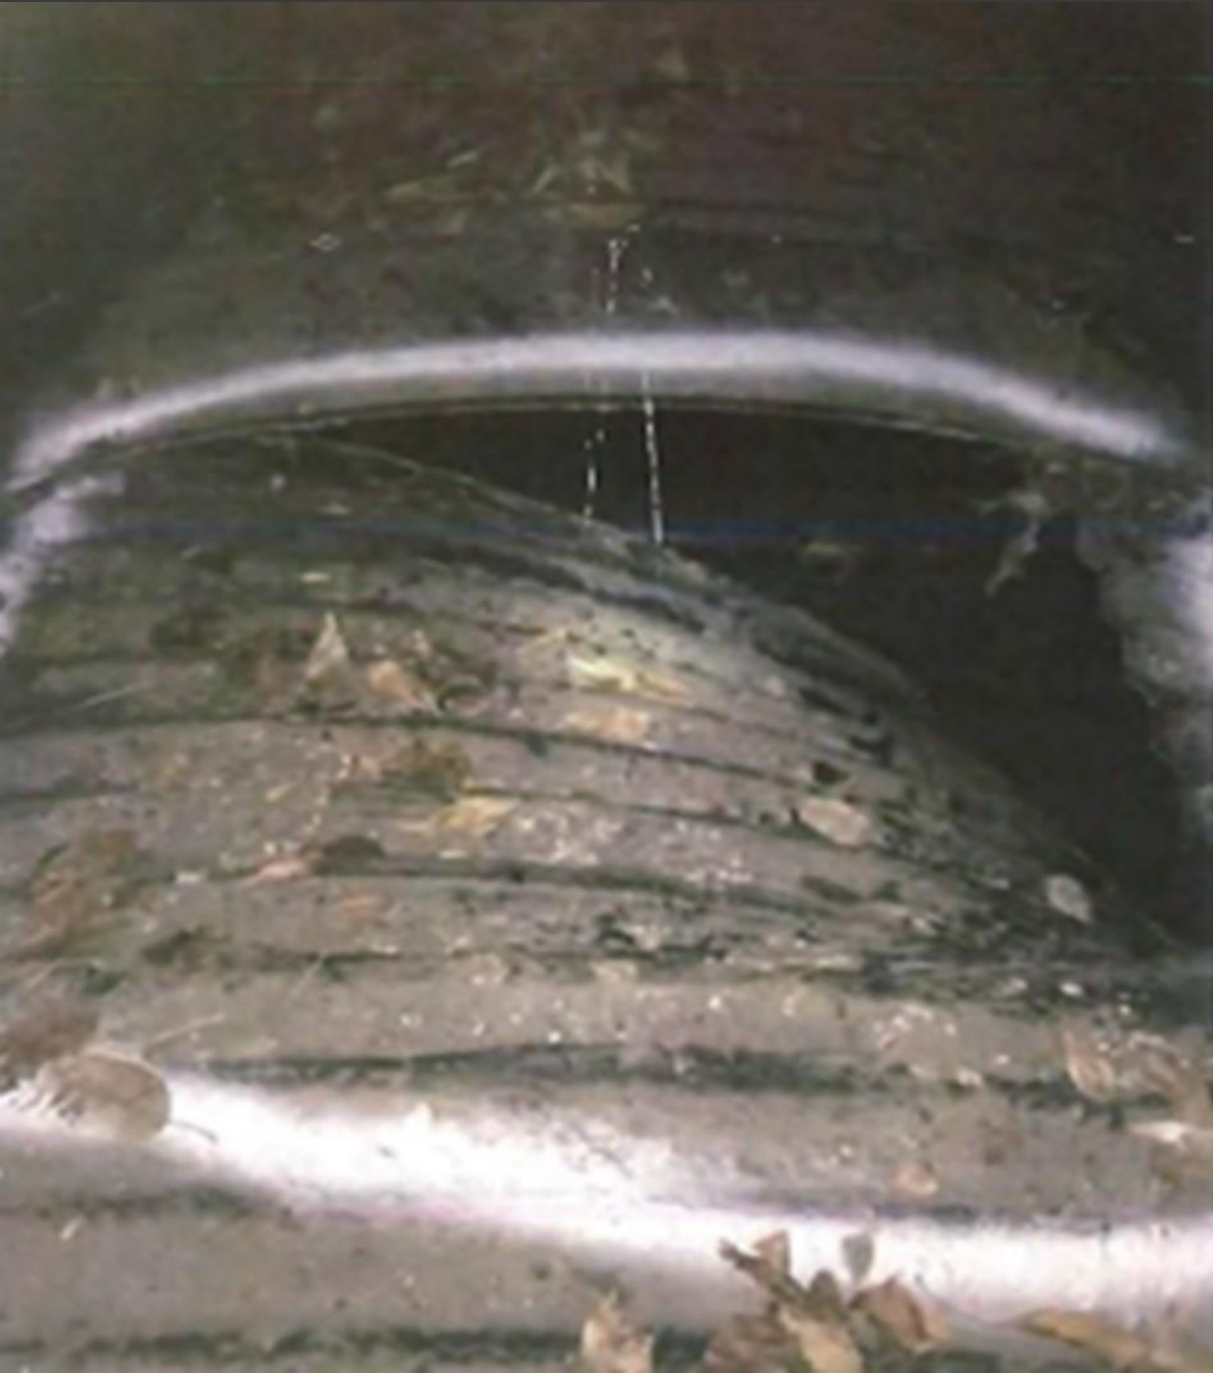
- Pipe-in-pipe is difficult to maintain with main access through City of Minneapolis storm sewer maintenance structures
- Limited locations to insert a camera for televising the inside conditions
- Frequent inspection and maintenance by walking storm sewer
- Repaired areas are susceptible to wear and damage from storm debris

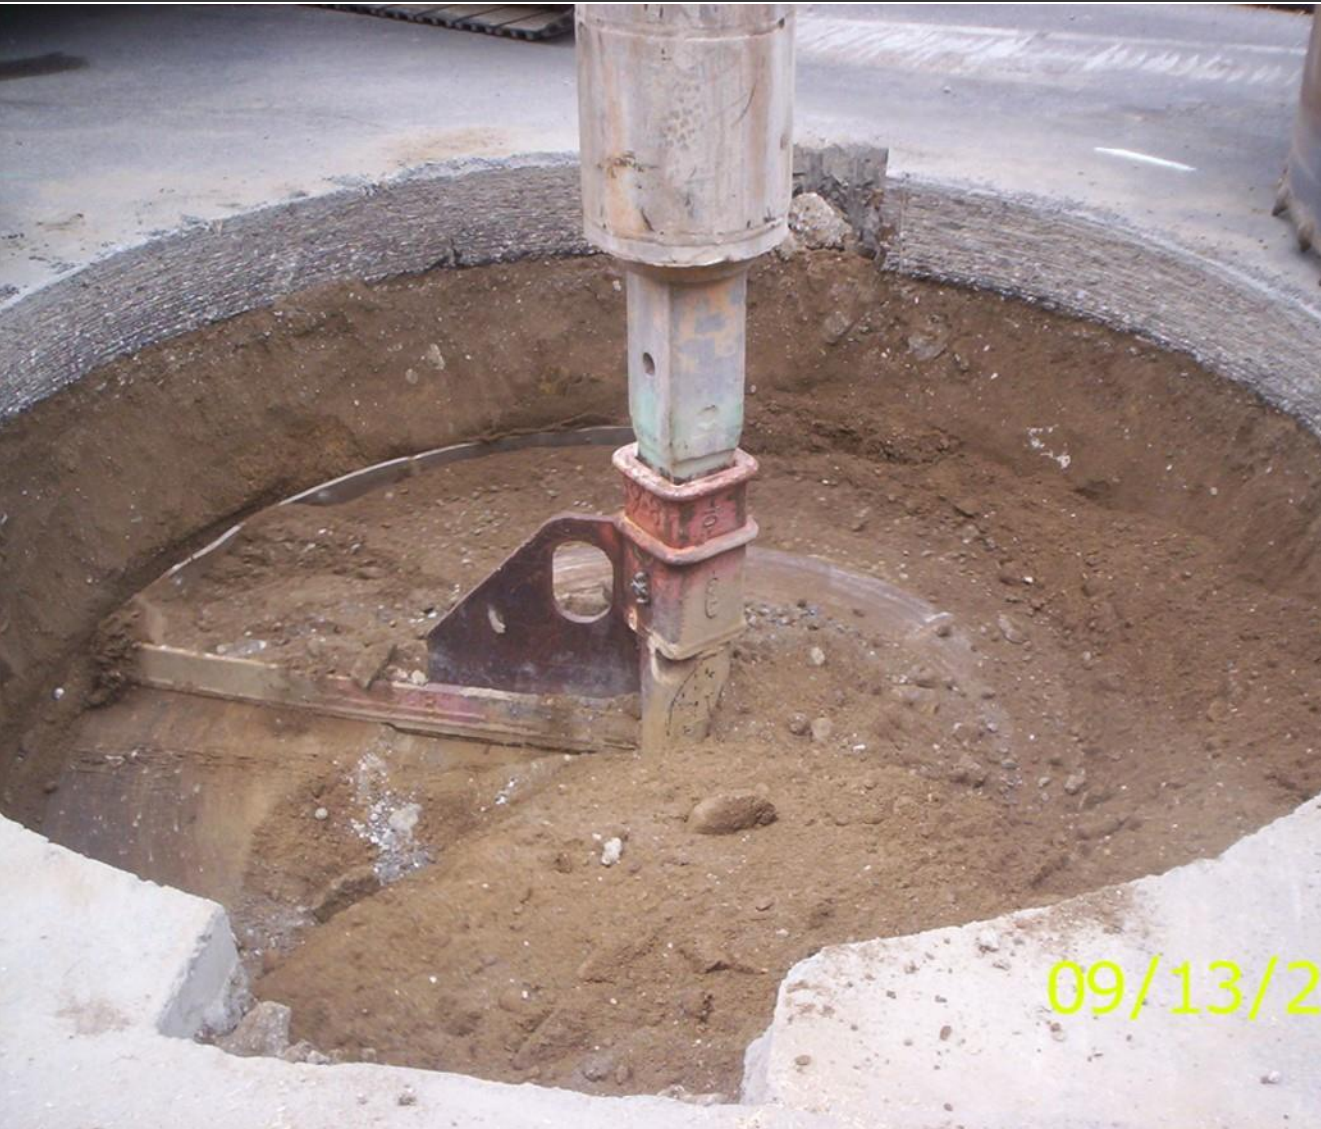
**Excavations were drilled down to concrete sewer**

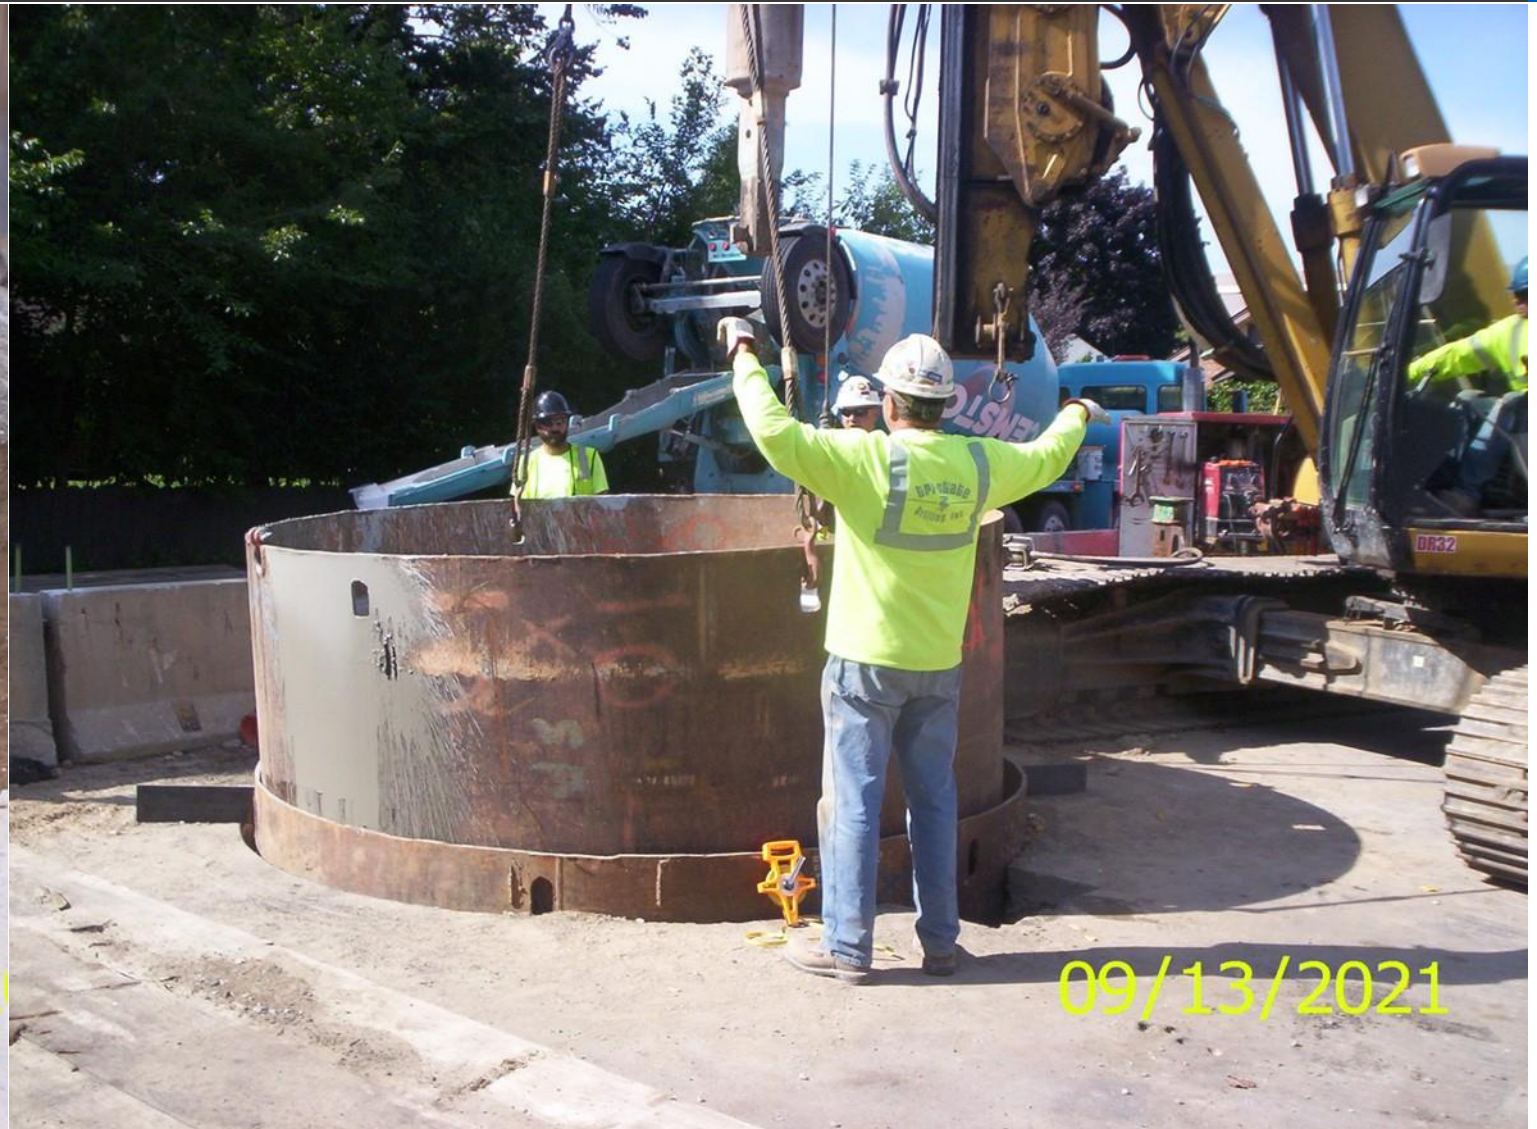
**Steel casing was used to support the soils**

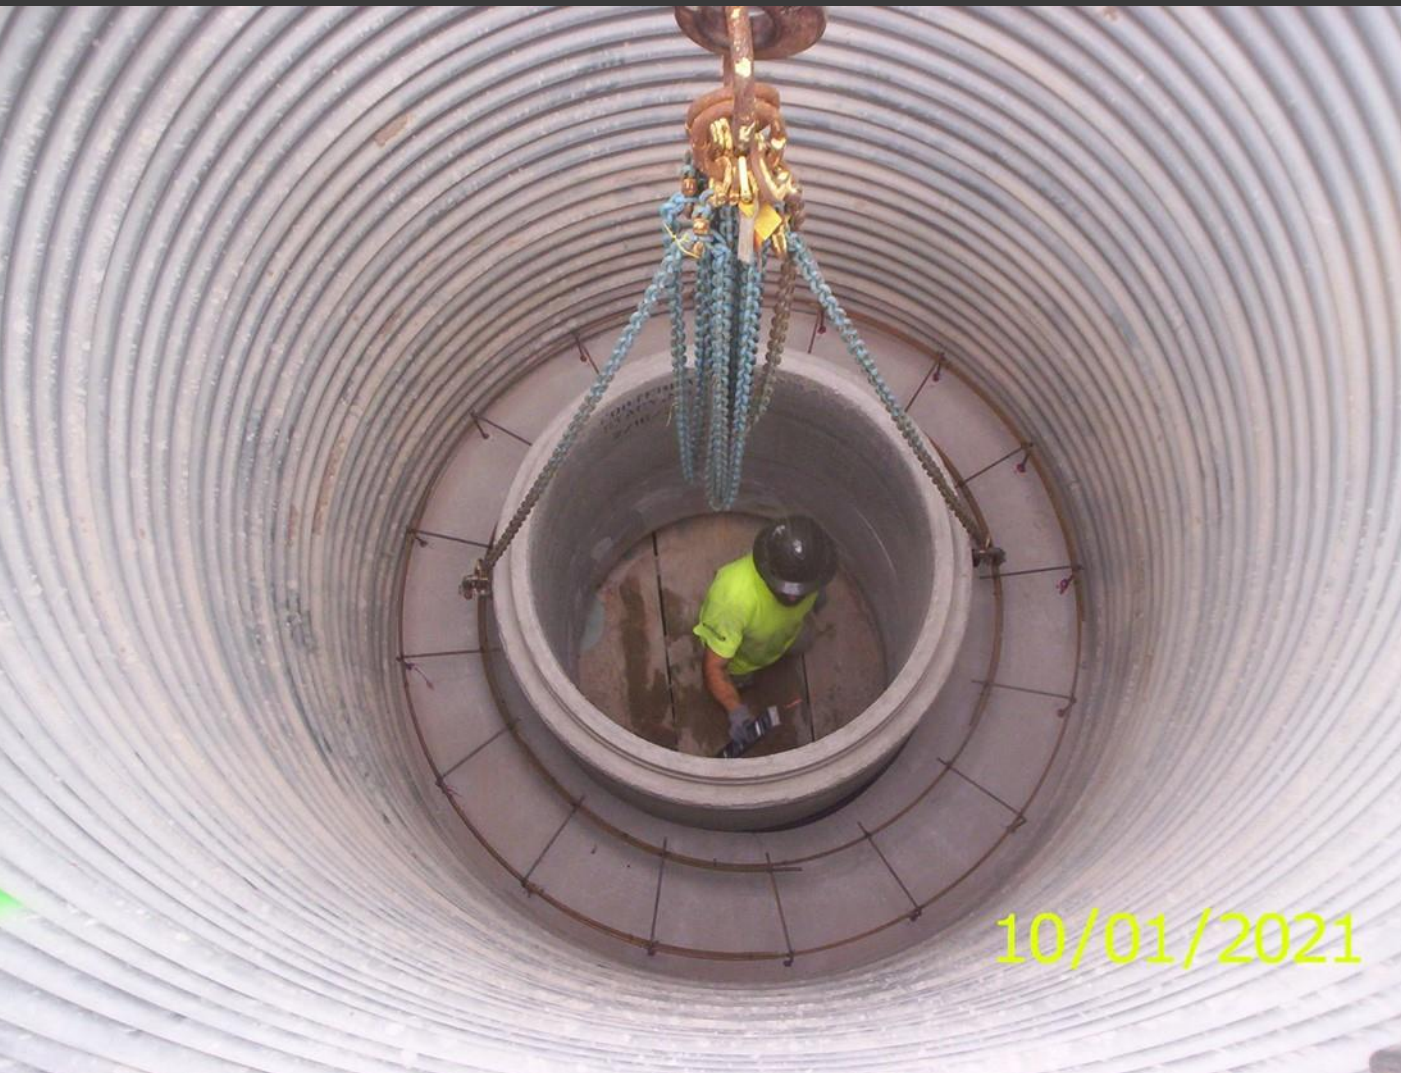
**Corrugated pipe used to form inside of concrete outer structure with new internal access riser formed over pipe**

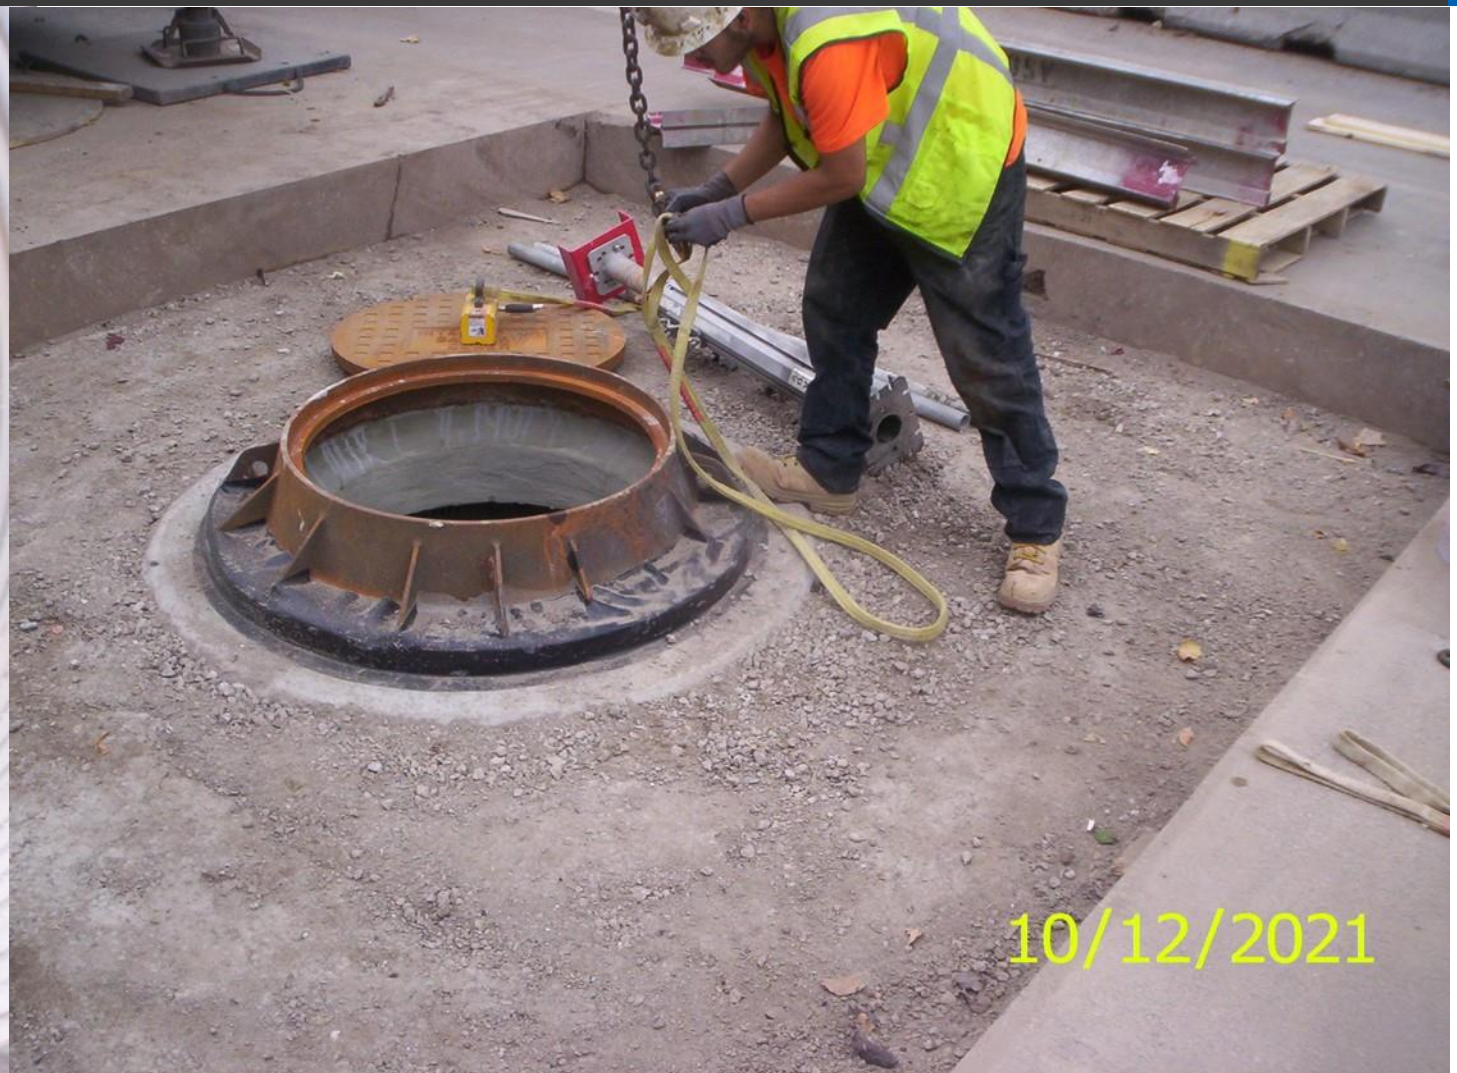
**New top slab and casting are set to match existing street**

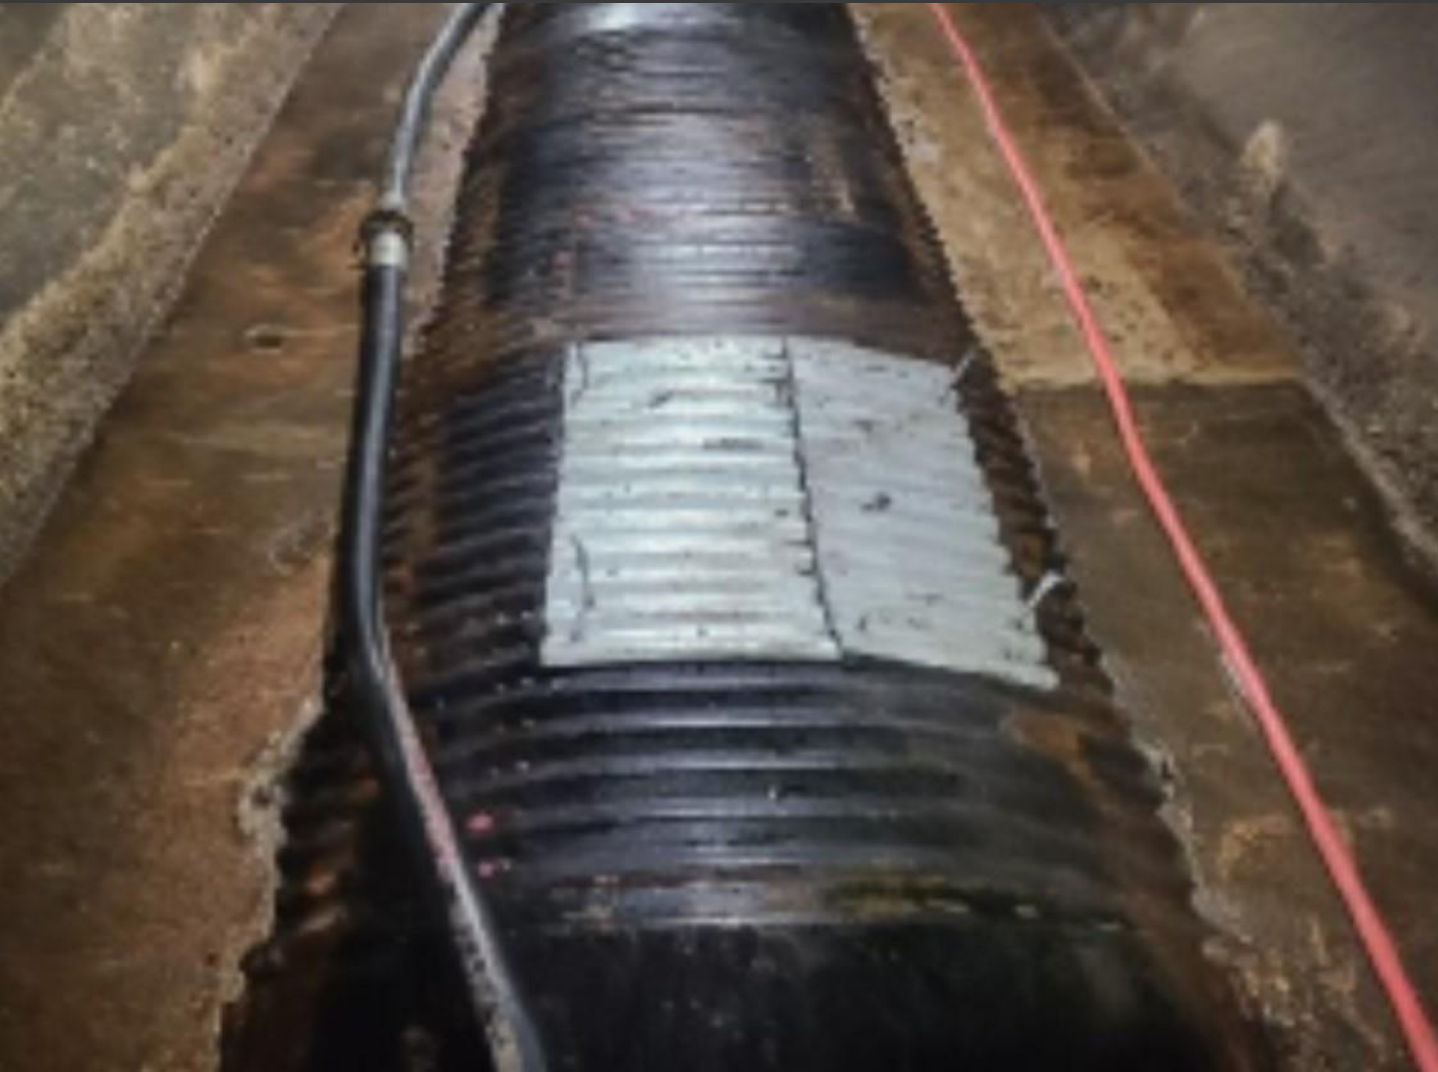
**Interceptor pipe is repaired and cleaned**

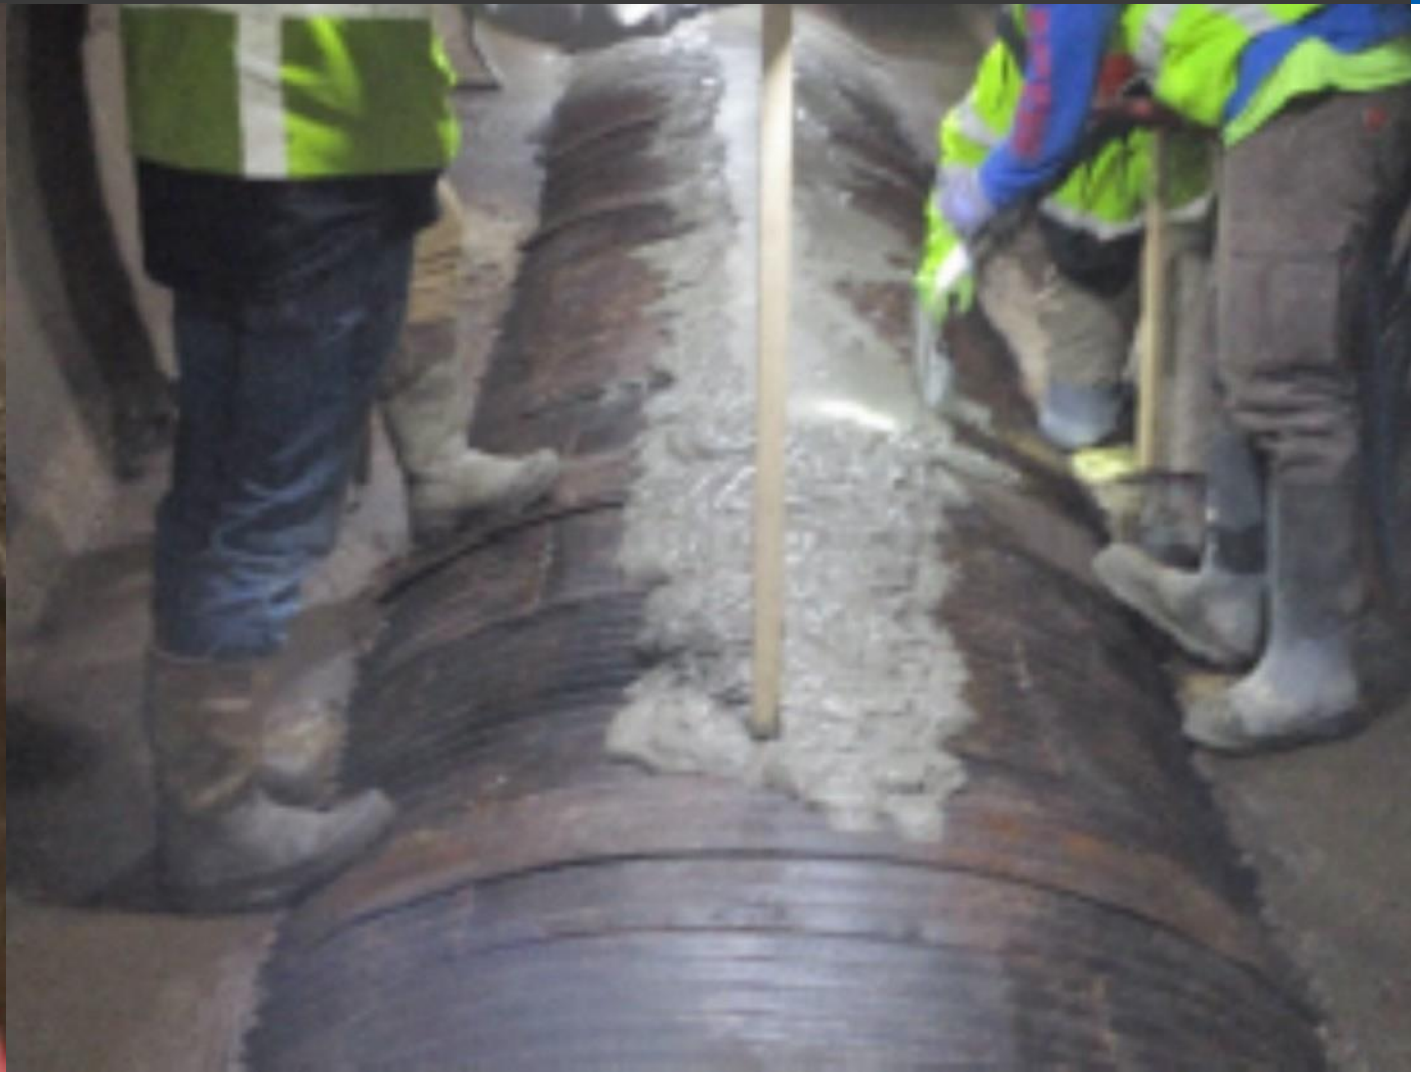
**Geopolymer concrete mat is applied to corrugated pipe**

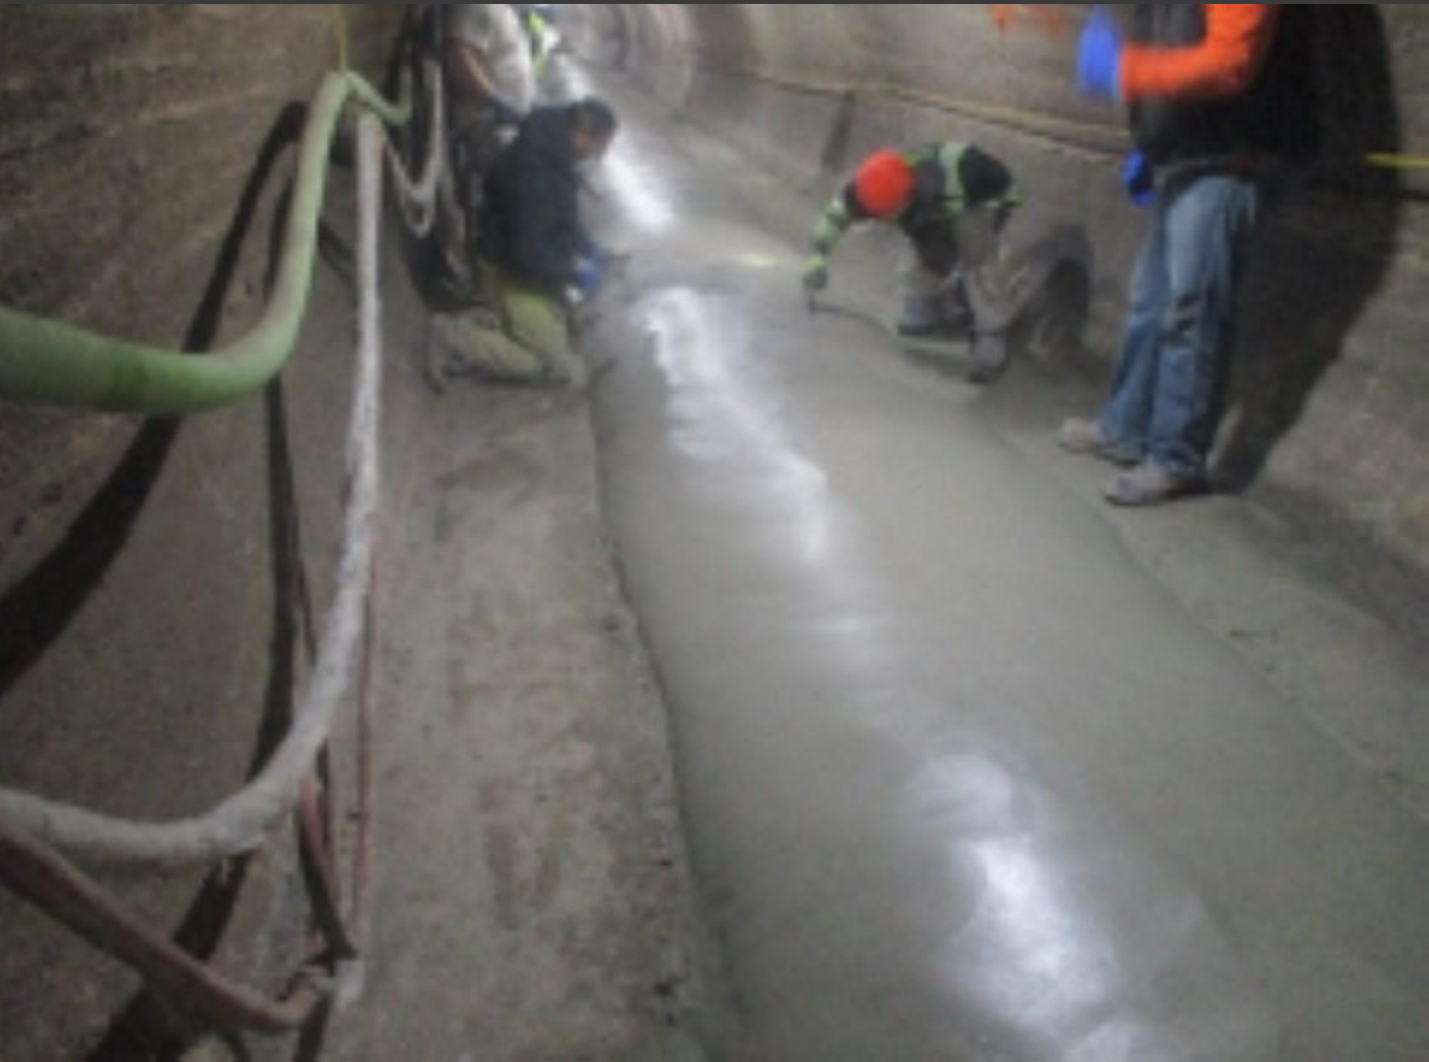
**Polymer mat is troweled smooth**

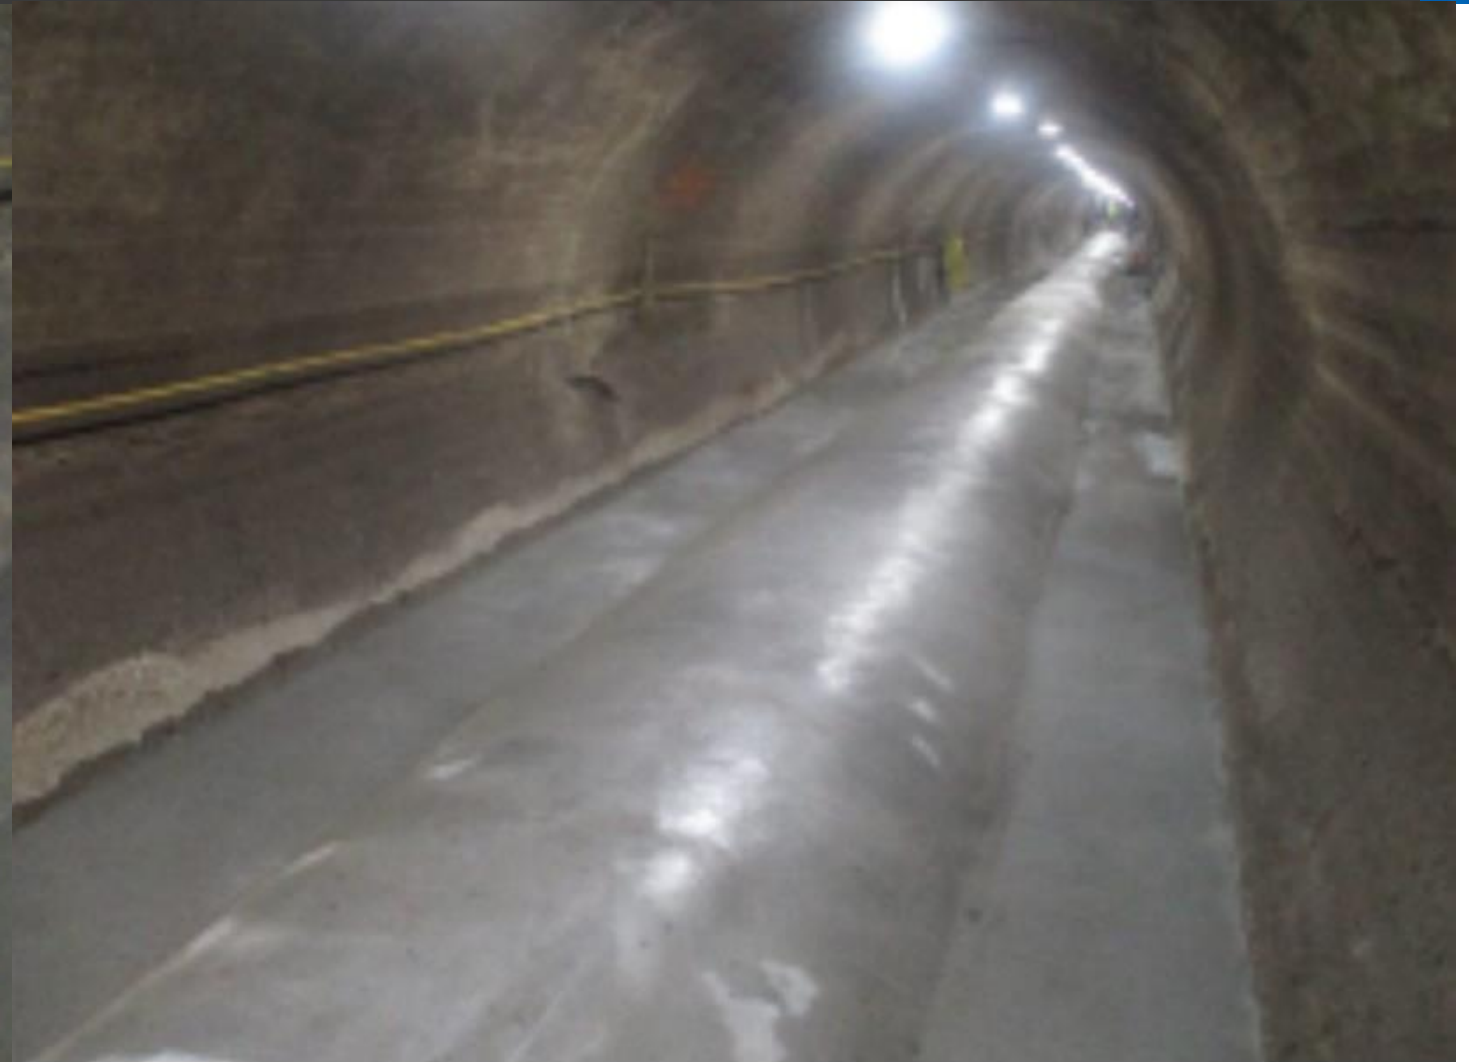
**Finished product**
