Business Item 2024-229

Ratification of Procurement After the Fact for Service Water Hydrant Repair and City Water Main

Environment Committee: October 22, 2024

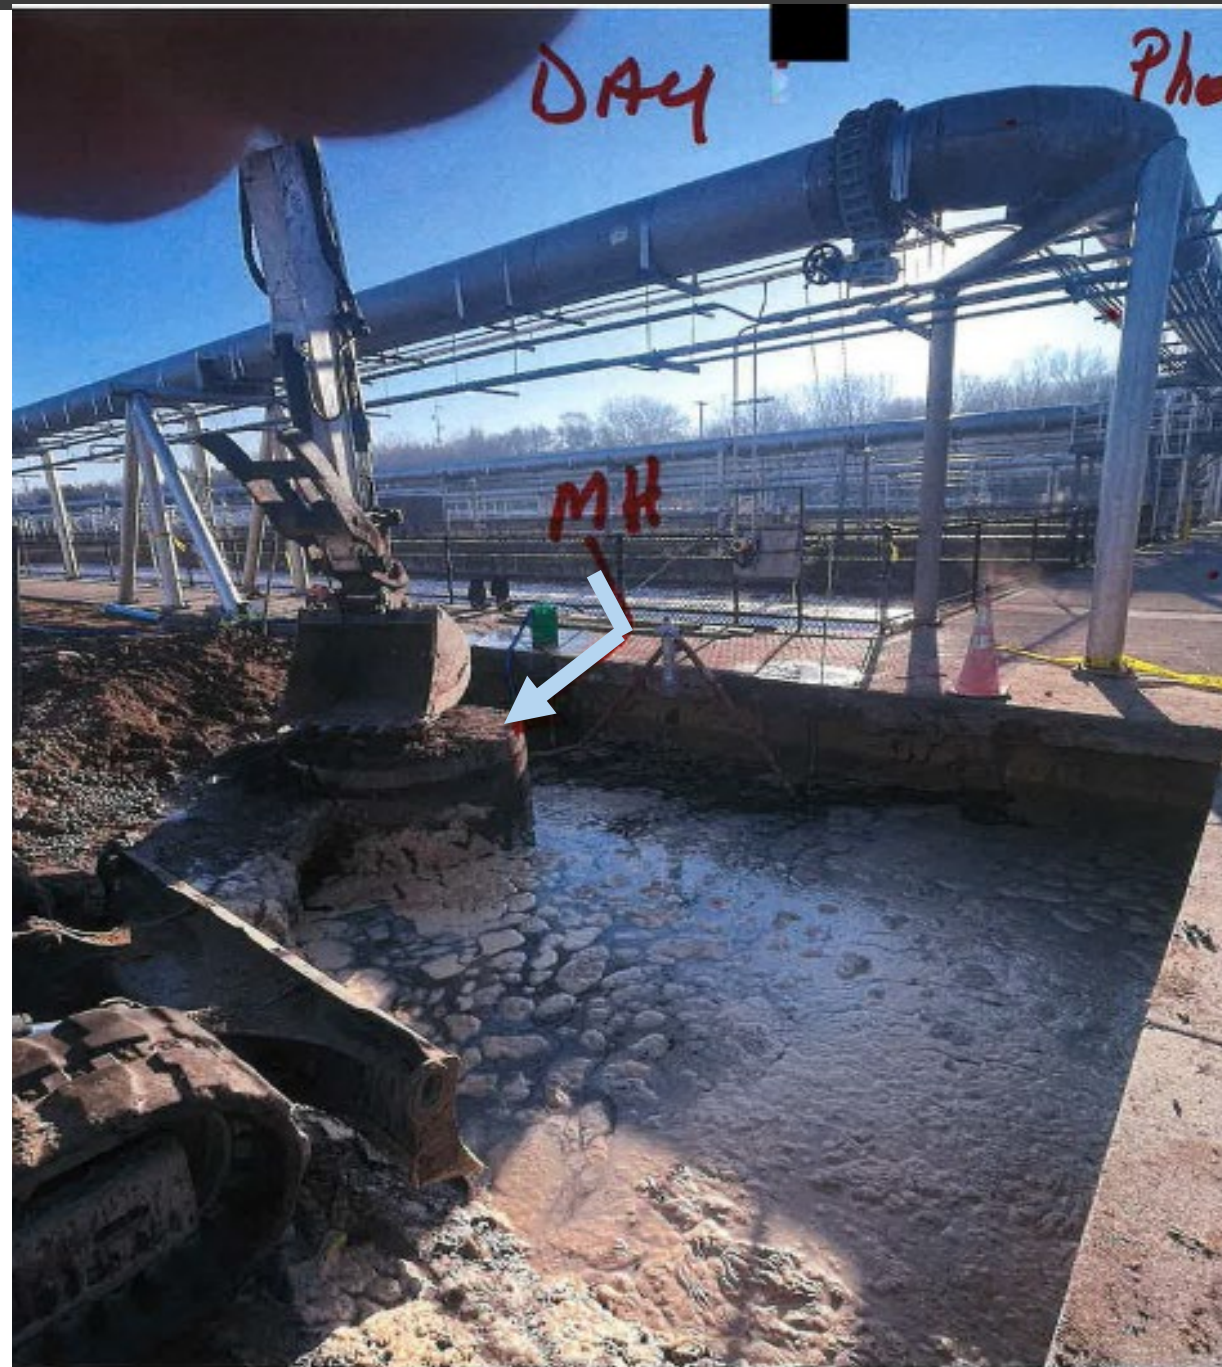
Utilities Assessment & Excavation

- Locates were scheduled and only identified the 3" yard hydrant line. Locates did not detect 30" (Ductile Iron Pipe) DIP, 2 – 2" conduits running parallel under sidewalk, or the 6" city water main located directly under the 30" DIP
- Once excavation started, water filled the hole almost immediately
- Large pumps were supplied by the contractor but were not able to keep up with the flow of water. At this point it was decided to utilize plant groundwater pumps to pump water from the site
- The plant pumps were able to pump down the excavation site and the utilities were uncovered and discovered that the city water main was cracked and rotted at the tank wall

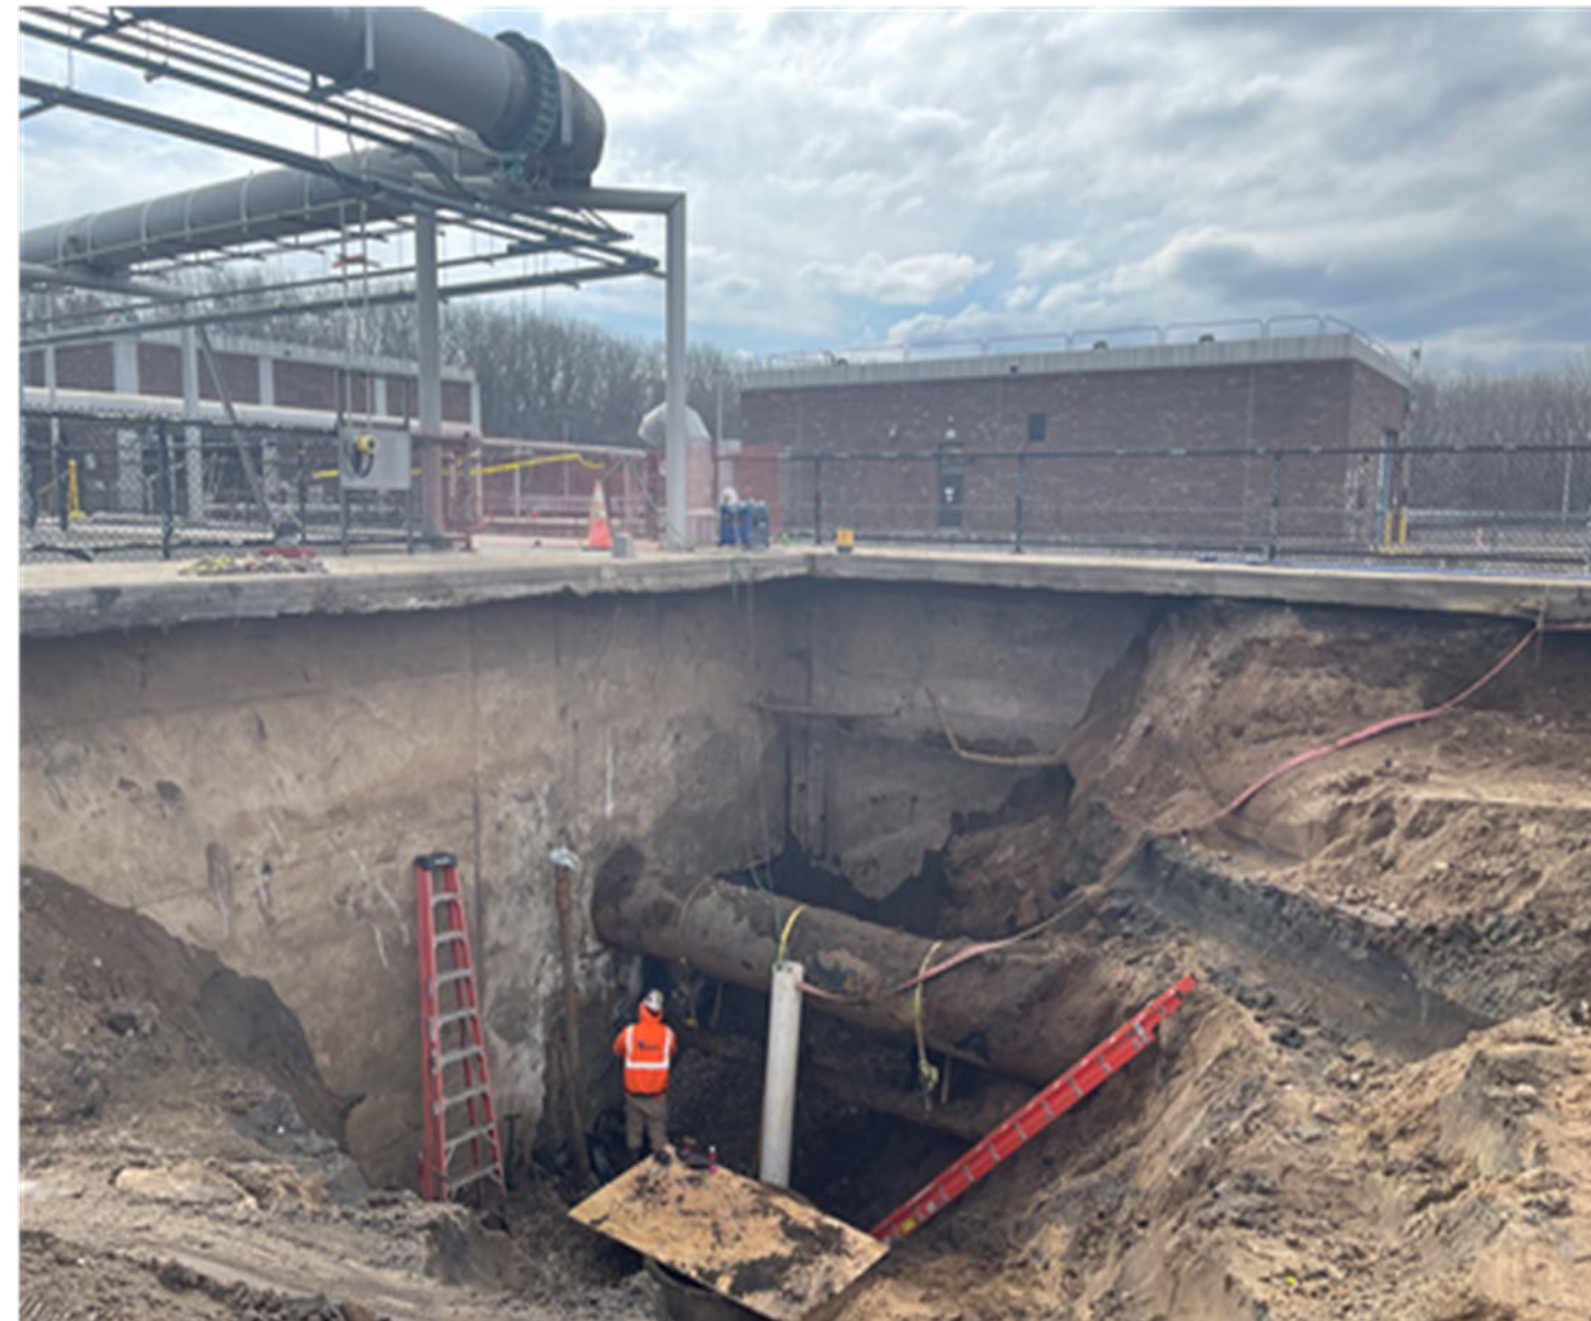
Excavation and Repairs

- As the excavation deepened, it also grew in width to prevent engulfment of crew. Safety was a high priority on this job as wet soil continued to collapse in on the hole
- Larger excavation equipment was needed to reach the depth of where the repairs were needed to be made
- A 48" diameter manhole access needed to be unstacked for the backhoe to reach the city water pipe
- For future excavations, utilities tape was laid over piping at required heights and plant drawing are being updated

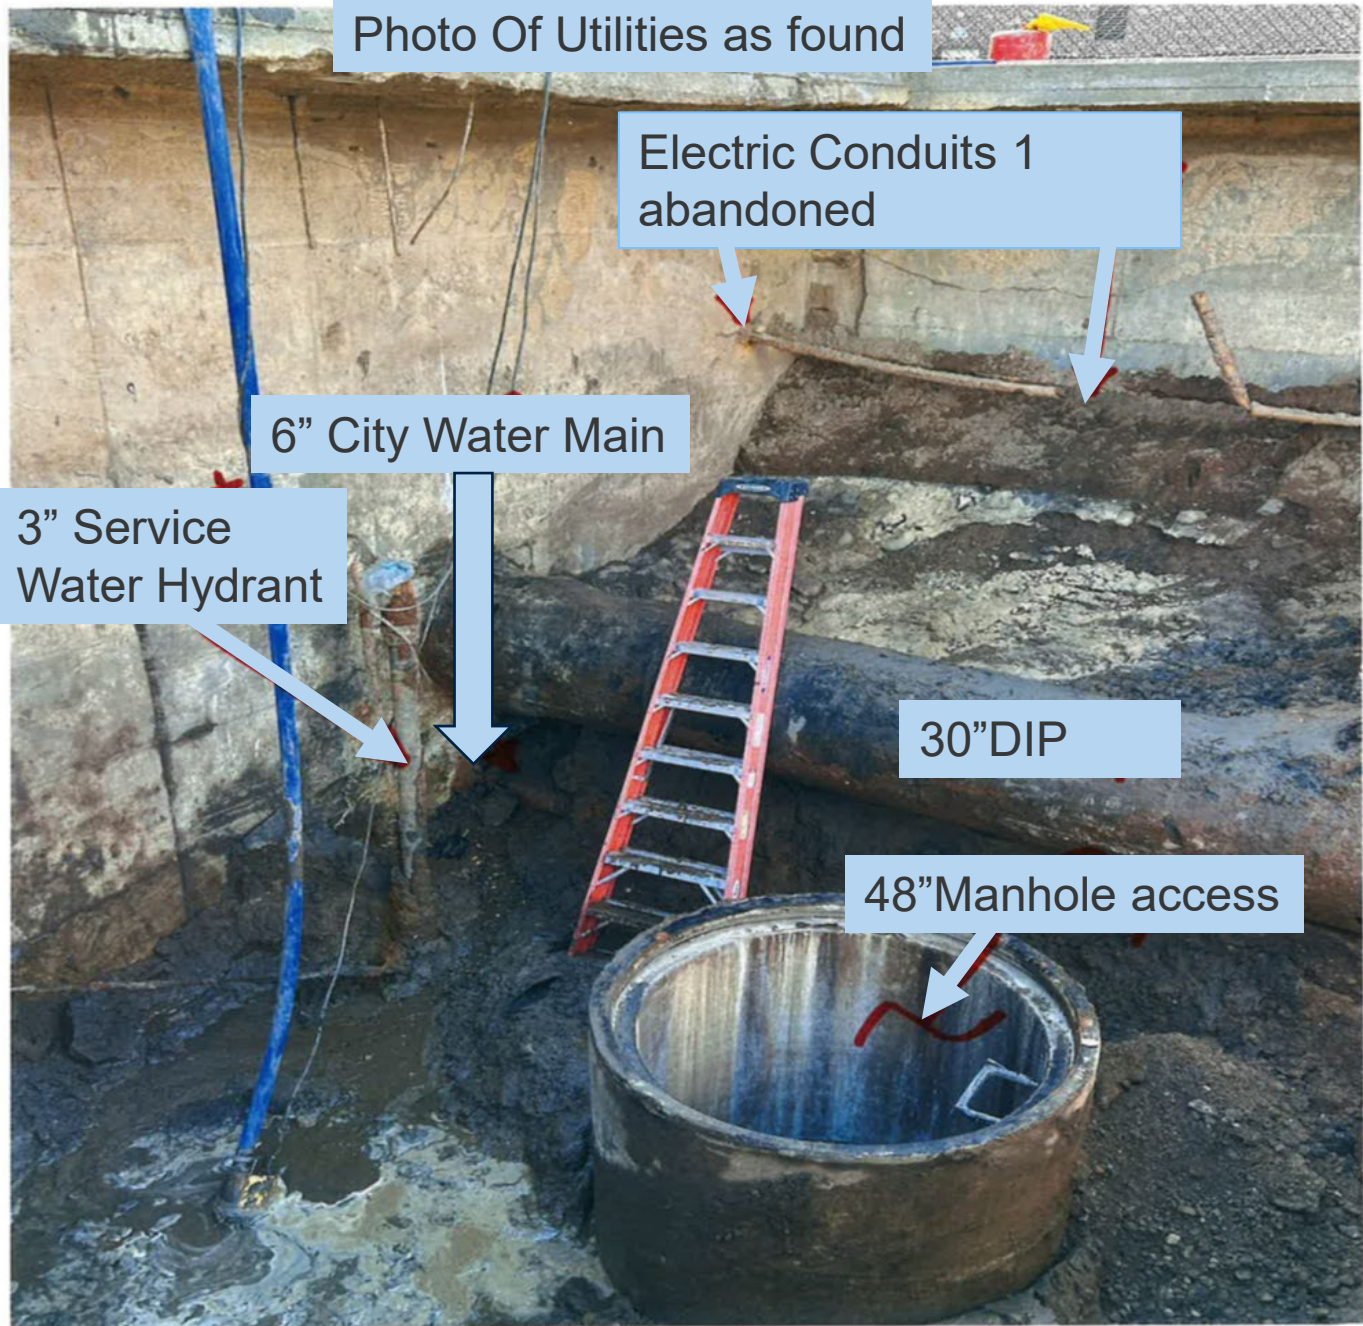
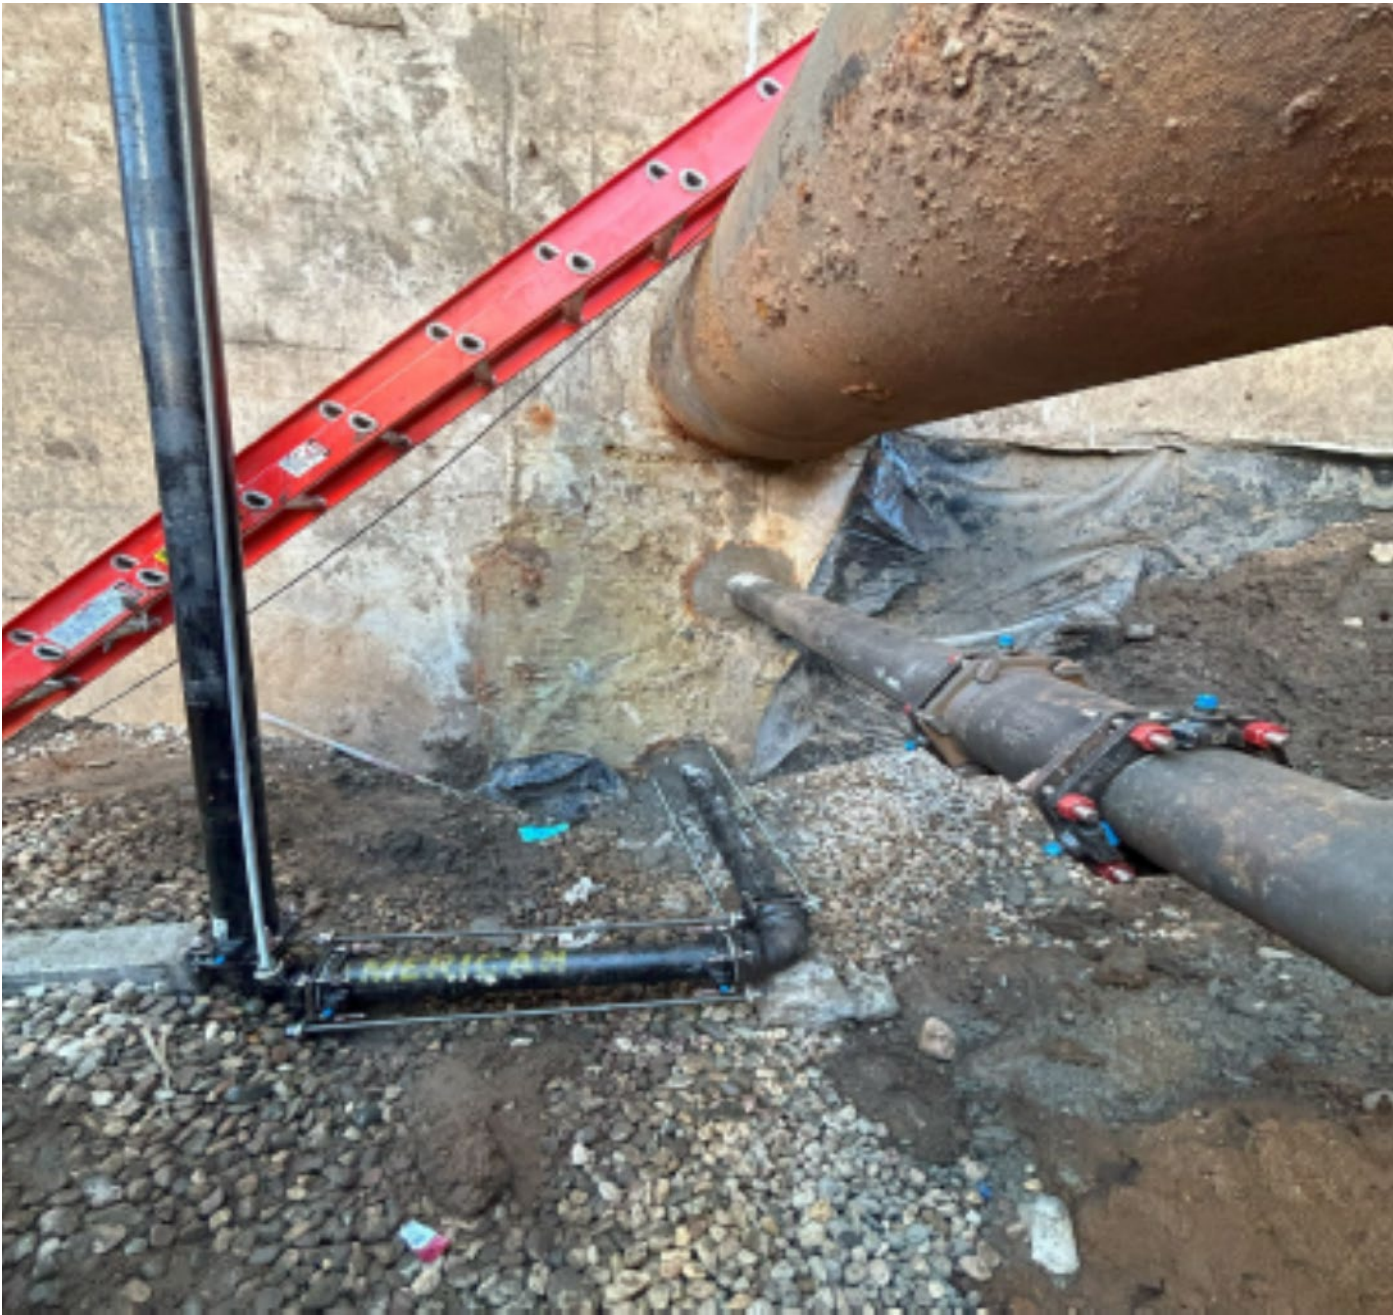
Identified all utilities in this area

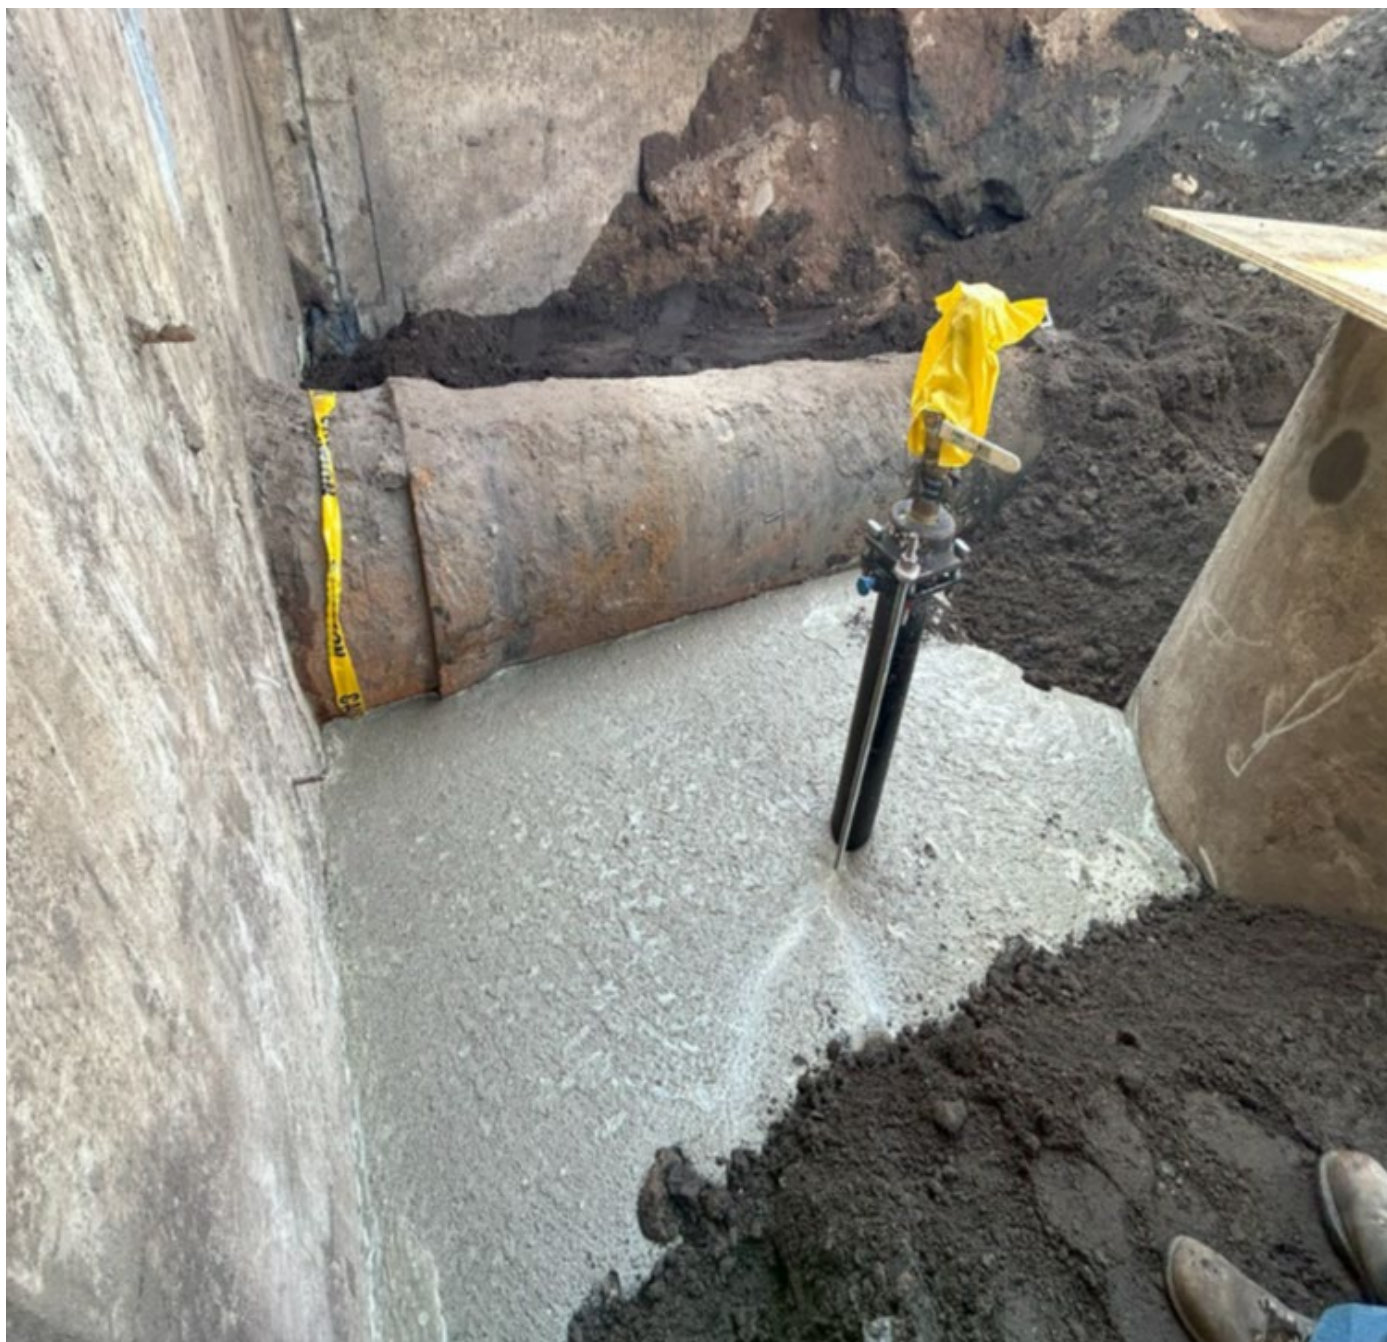
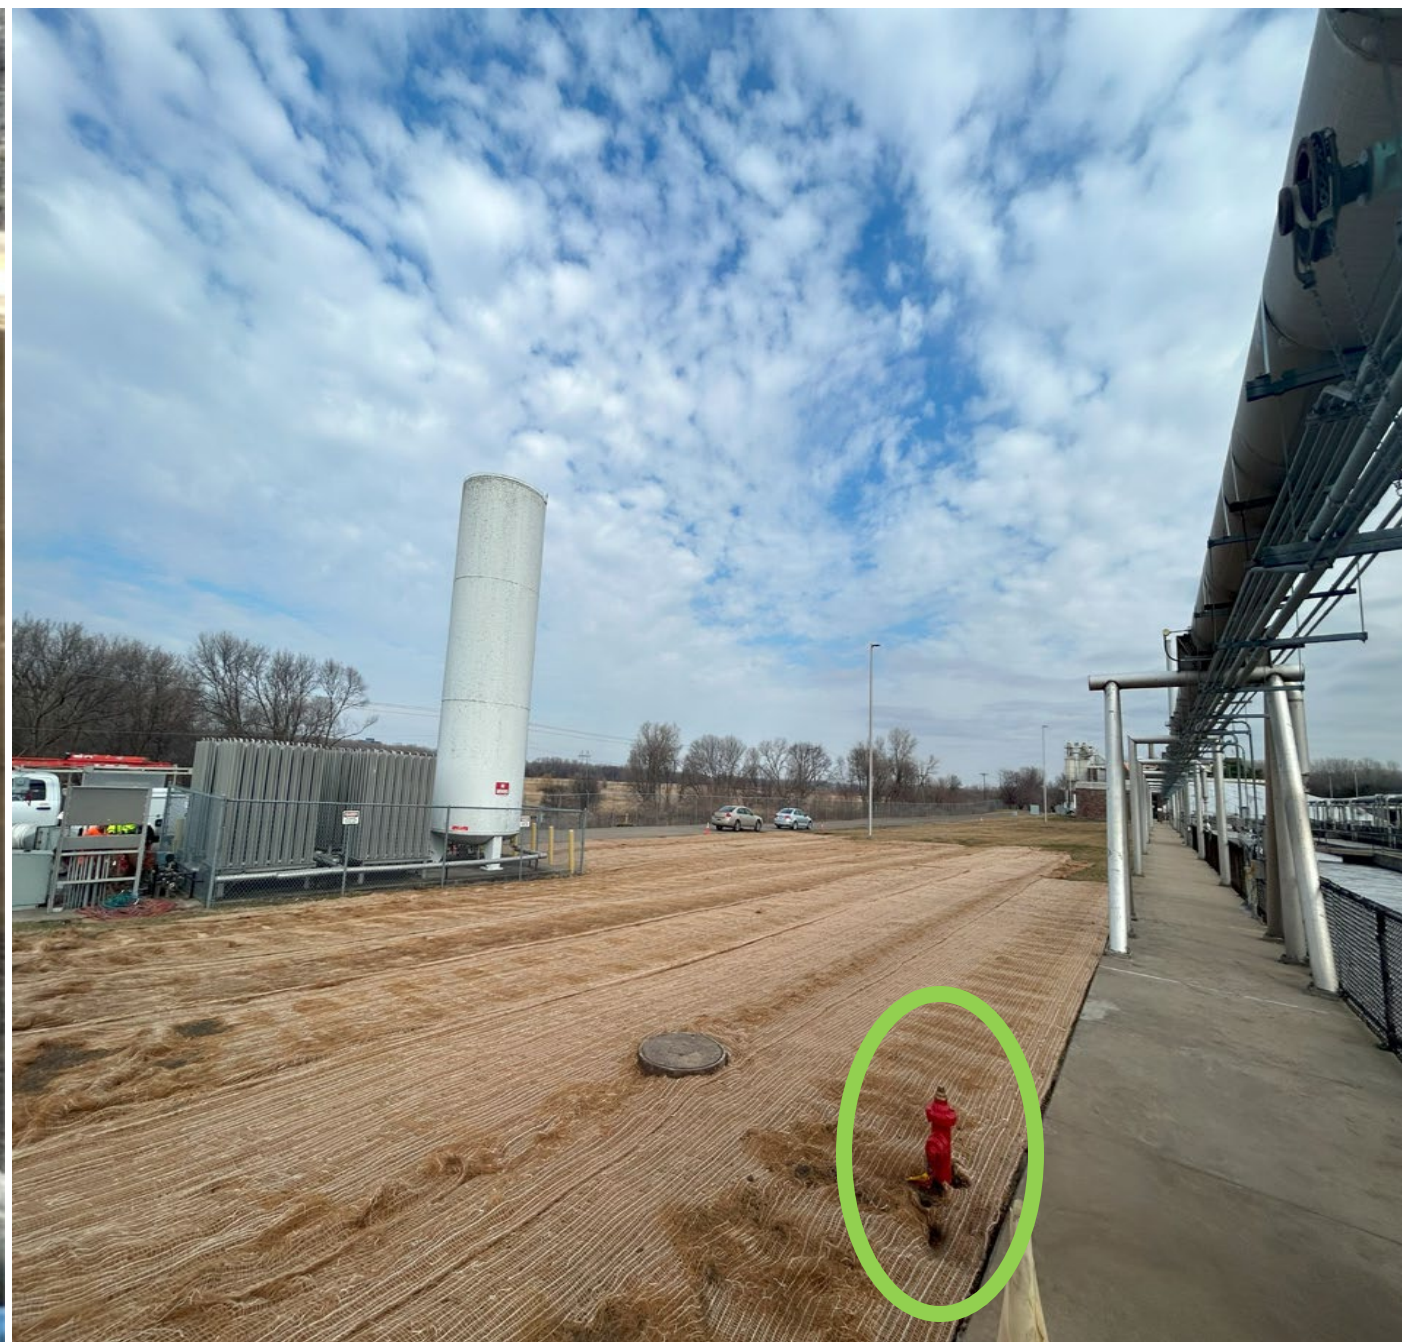
Infrastructure repaired and grounds restored
