ACTION TRANSMITTAL No. 2013-34

SUBJECT: Scope Change Request for Bridge No. 9 over the Mississippi River at the University of Minnesota

CITY OF MINNEAPOLIS PROJECT NO. SP 141-090-038
BRIDGE NO. 9 OVER MISSISSIPPI RIVER AND WEST RIVER PARKWAY

Attachment J – Condition Study Report: Bridge No. 9 Pedestrian Bridge Over Mississippi River

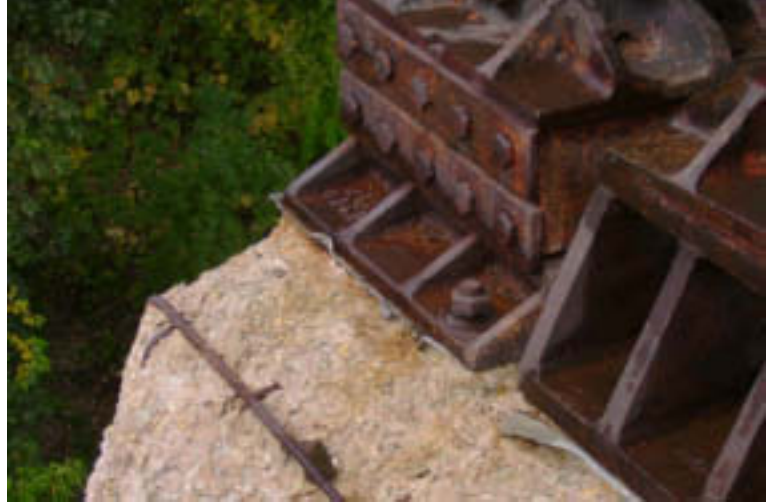
Pier 7: Pier Cap Deterioration

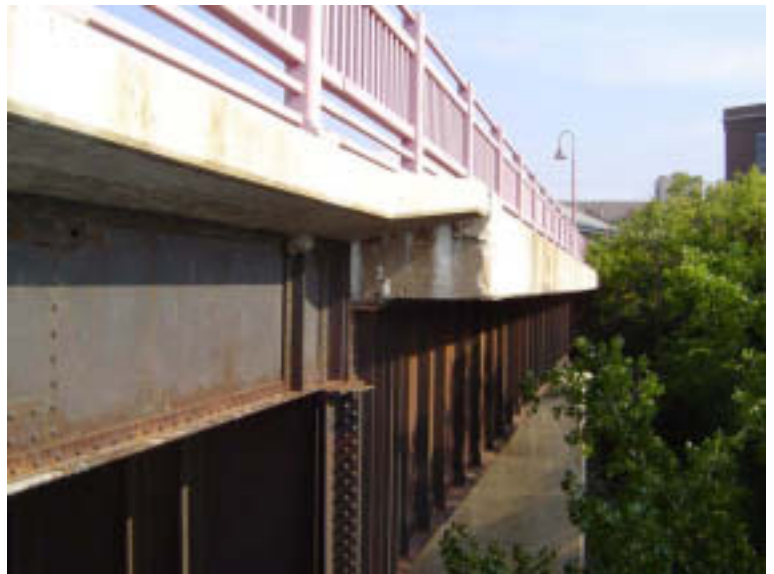
Span 2: Staining from Drainage

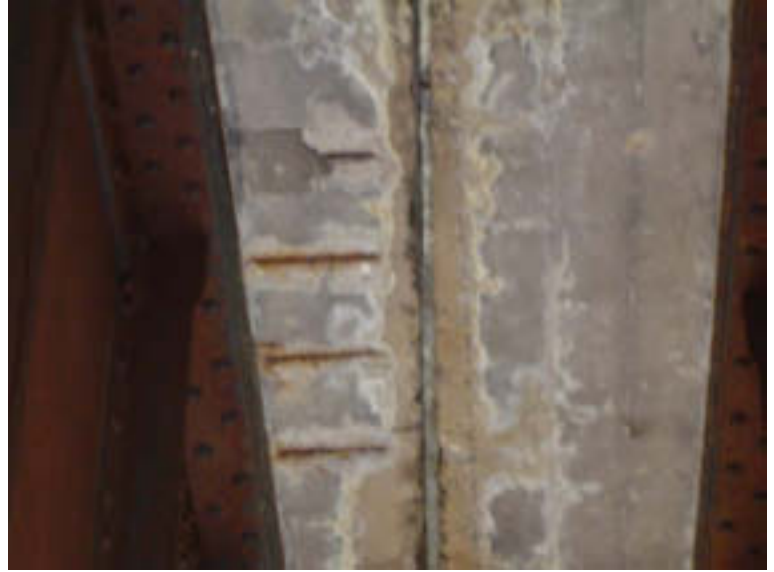
Span 6: Deck Expose Reinforcement

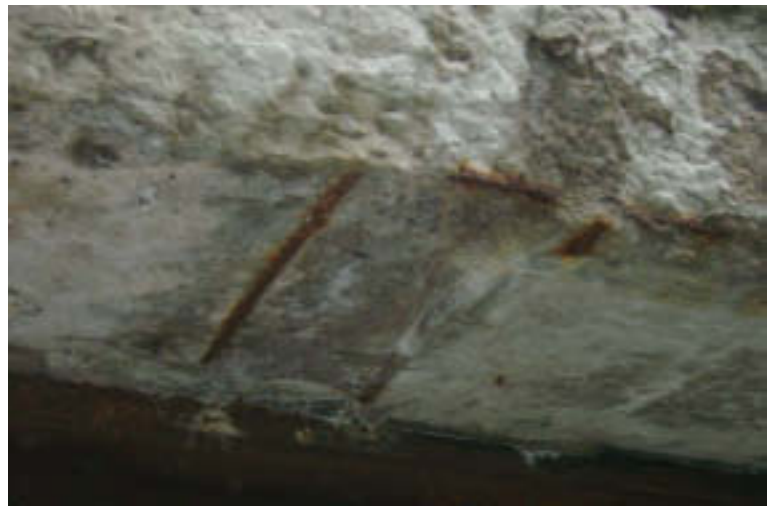
Span 6: Deck Expose Reinforcement
