ACTION TRANSMITTAL No. 2013-34

SUBJECT: Scope Change Request for Bridge No. 9 over the Mississippi River at the University of Minnesota

CITY OF MINNEAPOLIS PROJECT NO. SP 141-090-038
BRIDGE NO. 9 OVER MISSISSIPPI RIVER AND WEST RIVER PARKWAY

Attachment J – Condition Study Report: Bridge No. 9 Pedestrian Bridge Over Mississippi River

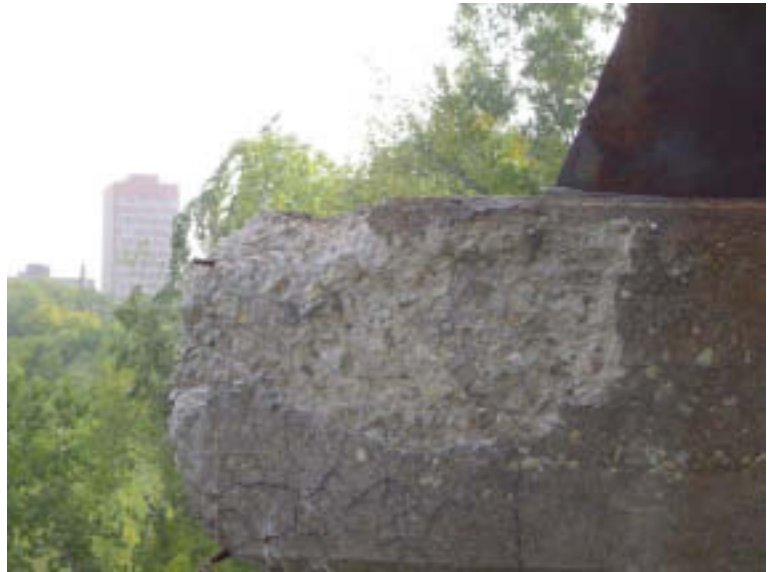
Pier 6: Pier Cap Deterioration

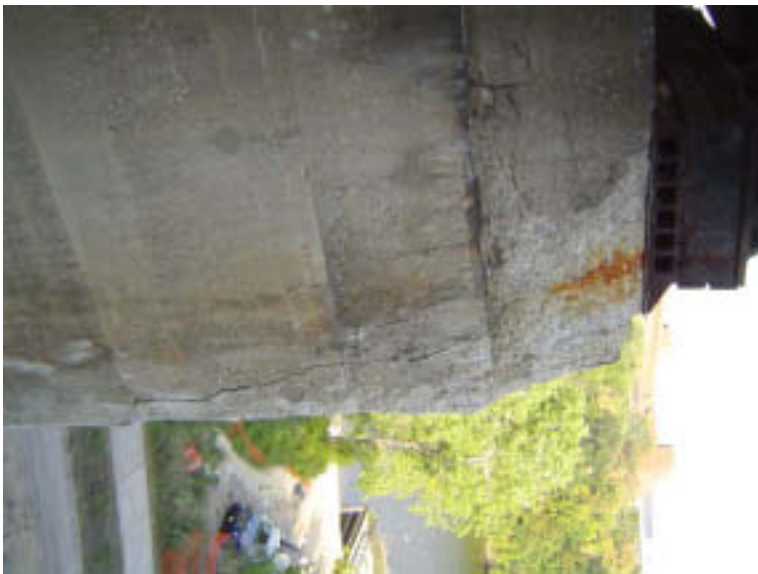
Pier 7: Pier Cap Deterioration

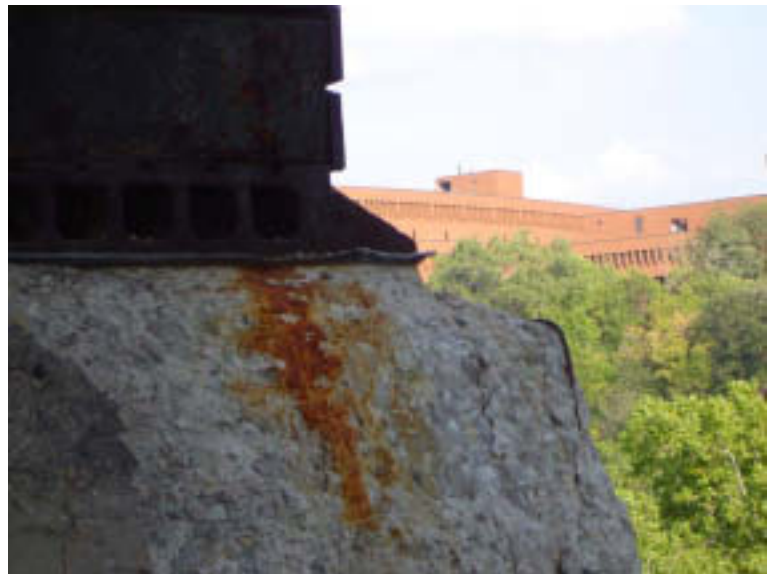
Pier 7: Pier Cap Deterioration

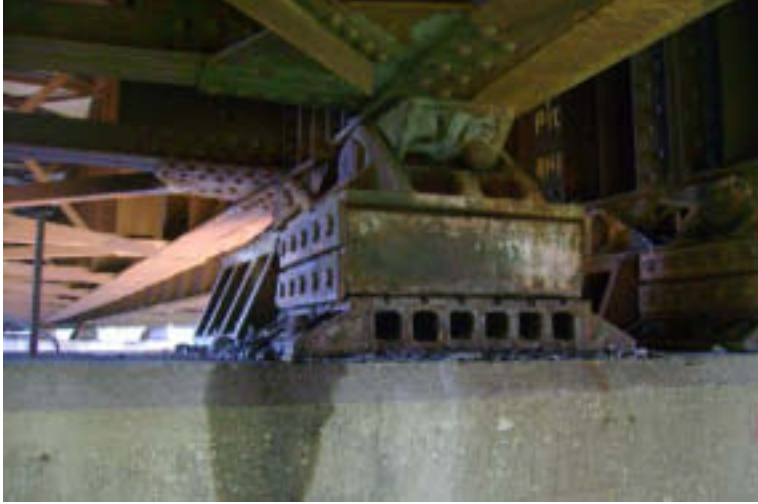
Pier 7: Drainage on Cap from Deck

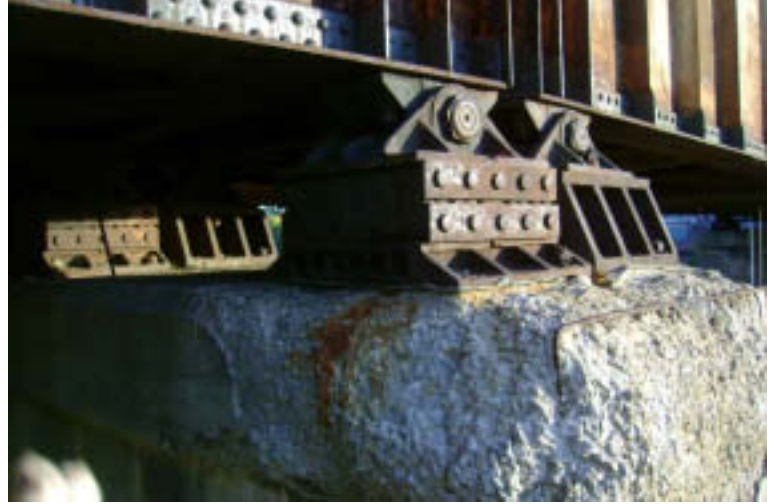
Pier 7: Pier Cap Deterioration

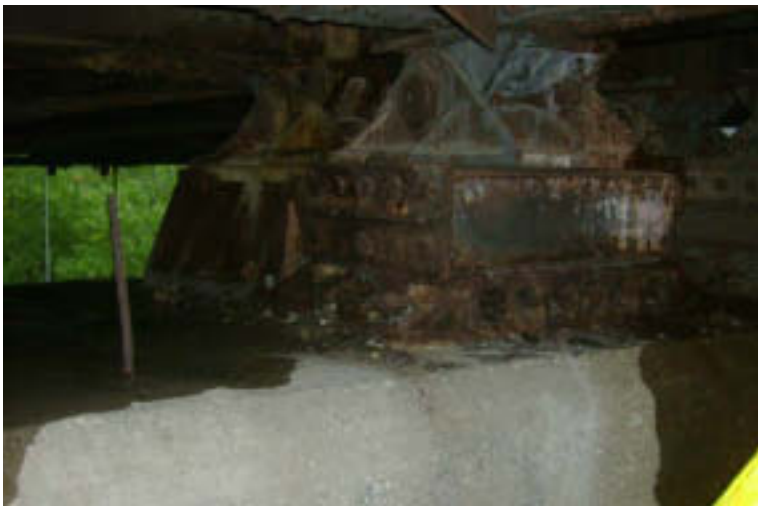
Pier 7: Drainage on Cap from Deck

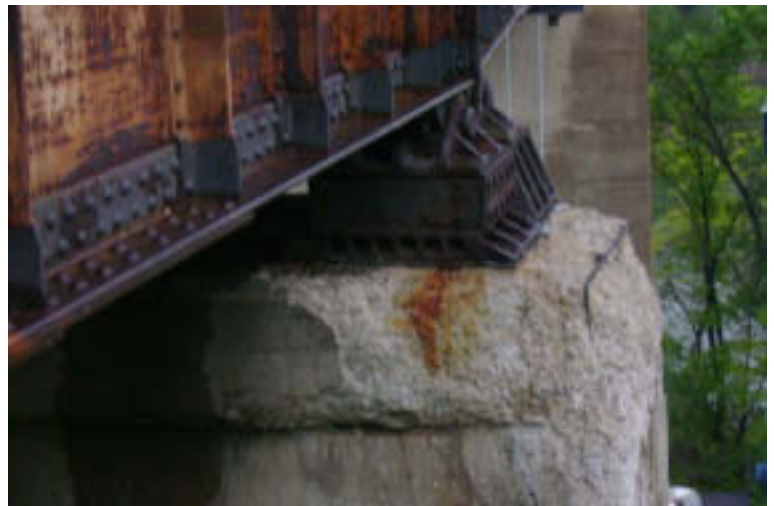
Pier 7: Pier Cap Deterioration

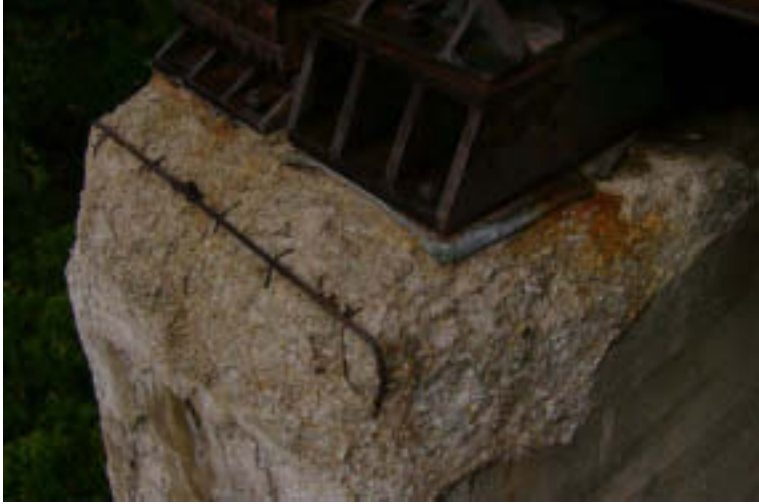
Pier 7: Pier Cap Deterioration

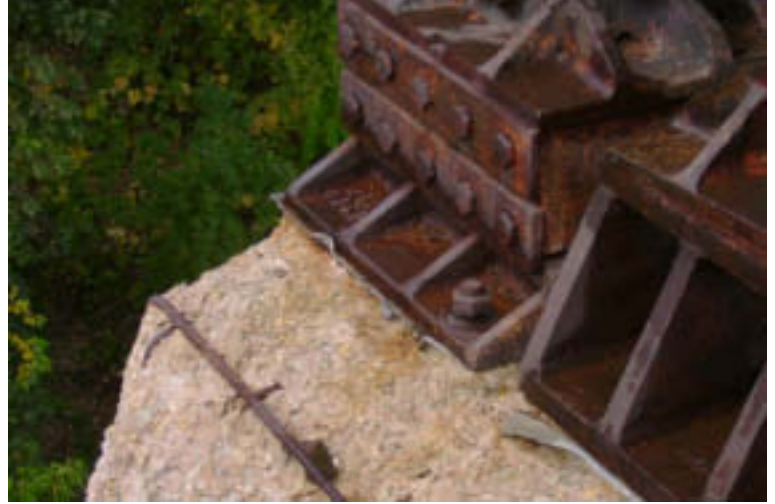
Pier 7: Pier Cap Deterioration

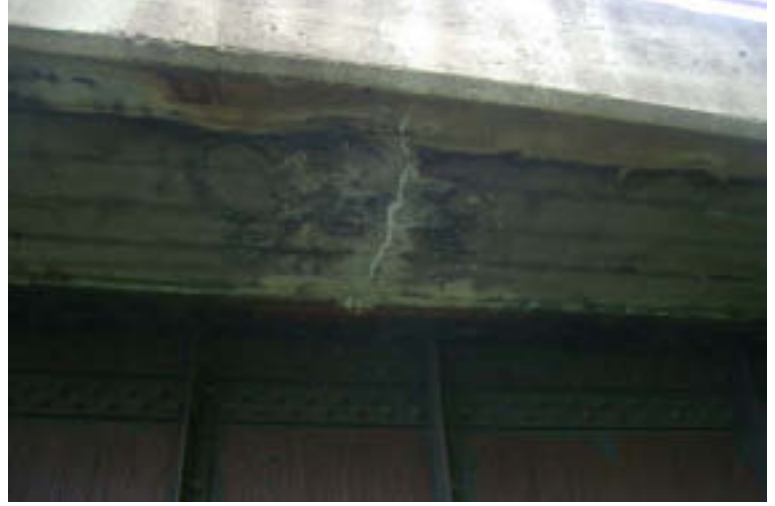
Span 1: Soffit Crack

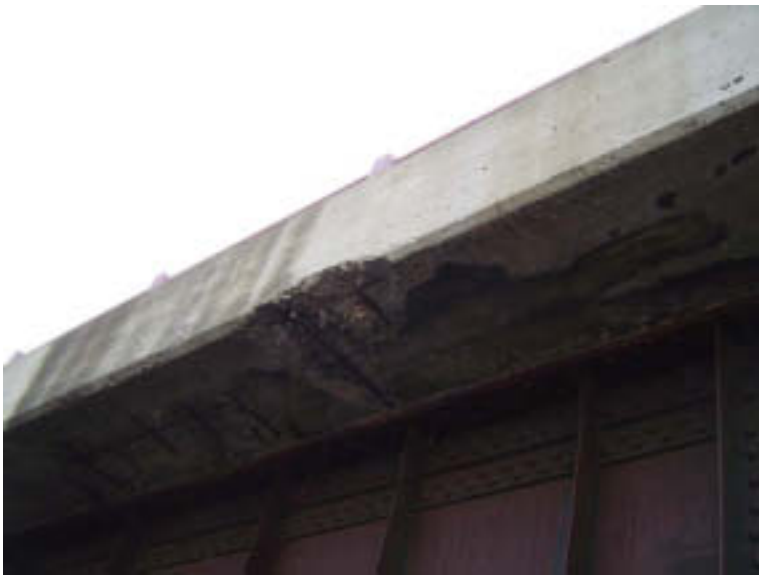
Span 1: Soffit Exposed Reinforcement

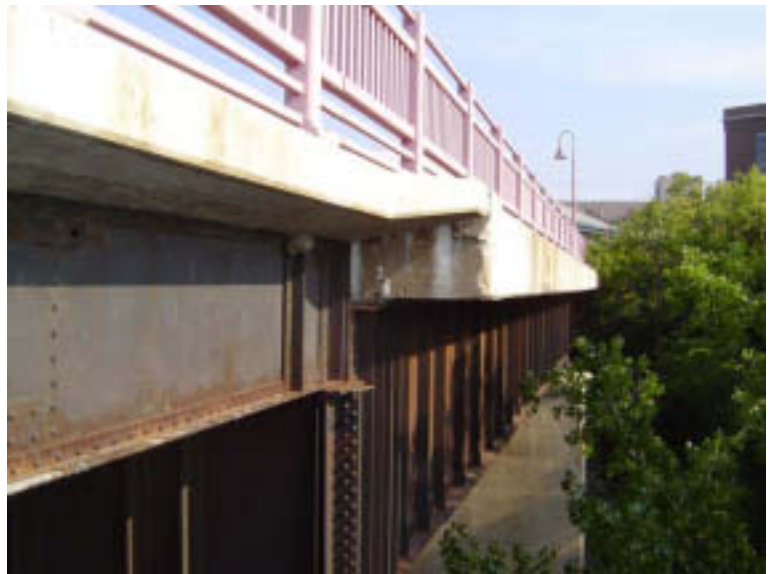
Span 2: Staining from Drainage

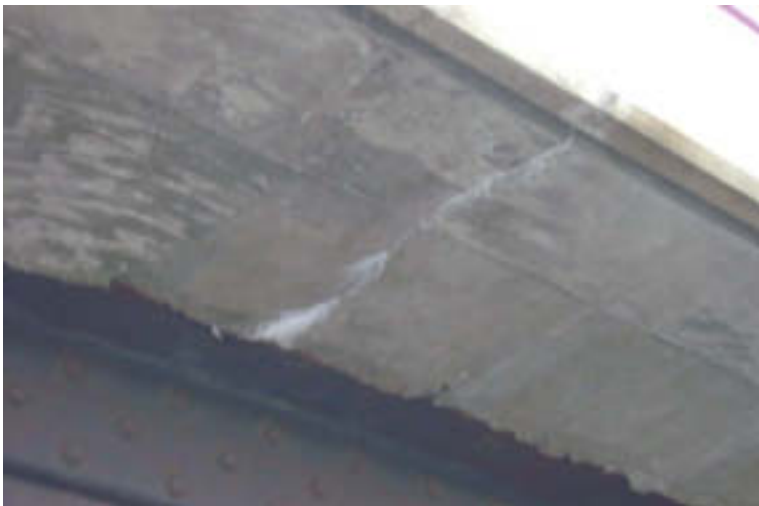
Span 4: Deck Crack and Bleaching

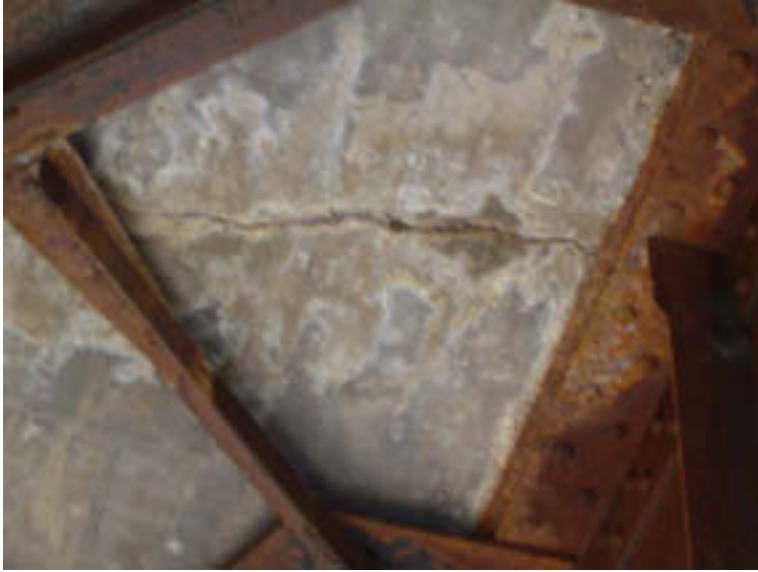
Span 6: Drainage Cracks

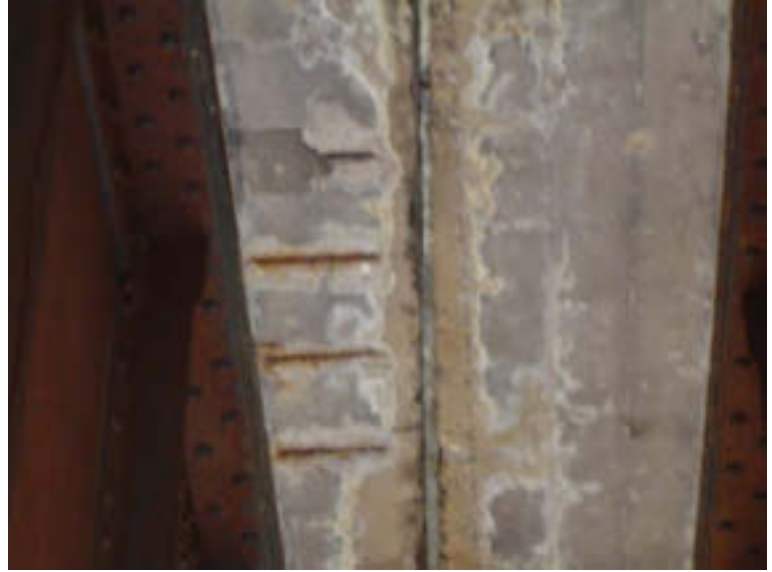
Span 6: Deck Expose Reinforcement

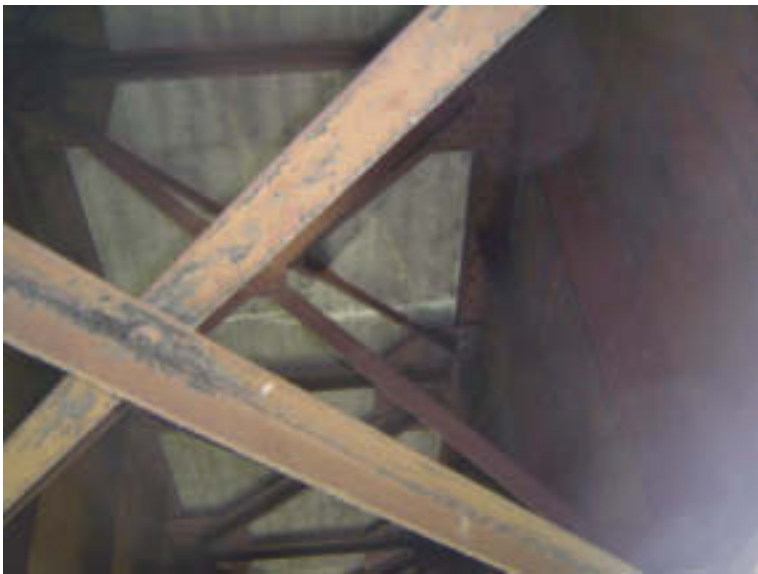
Span 6: Deck Crack

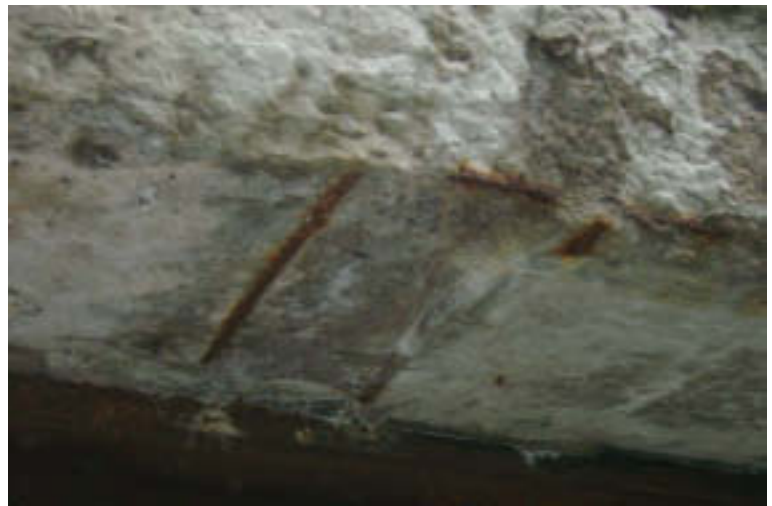
Span 6: Deck Expose Reinforcement

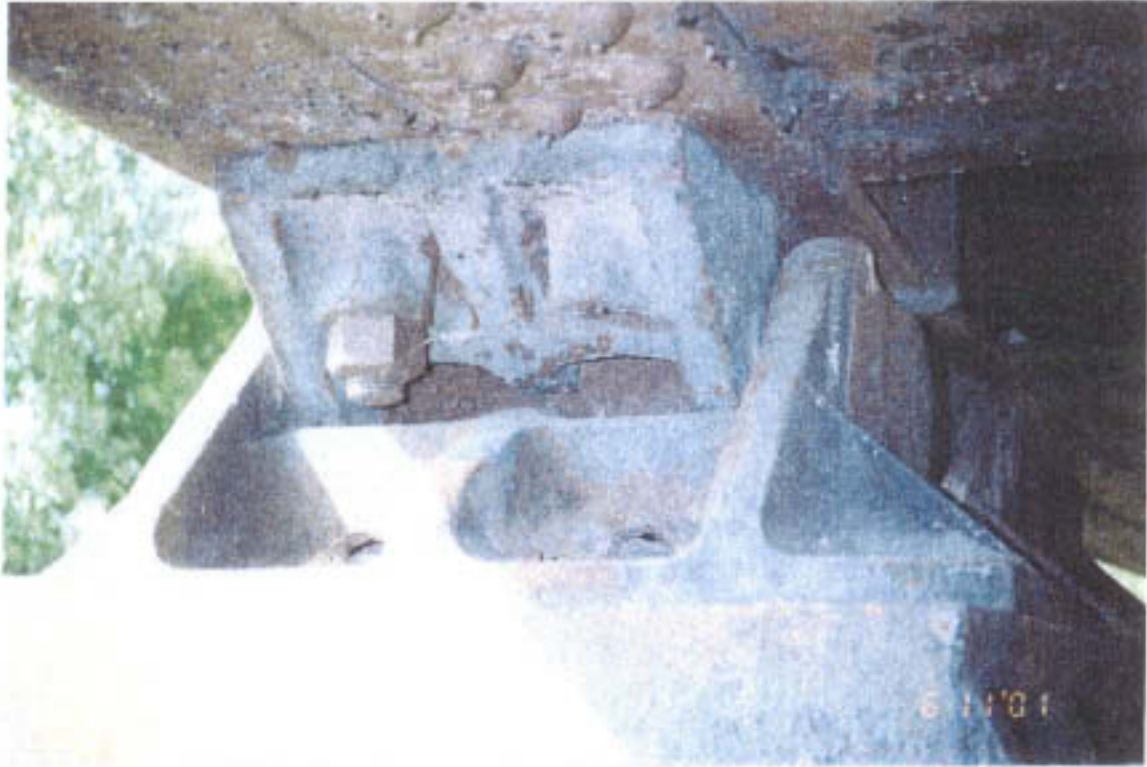
Picture #1

Abutment #1-Fixed bearing are rusted throughout. The abutment cap is delaminated, spalled and full of debris.

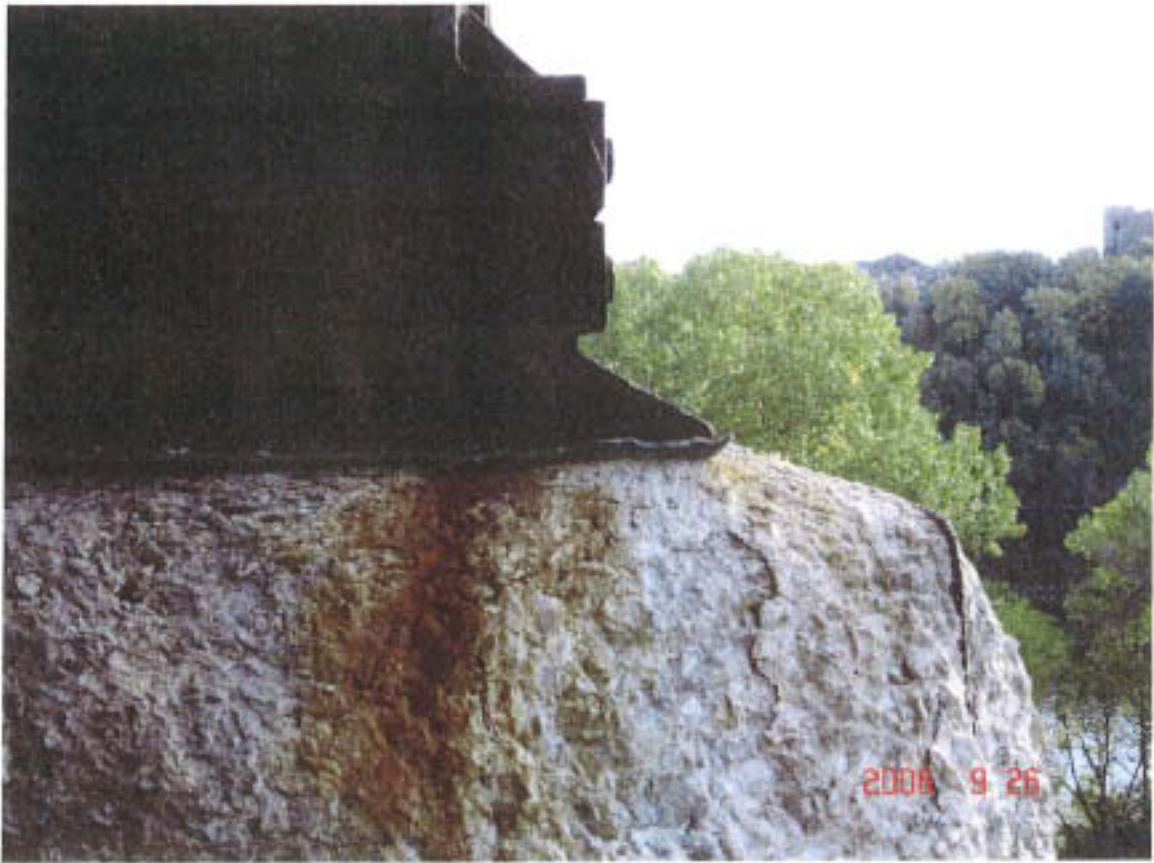
Picture #1

Abutment #1- Fixed bearing are rusted throughout. The abutment cap is delaminated, spalled and full of debris.

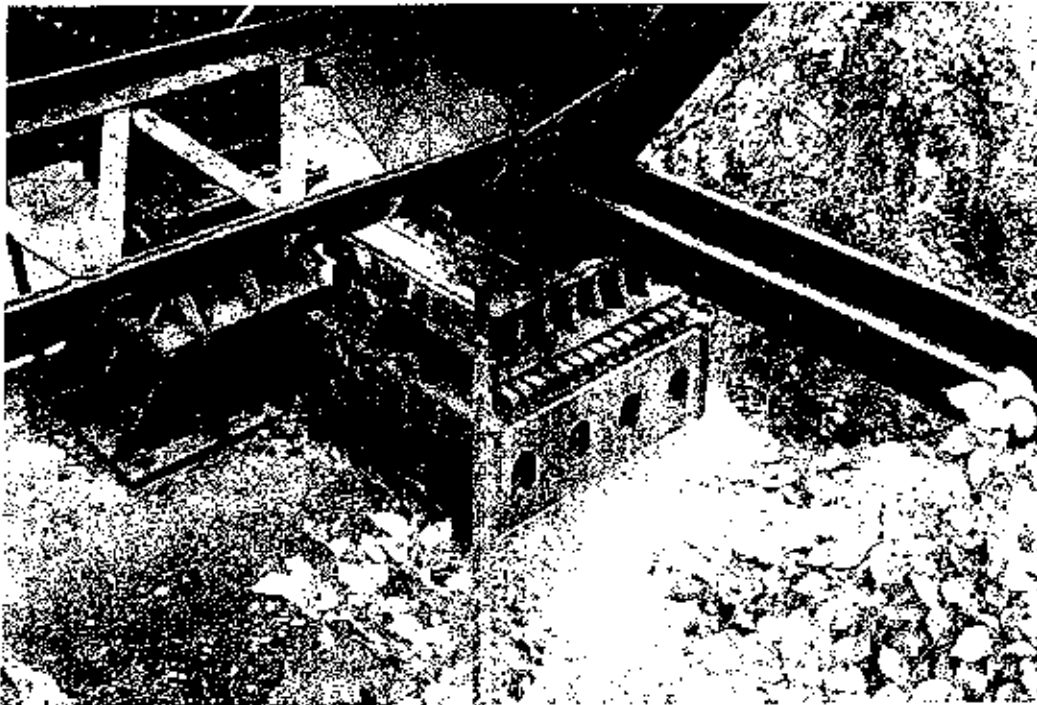
Spot-Checked Expansion Bearing Assembly

All of the expansion bearing assemblies are rated at Condition State Level 2 on the current Mn/DOT Bridge Inspection Report. According to the Mn/DOT *Bridge Inspection Manual*, Condition State Level 2 for expansion bearings is defined as follows:

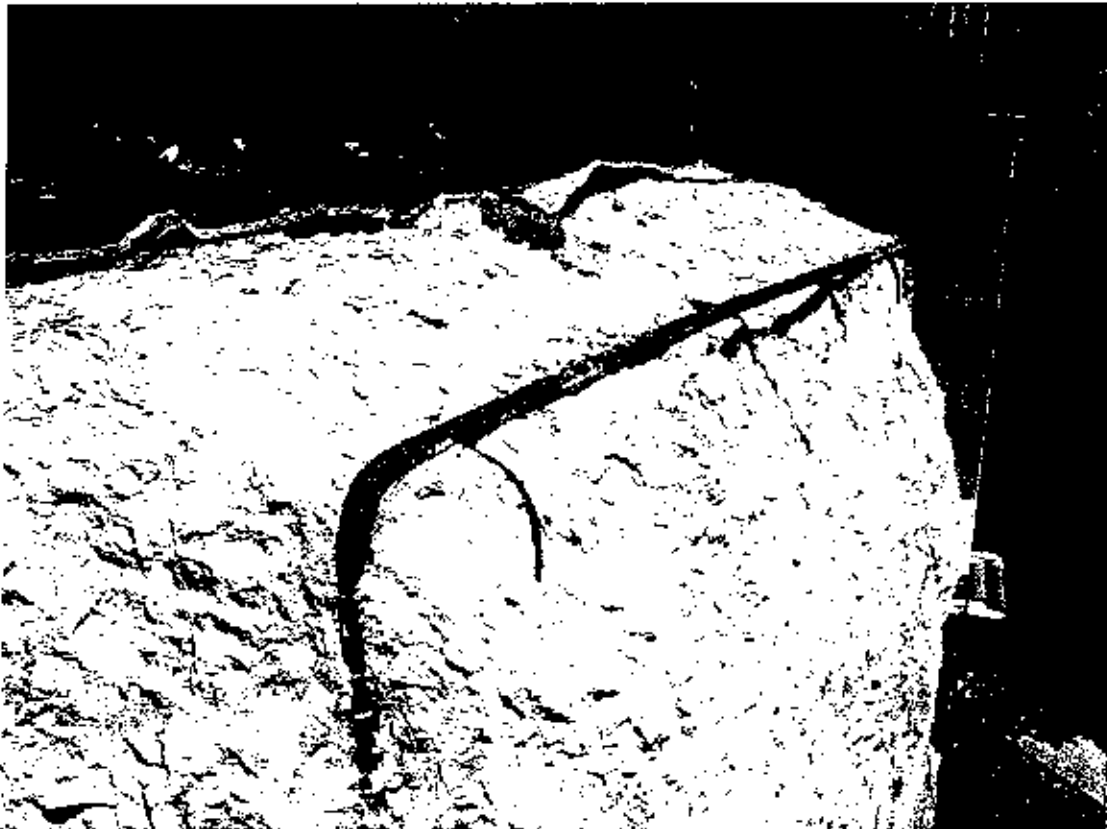
Exposed Rebar and Spalled Concrete at End of Cap

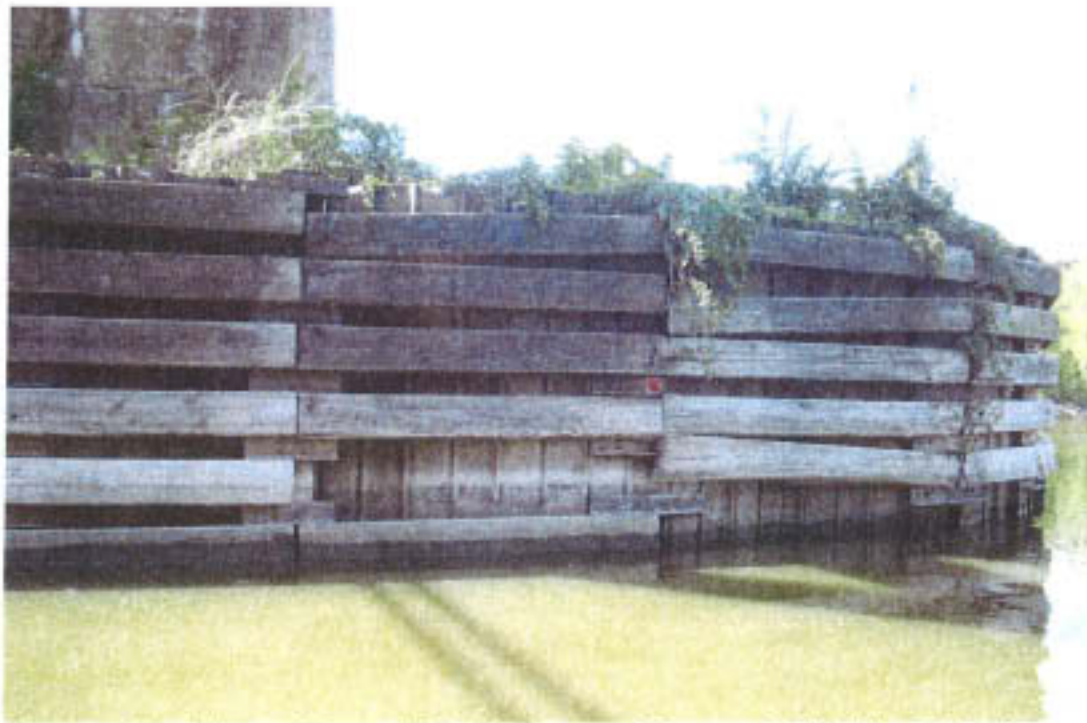
Photograph 2. View of Damaged Fender System at Upstream Half of Pier 4, Looking West.

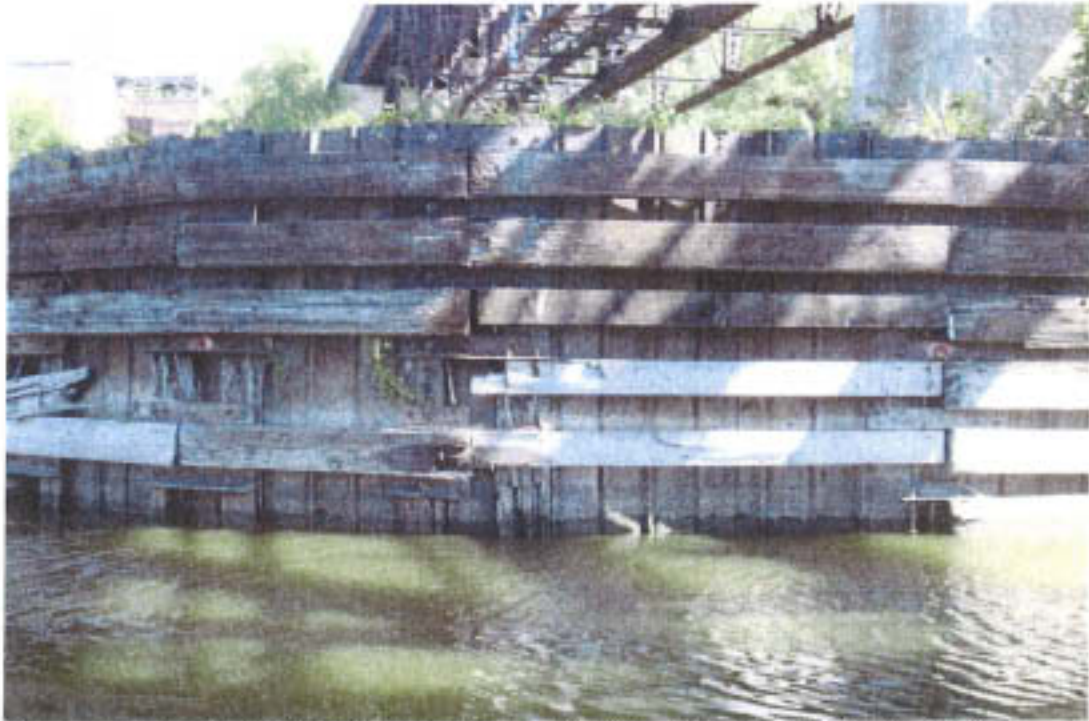
Photograph 3. View of the Damaged Fender System at Upstream Nose of Pier 4, Looking East.

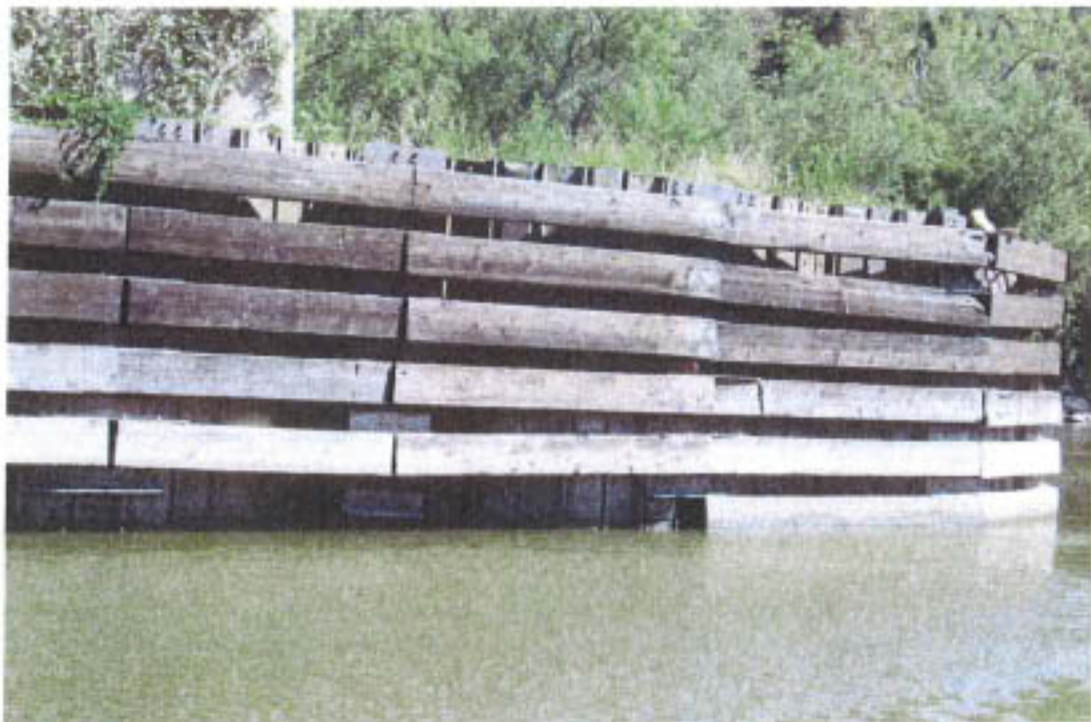
Photograph 4. View of the Damaged Fender System at Downstream Half of Pier 4, Looking East.

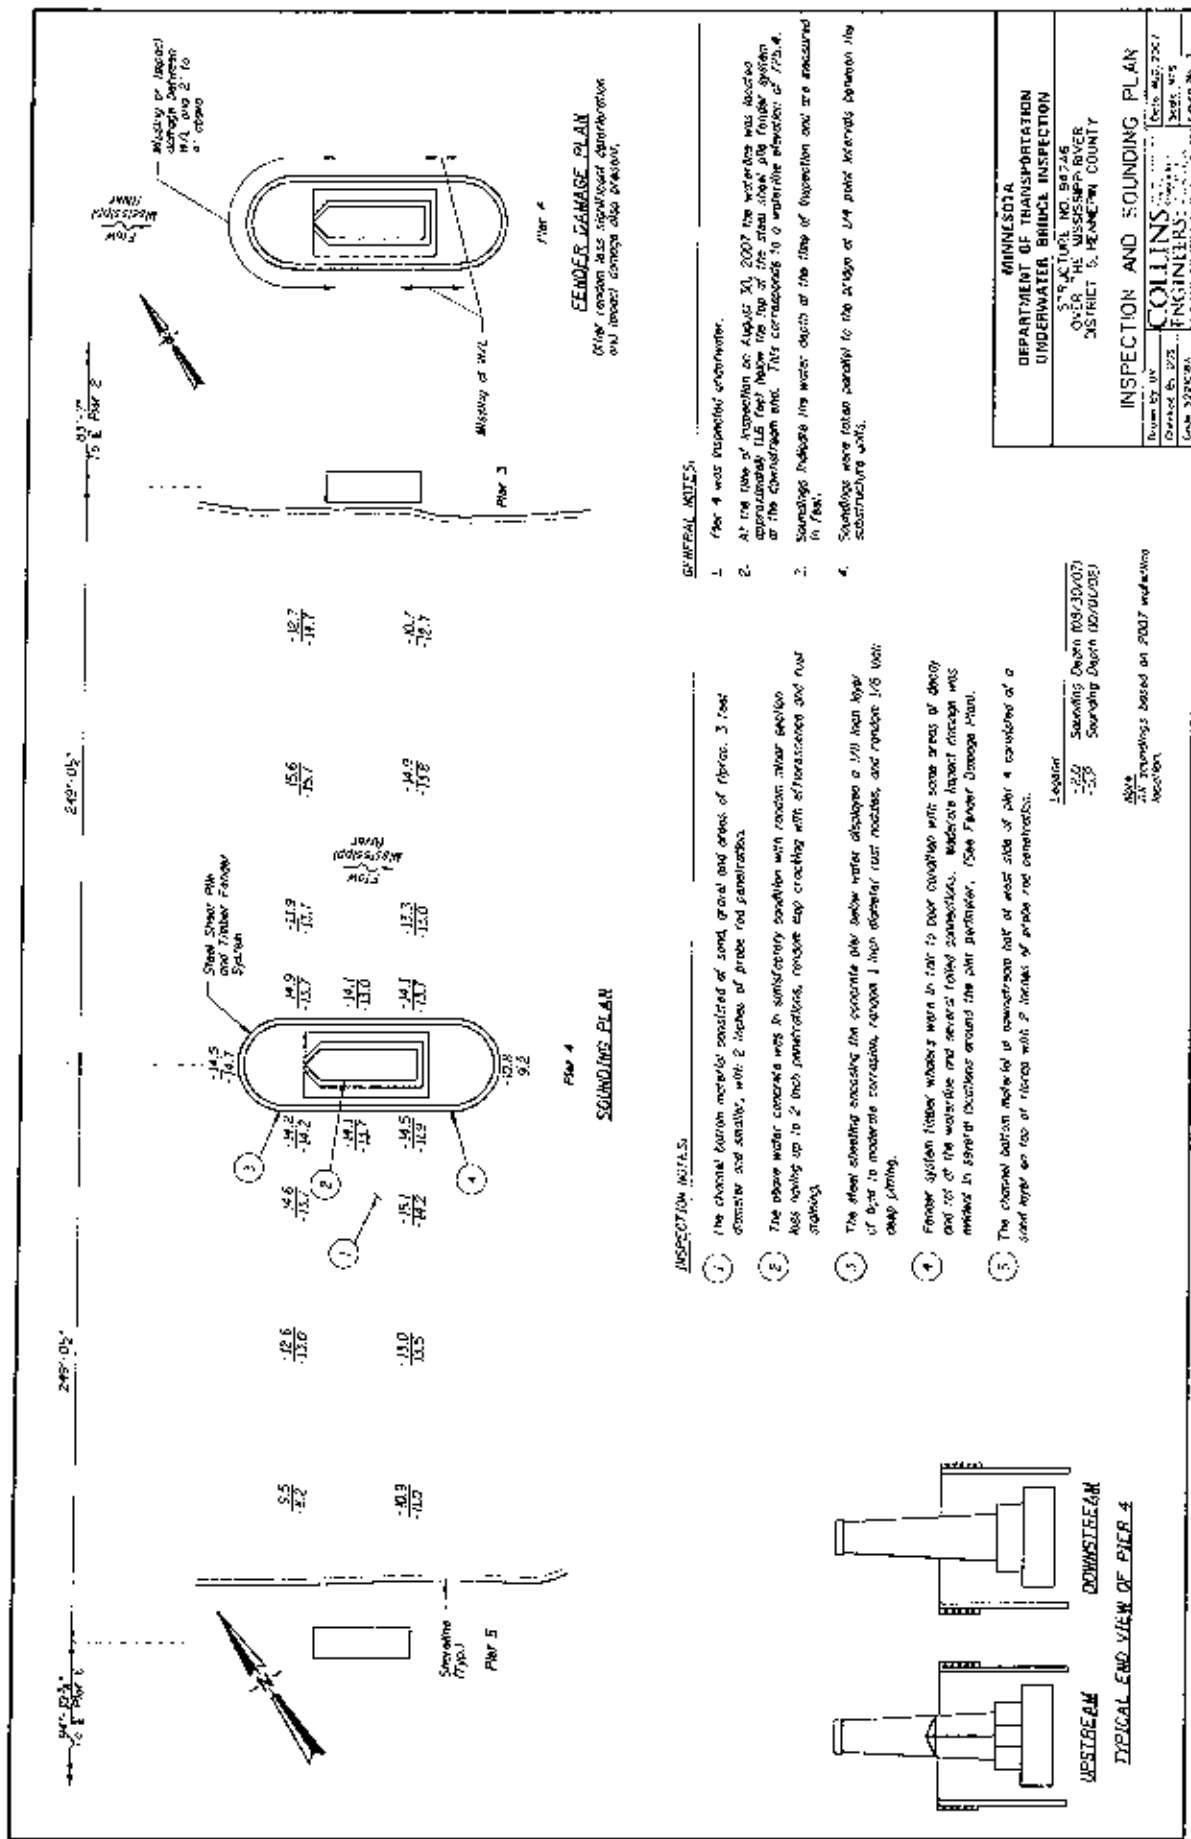
EENDER DAMAGE PLAN
 Other random less significant observations on Eender damage also present.
