# Seneca Primary Tank 2 Rehabilitation

Contract 21P091

September 2022 John Tierney

**Seneca Primary tank #2  
Commissioned in 1972  
155' Diameter 12' Deep  
2.1 Million Gallon Tank**

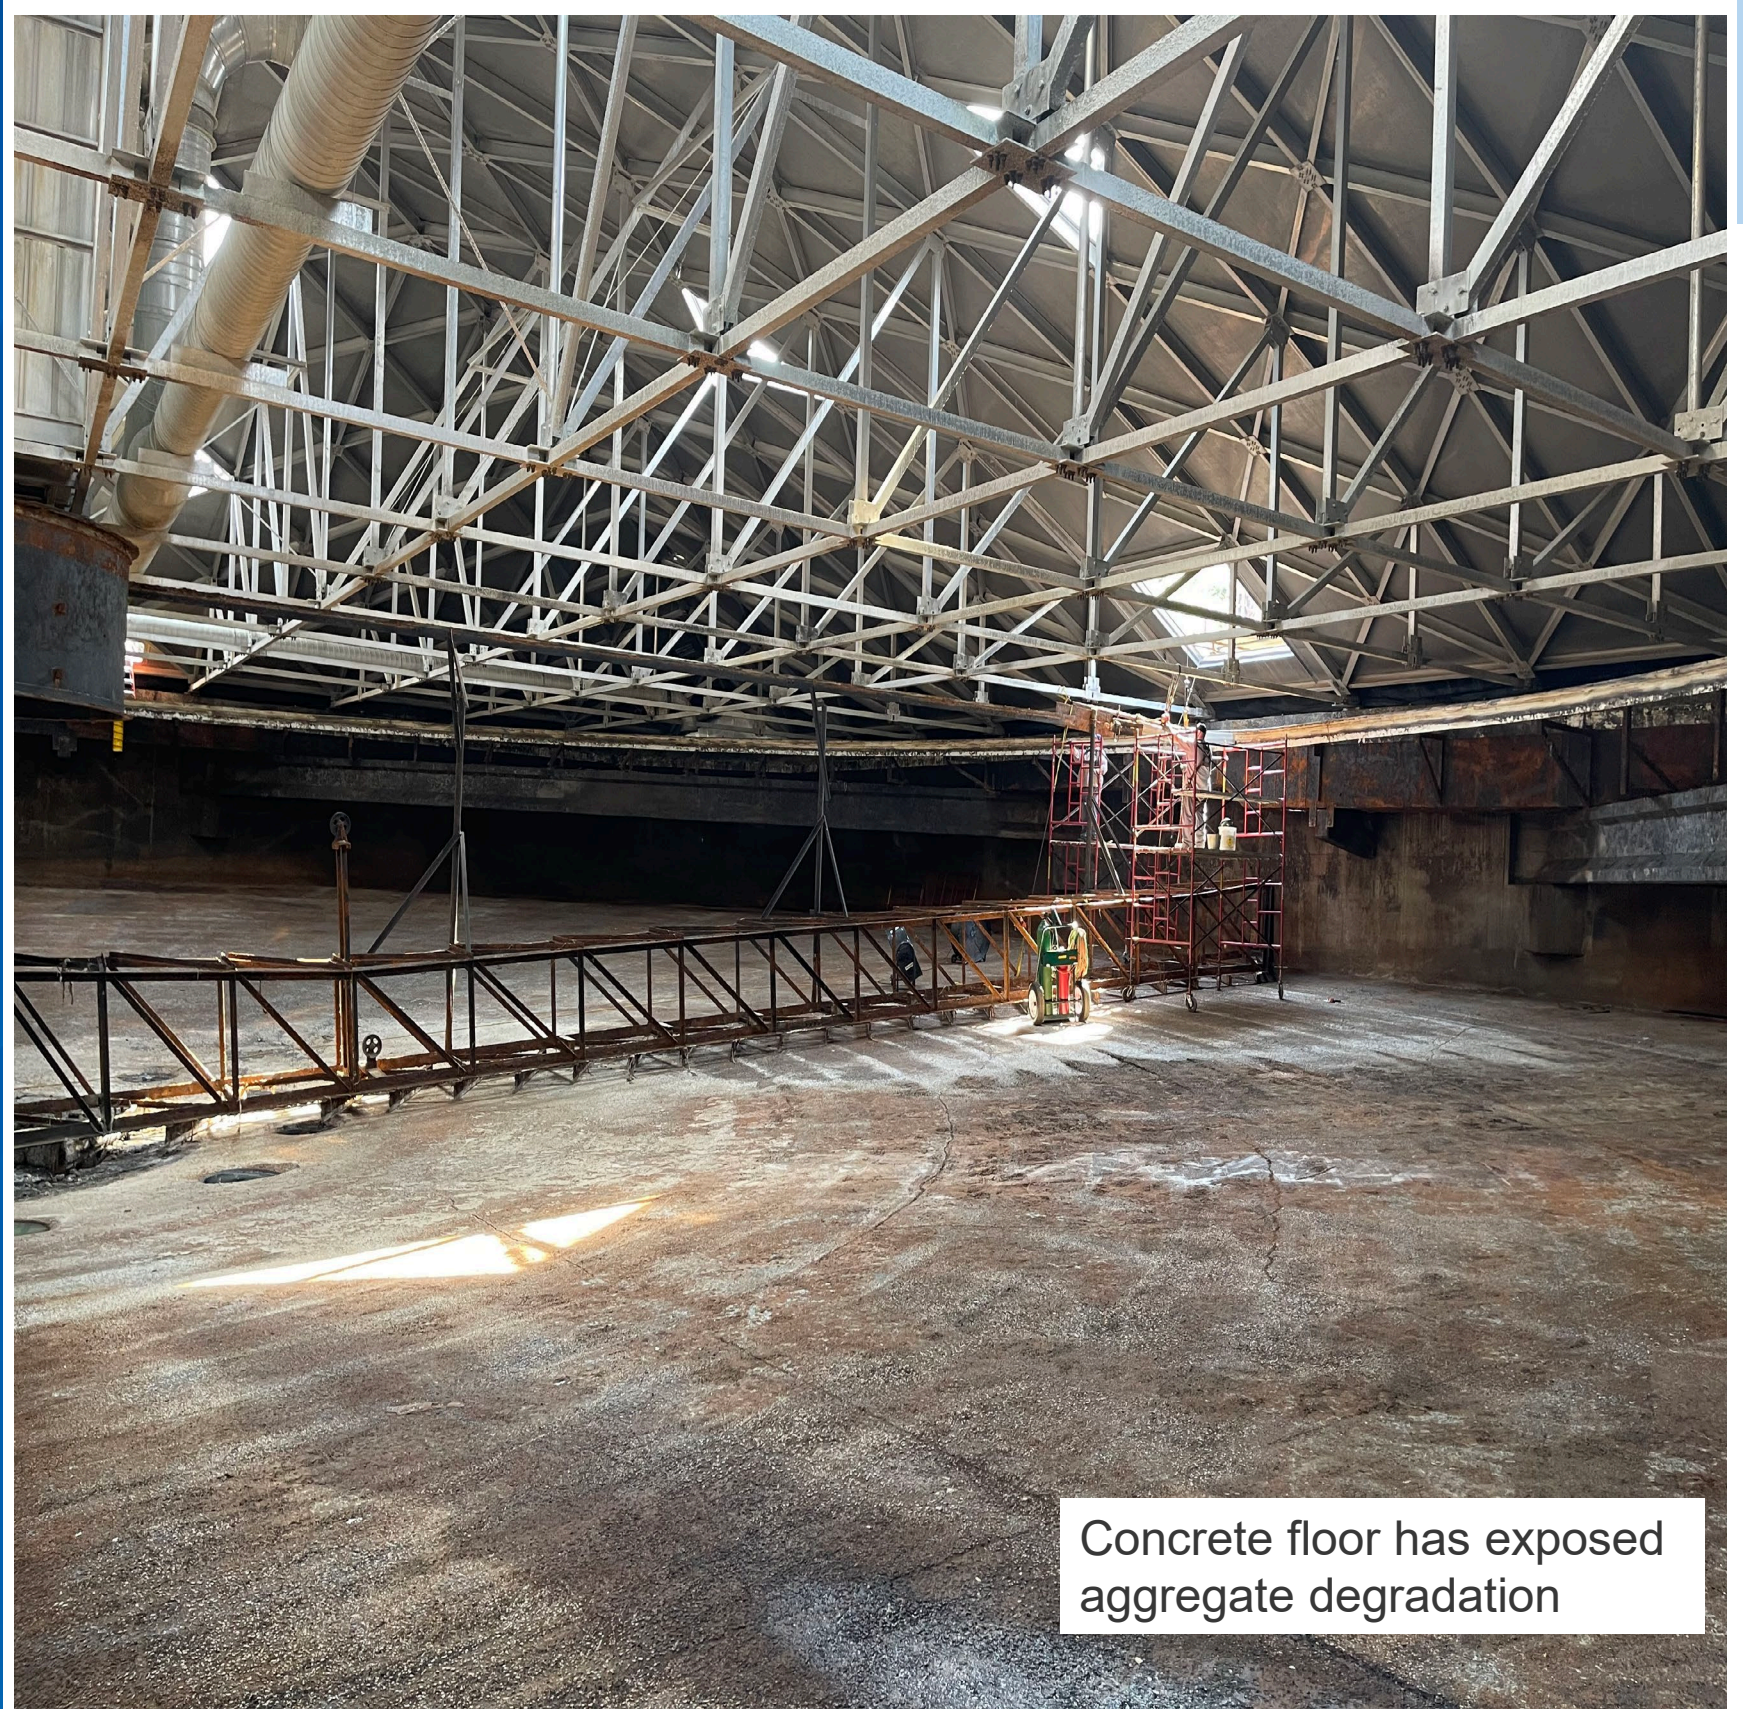
Concrete floor has exposed aggregate degradation

**After years of operating in these conditions, the surfaces of the steel and concrete structures need to be properly prepped and have protective coatings applied to all these surfaces**

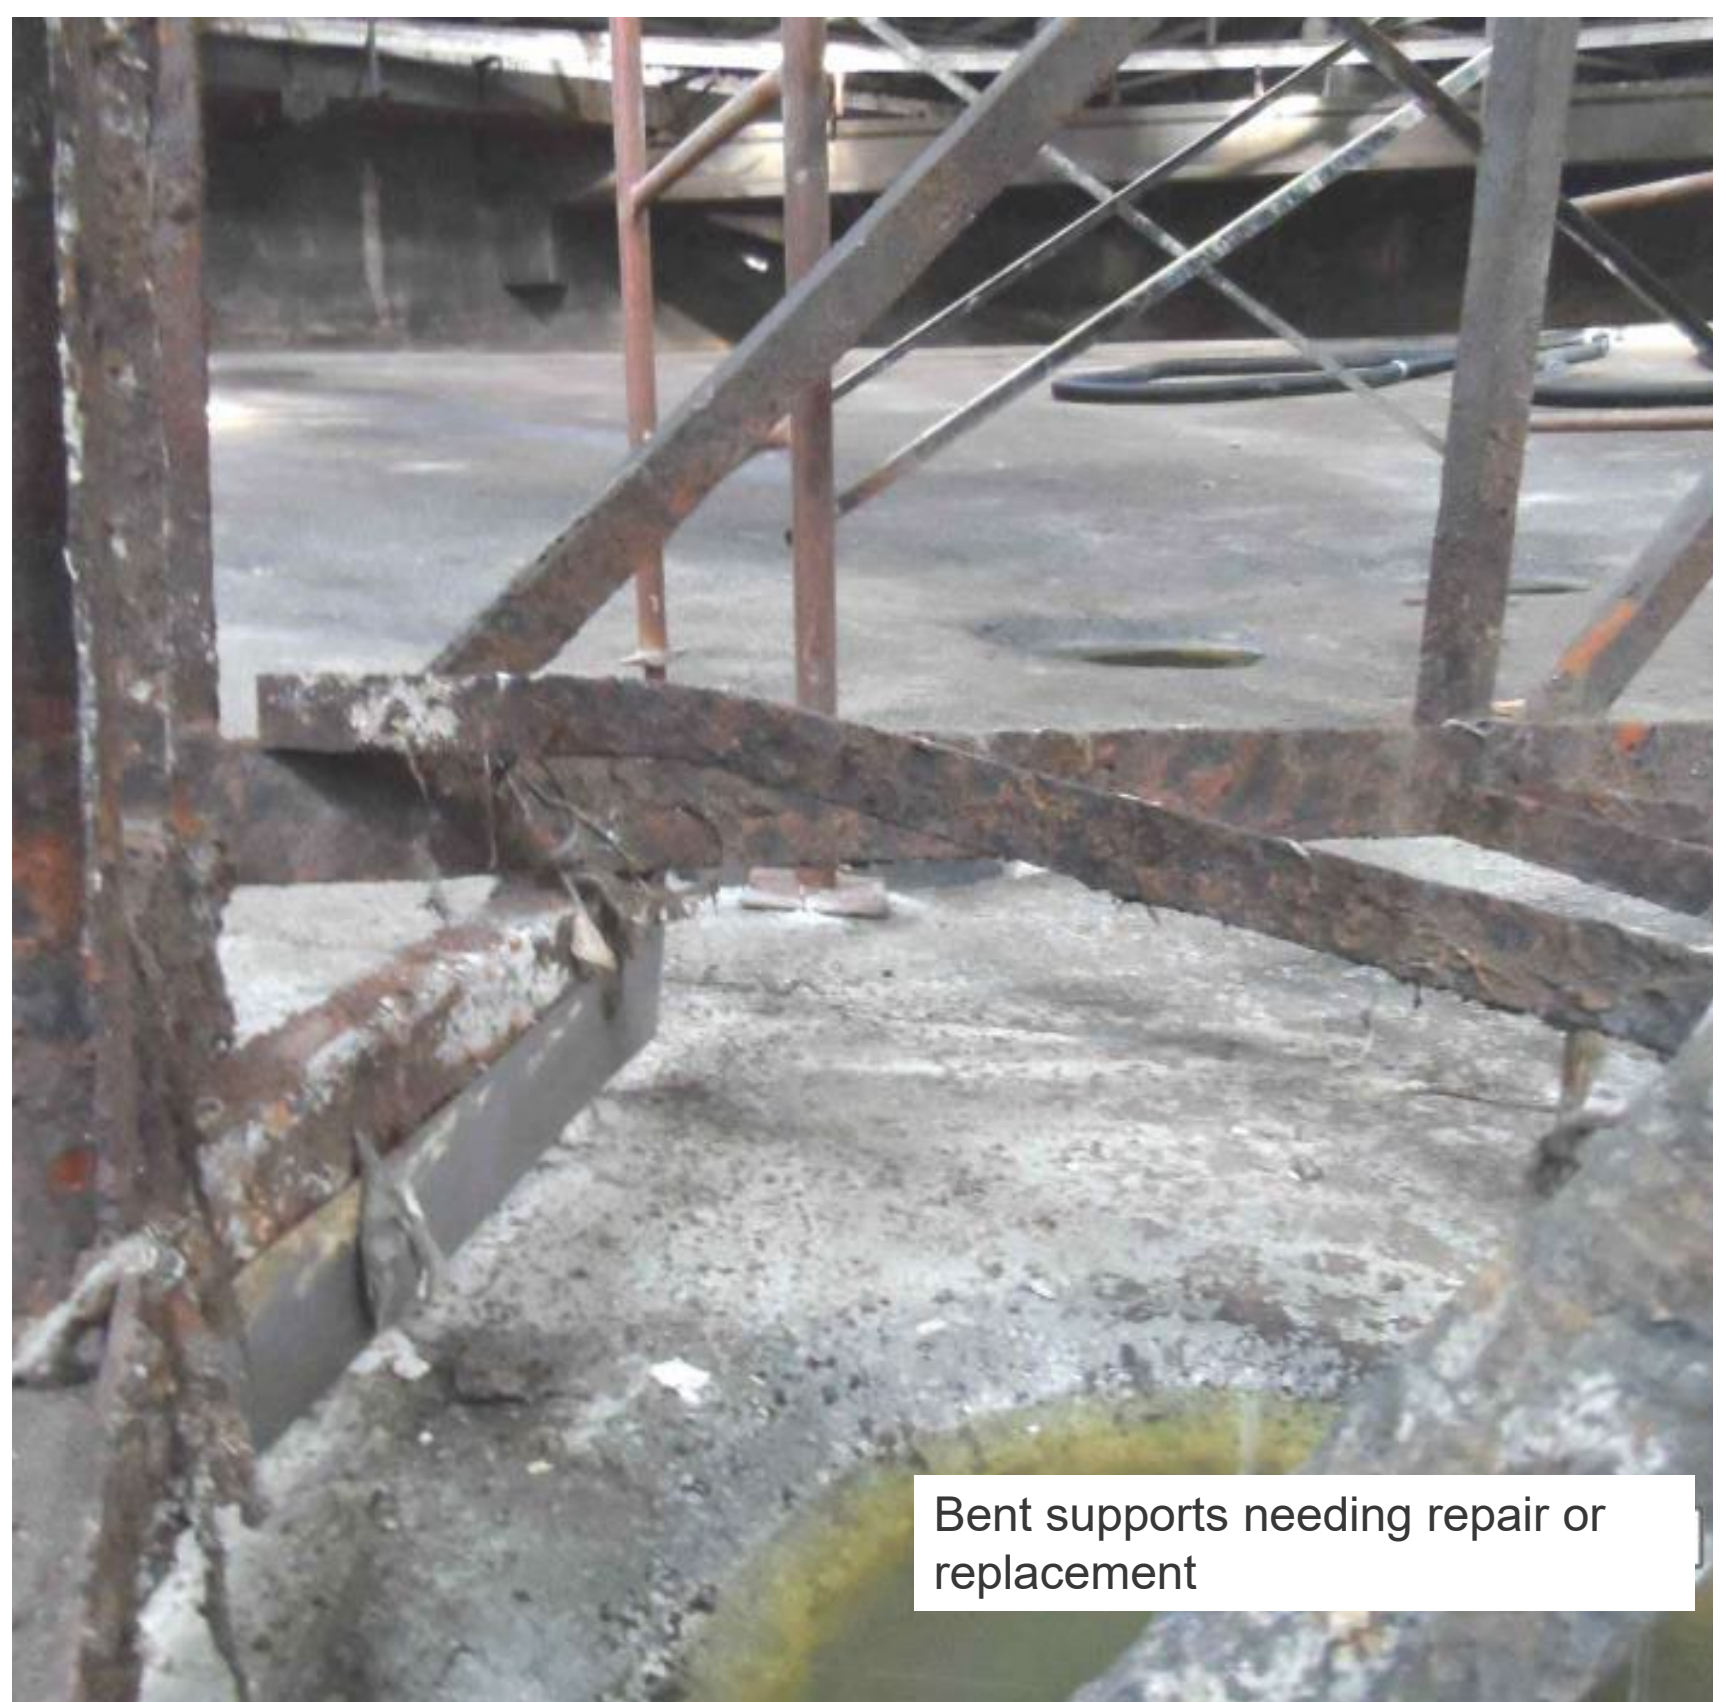
Bent supports needing repair or replacement

**Mounting hardware, steel supports and normal wear parts need to be inspected and replaced, all internal surfaces need sand blasting and protective coatings applied**

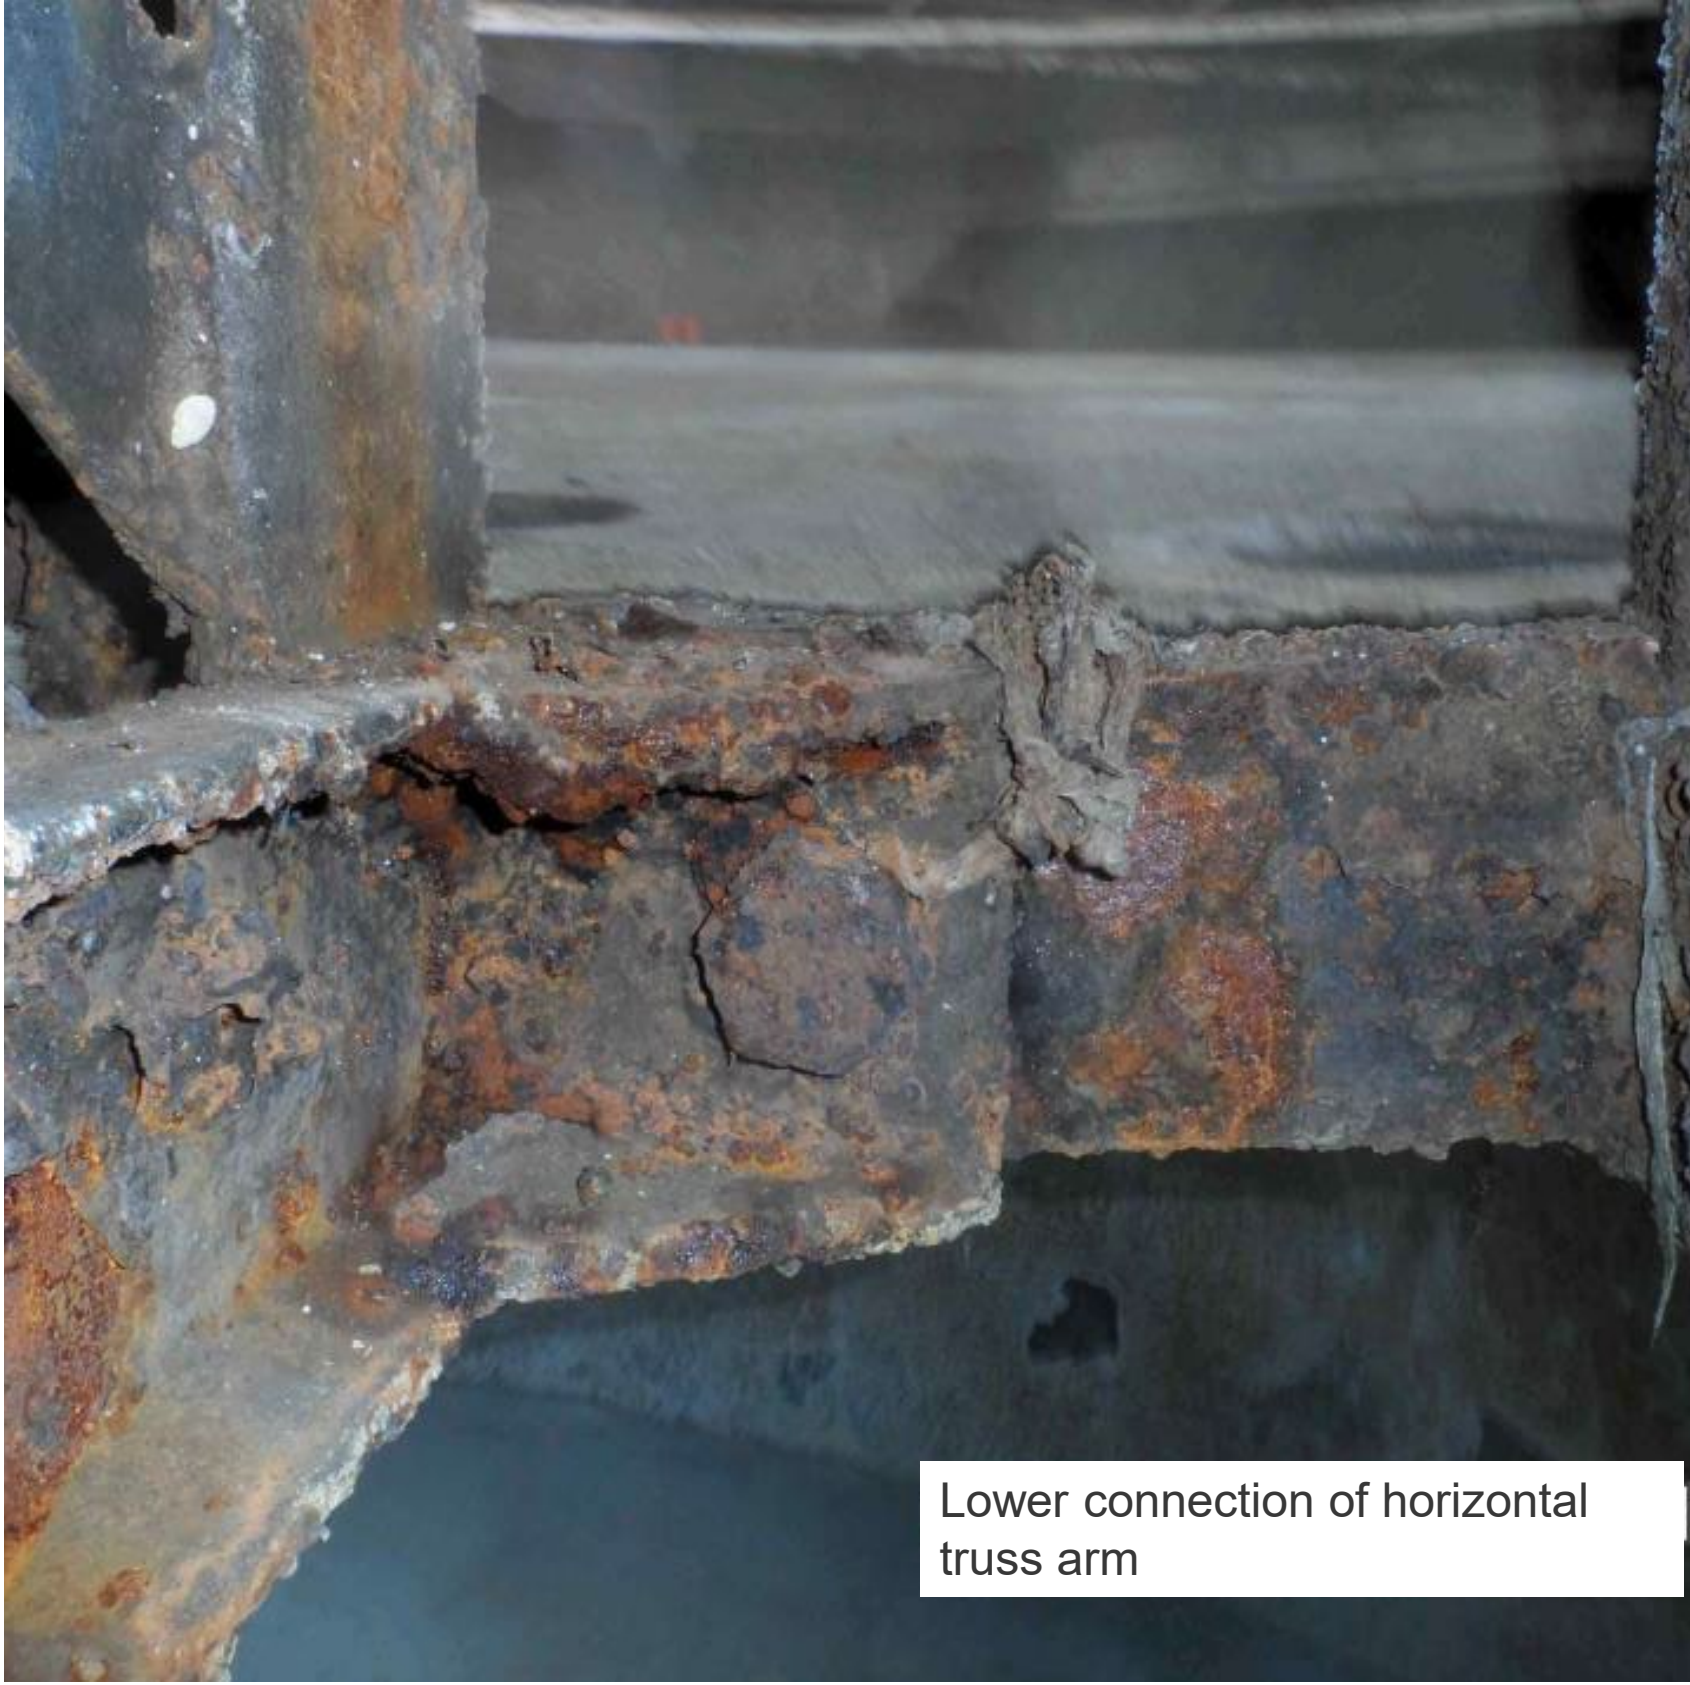
Lower connection of horizontal truss arm

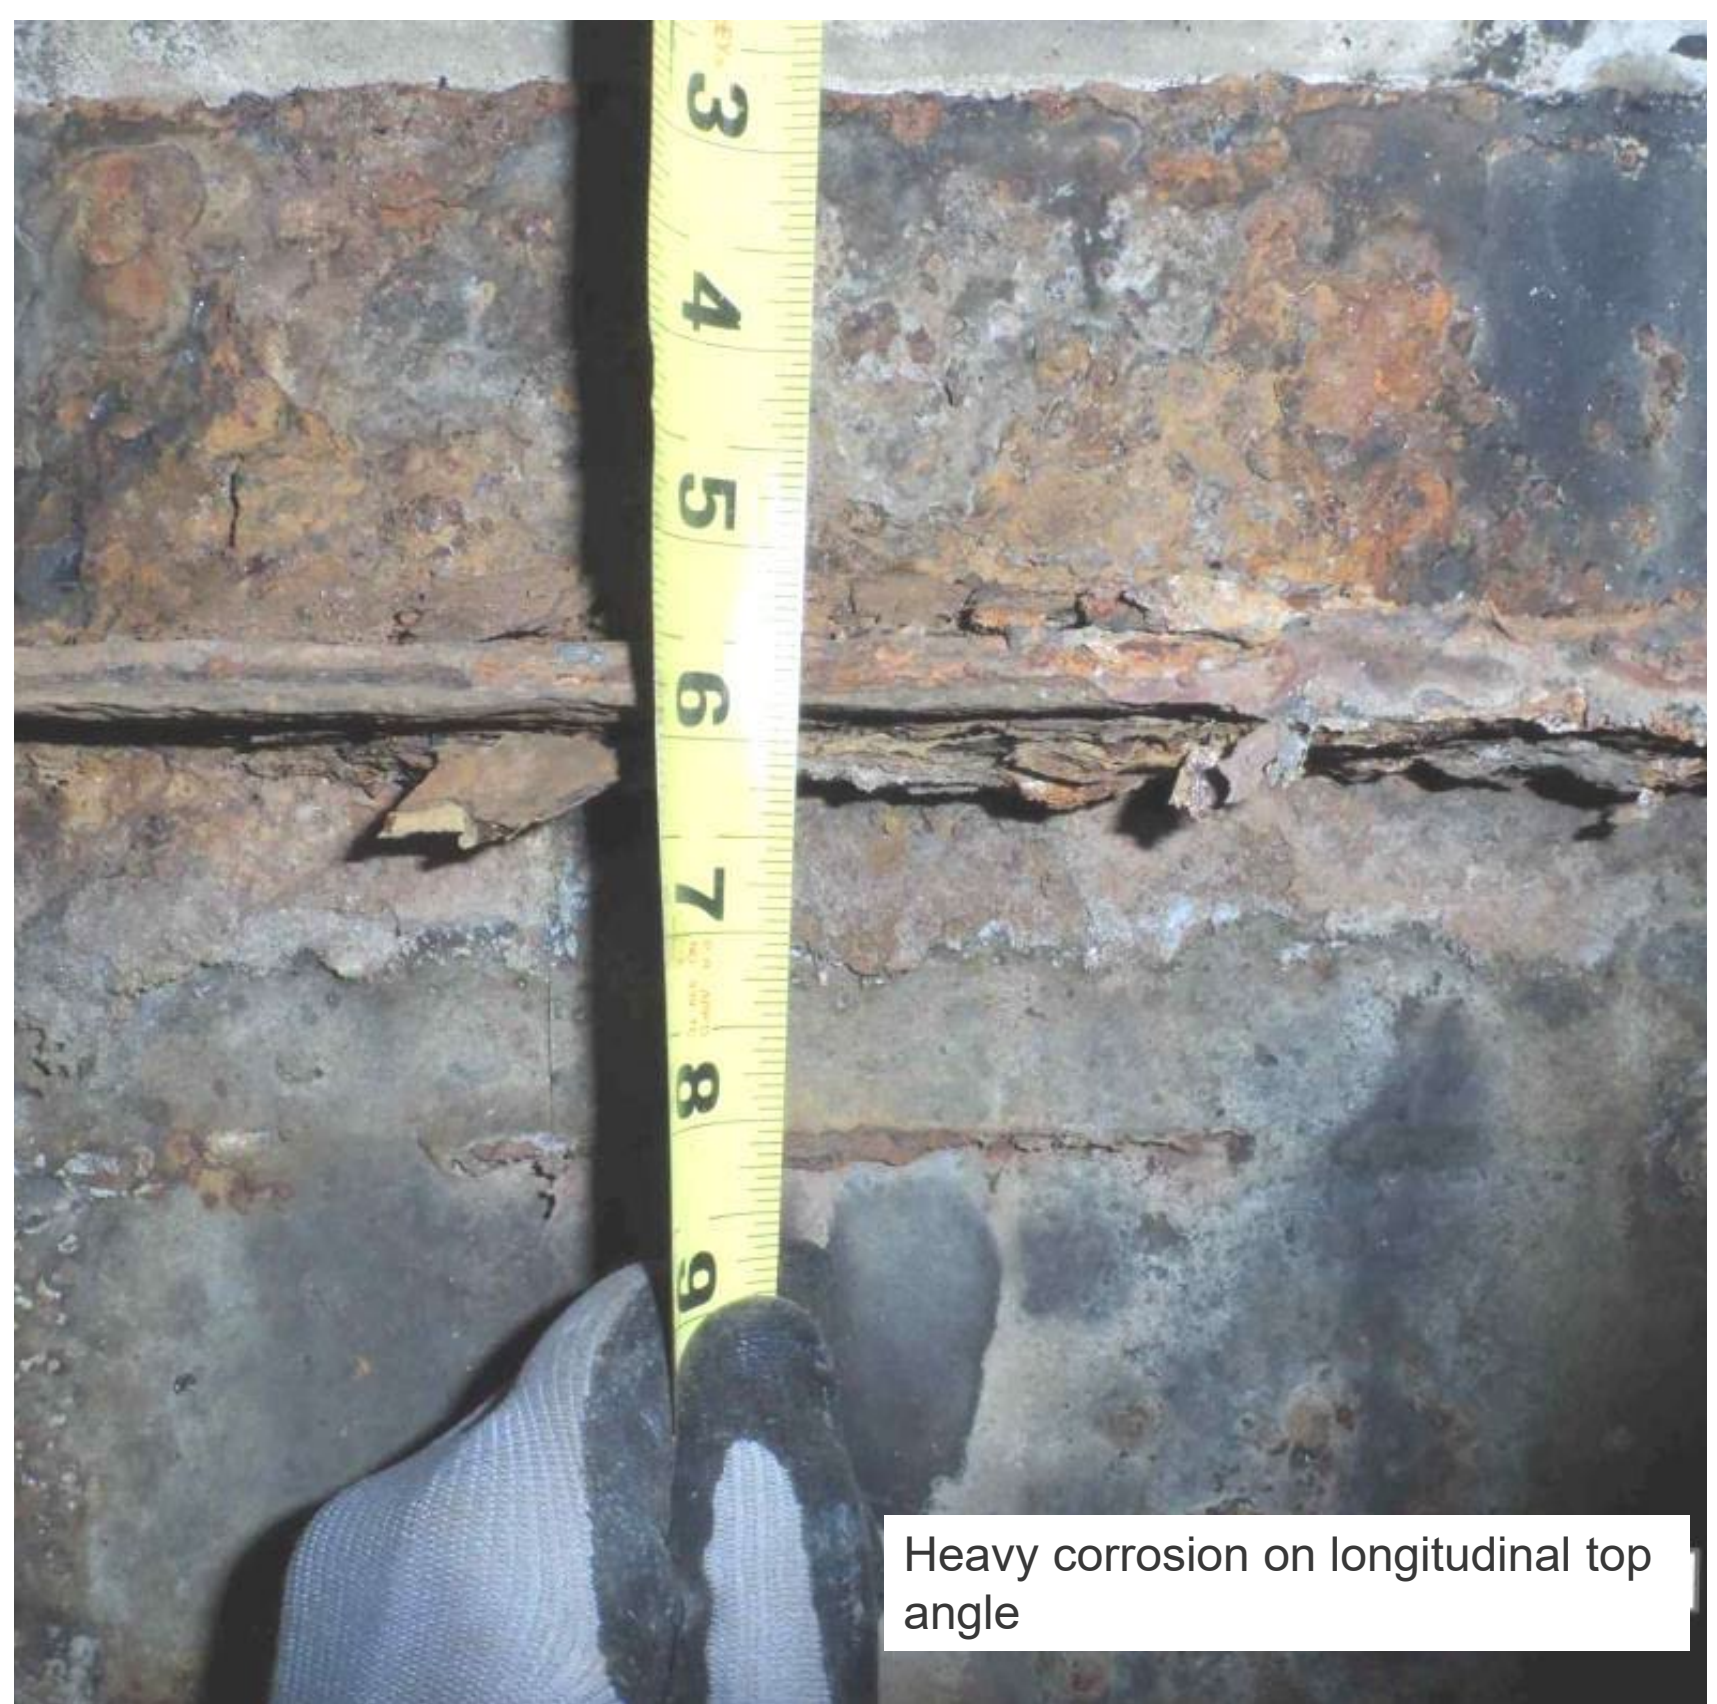
Heavy corrosion on longitudinal top angle
