Information Item:

1-MN-320 Rehabilitation Update

Environment Committee: April 11, 2023

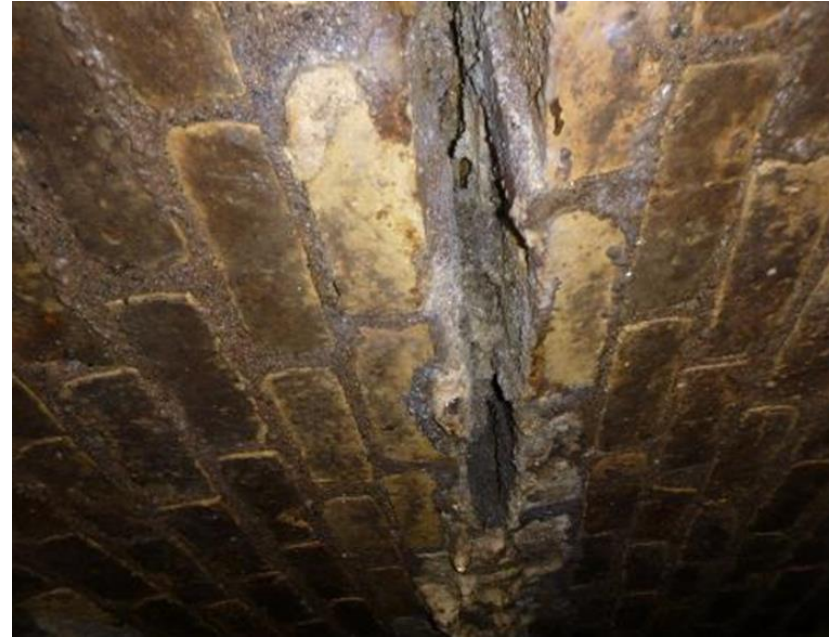
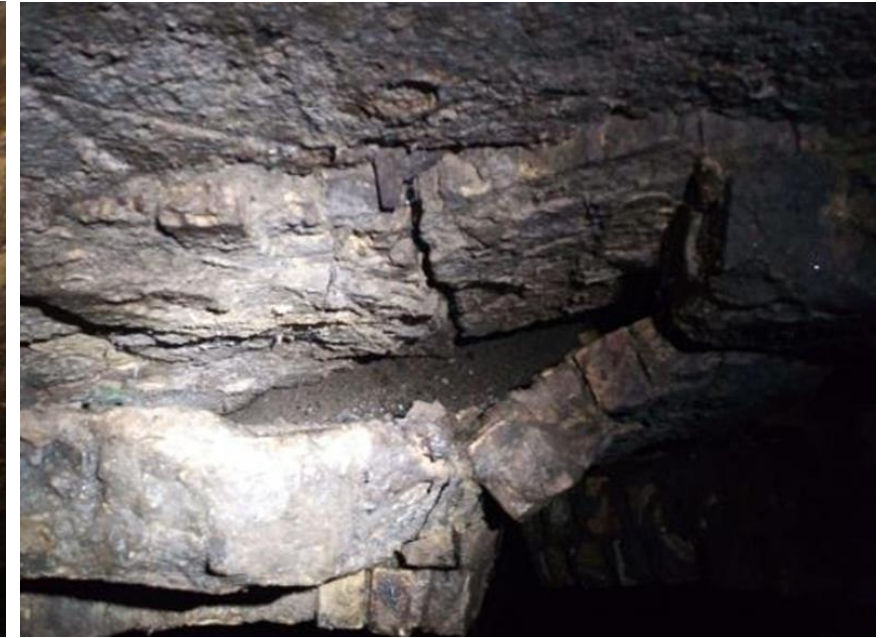
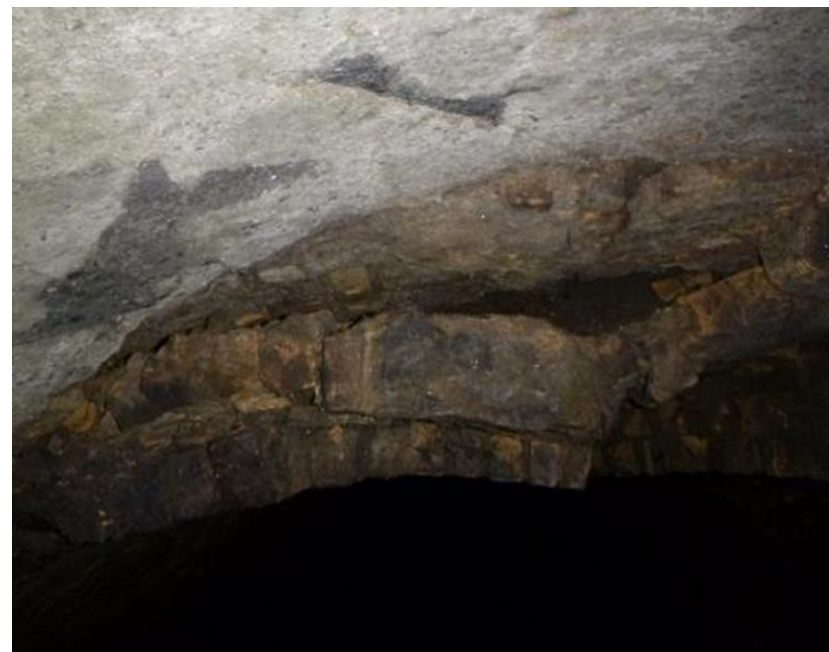
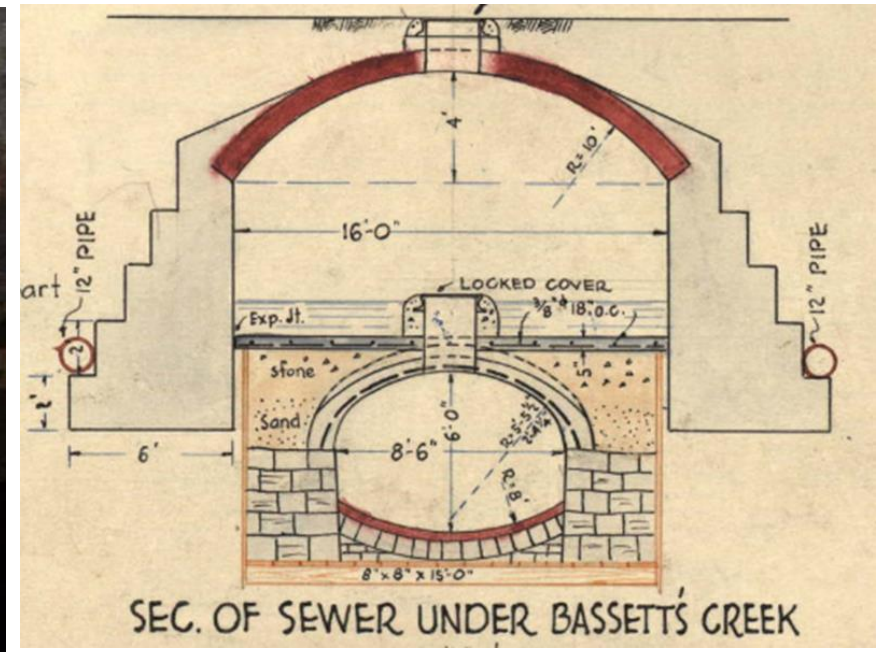
CCTV inspection shows a failing pipe

- Constructed in late 1800s
- Poor condition
- High maintenance cleaning costs
- Source of odors
- Does not meet current standards

- Eliminate failing pipe
- Increase pipe slopes to self-cleaning grades
- Reduce backwater effect
- Minimize/eliminate sediment build-up to maintain capacity
- Reduce odors
