04868 - CSAH 15 (Shoreline Drive) over Tanager Channel Bridge (No. 27592) Replacement

Regional Solicitation - Roadways Including Multimodal Elements

CSAH 15 (Shoreline Drive) over Tanager Channel Bridge (No. 27592) Replacement

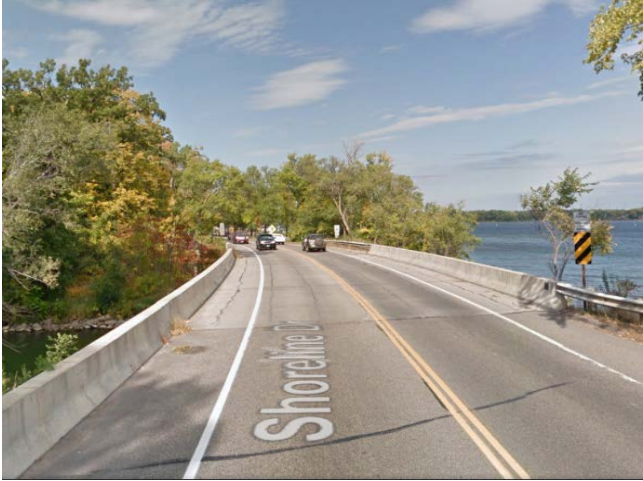
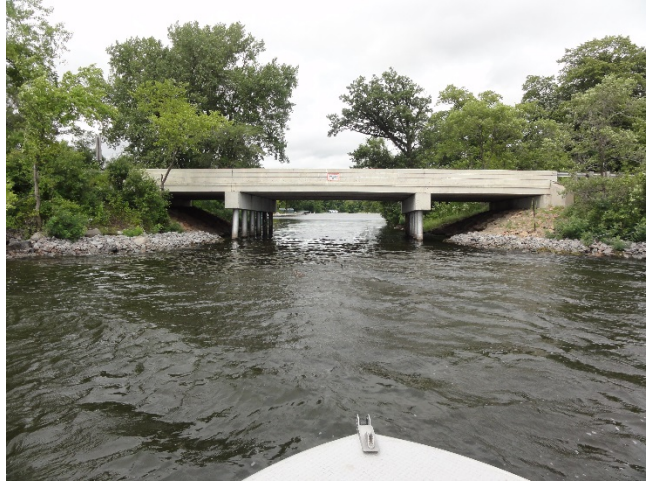
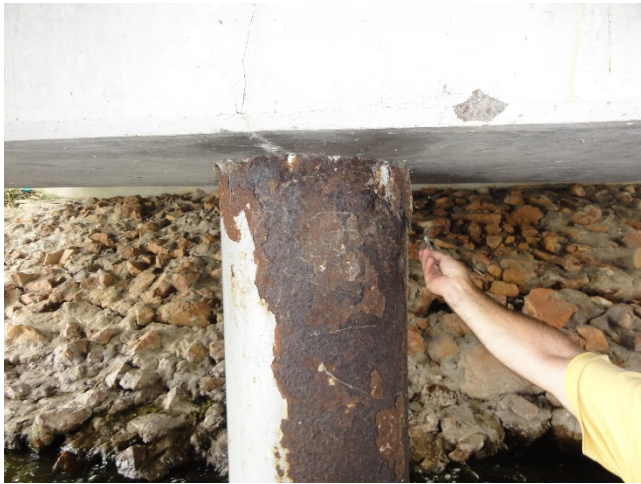
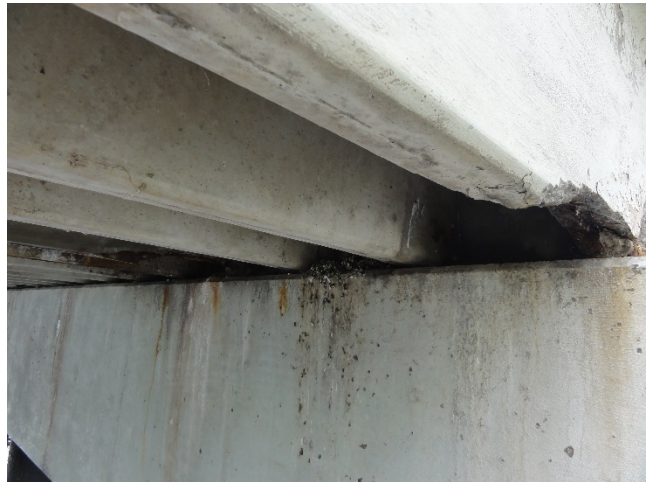
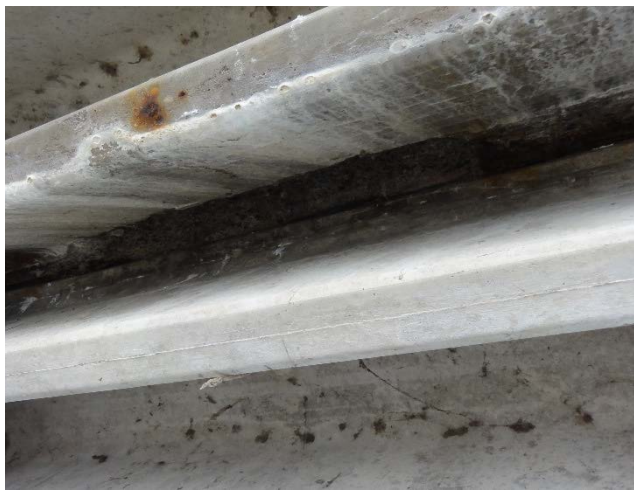
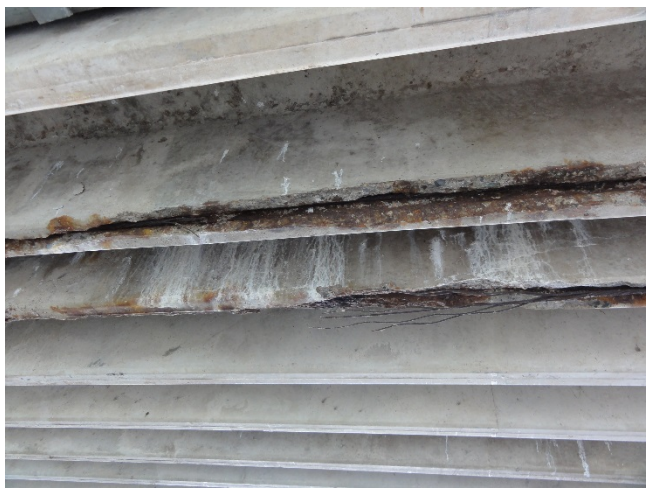
Substructure: [5] Cracking of pier caps. Corrosion, section loss of piles.

- 22. Seal large deck cracks w/ bit. Seal other deck cracks w/ epoxy.
- 301. Repair poured deck joints.
- 320. Repair spalled approaches.
- 374. Monitor cracked and deteriorated concrete quad-T beams. Clean, lightly blast and coat exposed prestressing strands on 2 West T's.
- 382. Clean and paint piling.
- 985. Repair slumped slope paving.
- 988. Notify utility company of missing hanger assemblies in N span.
