05348 - Hopkins to Chaska LRT Corridor Slope Restoration

Project Name Hopkins to Chaska LRT Corridor Slope Restoration

To: Jessica Galatz and Dean Michalko, P.E
From: Joel Swenson, P.E.
Subject: Task 2 – Preliminary Design and Cost Estimate for the North Pipe Crossing, Downstream Toe, and South Pipe Crossing Damage Areas
Date: January 29, 2016
Project: 23101014

To: Jessica Galatz and Dean Michalko, P.E.
From: Joel Swenson, P.E.
Subject: Attachment B – Damage Details, Repair Discussion, and Cost Explanation
Date: January 29, 2016
Project: 23101014

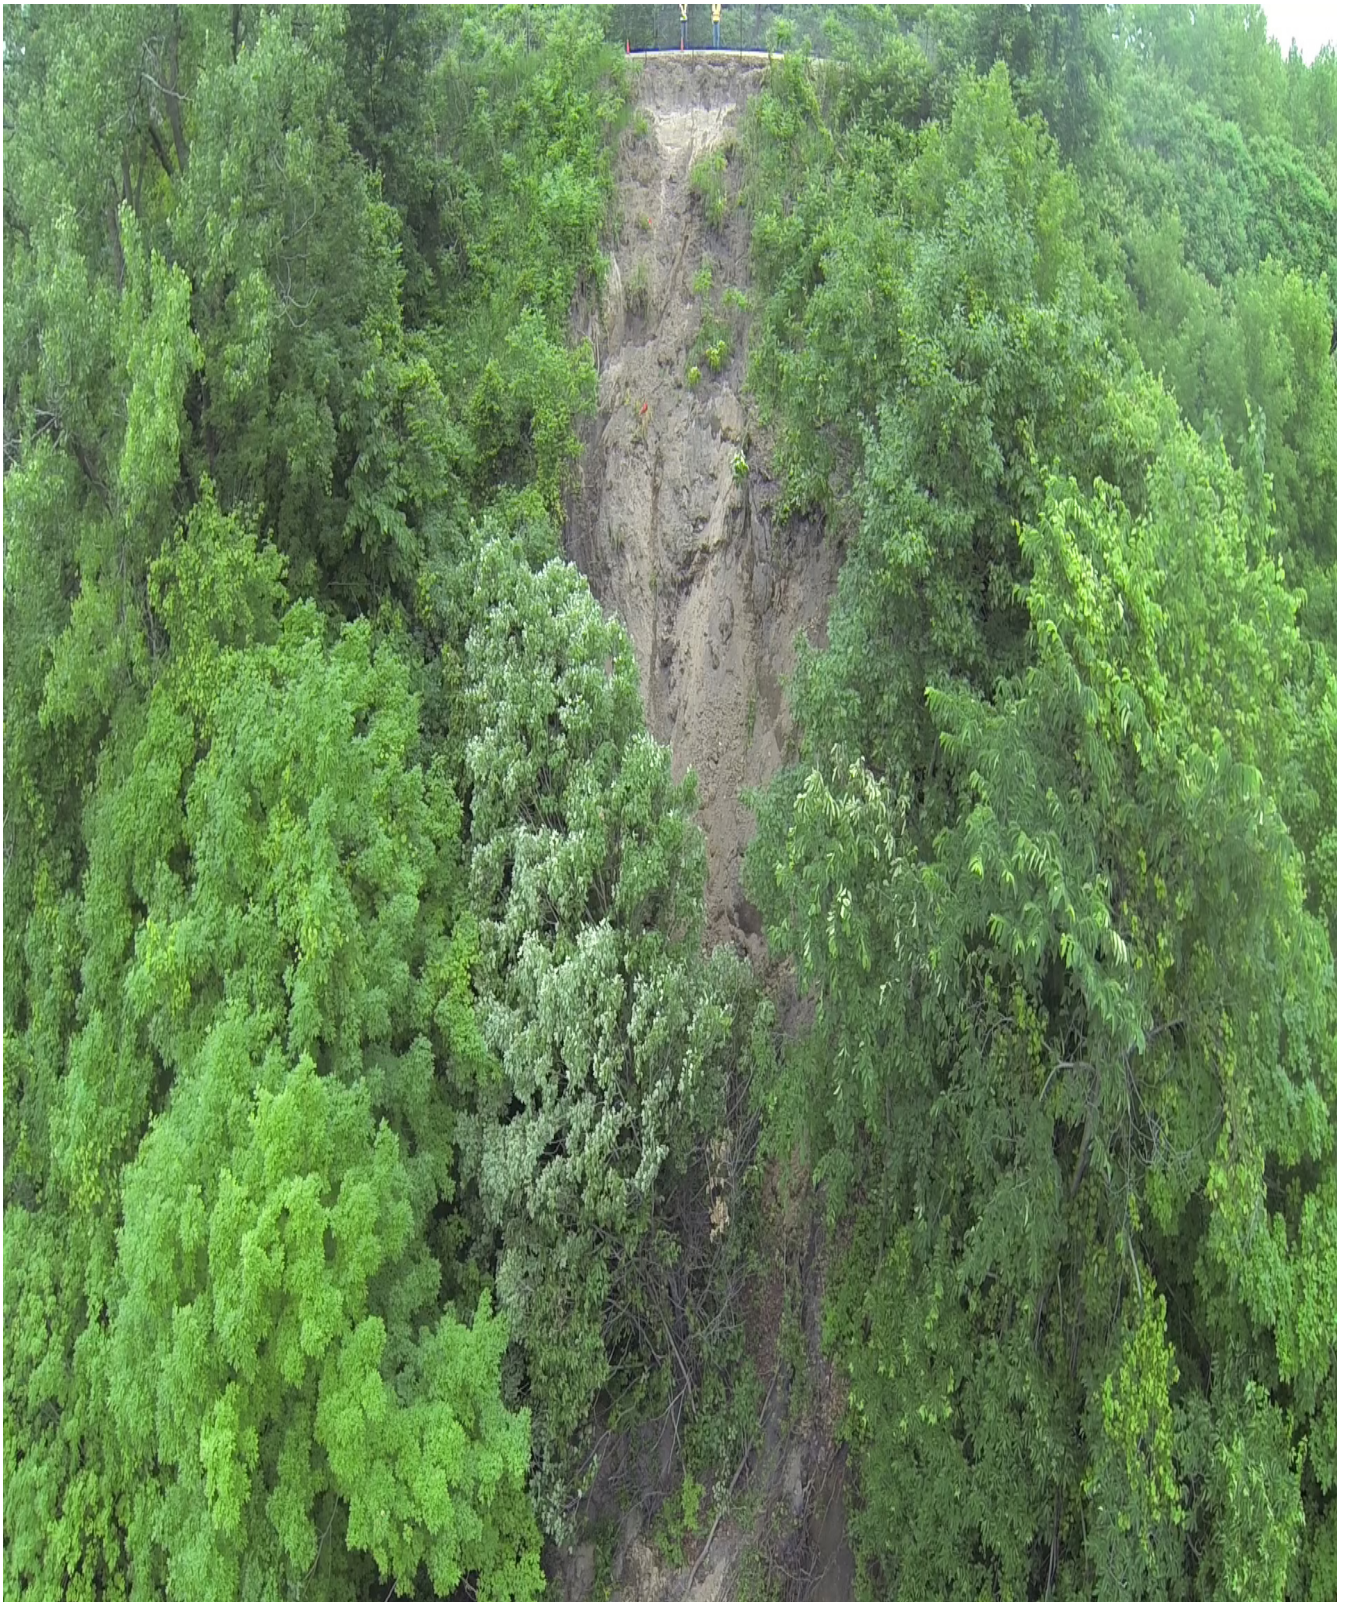
Trail damage immediately after storm event

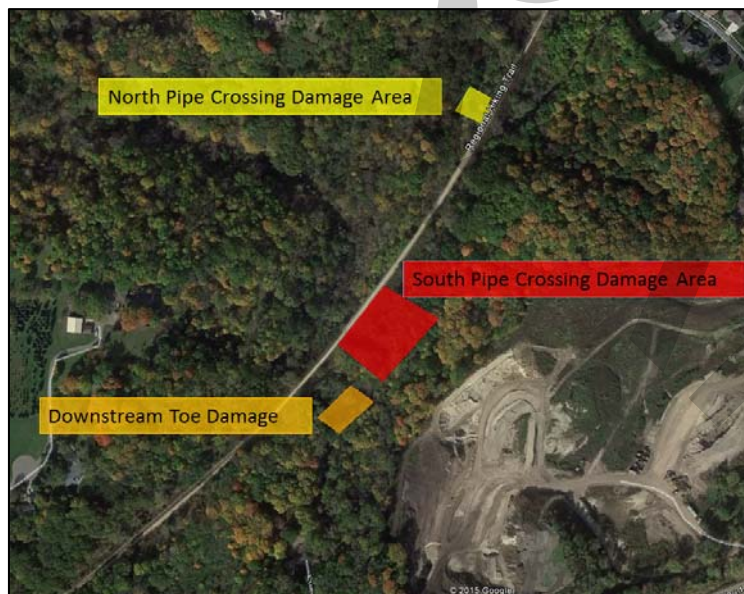
Figure 1 Approximate Damage Areas

Barr Engineering Co. (Barr), under contract with Hennepin County Regional Railroad Authority (HCRRA), has completed a preliminary design and cost estimate (Task 2) for the damage along the Minnesota River Bluffs LRT Regional Trail in Carver County, Minnesota. The trail damage was assessed as part of Task 1 [Reference 1] and sent to the Federal Emergency Management Agency (FEMA) to aid in completing the Project Worksheet (PW) # HCR001G. These areas are shown on **Figure 1**. Additional photos of the damage at each of these areas are provided in **Attachment A**.

It was determined that if these areas were left unrepaired impacts to the trail would likely occur. Therefore, HCRRA and Barr proceeded with Task 2 where repair solutions were provided for each of the three damage areas, as described below, based on field investigations and preliminary engineering design. Additional discussion of the damage at each area and details for the proposed repairs are provided in **Attachment B**.

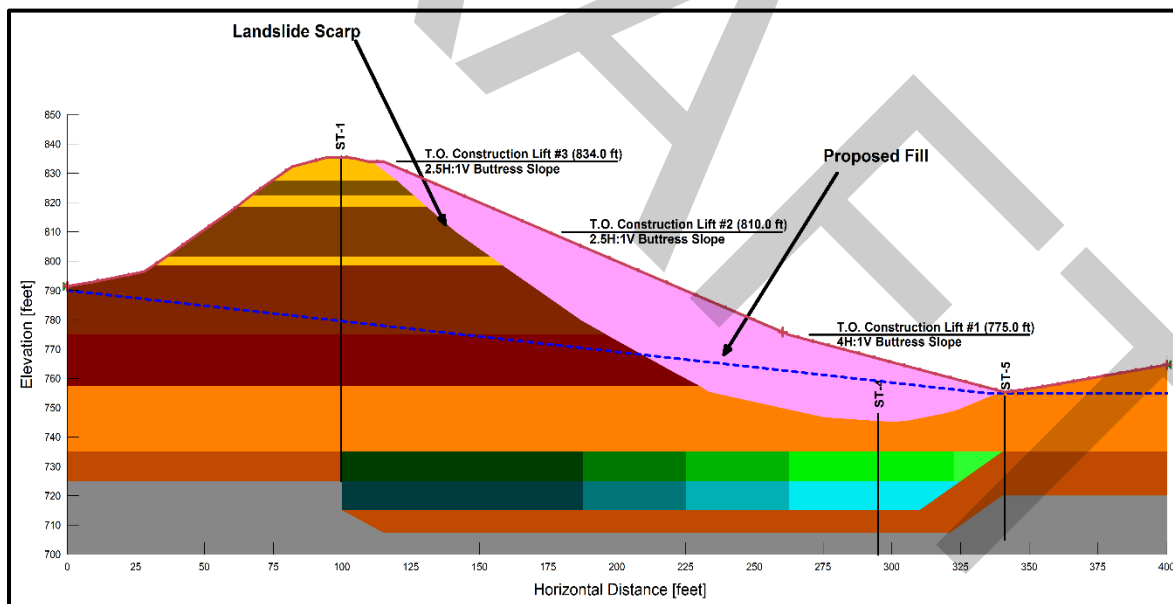
Figure 2 Schematic of the proposed fill during staged construction

- The cross-section in **Figure 2** shows the existing embankment, proposed slopes, and approximate elevation of each construction stage.

- Solution: Fill with staged construction and extend the existing 5 foot diameter corrugated metal arch pipe (CMAP) approximately 300 feet. The CMAP will be supported with a deep foundation and grade beam. Due to the low shear strength and high compressibility of the underlying soil, it is not recommended to construct the full height of the embankment at one time. Phased, or staged, construction is recommended. For this approach, groundwater pressures will need to be monitored during construction. A plan view of the fill extents is shown in **Large Figure 1**.

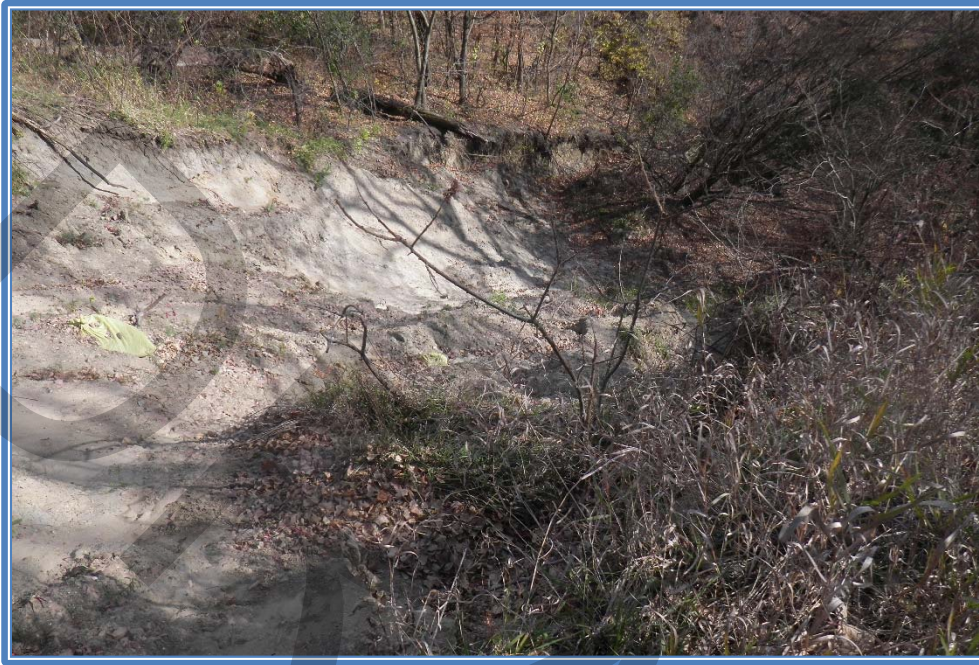
Photograph 1 South Pipe Crossing Damage (looking down-slope from trail)

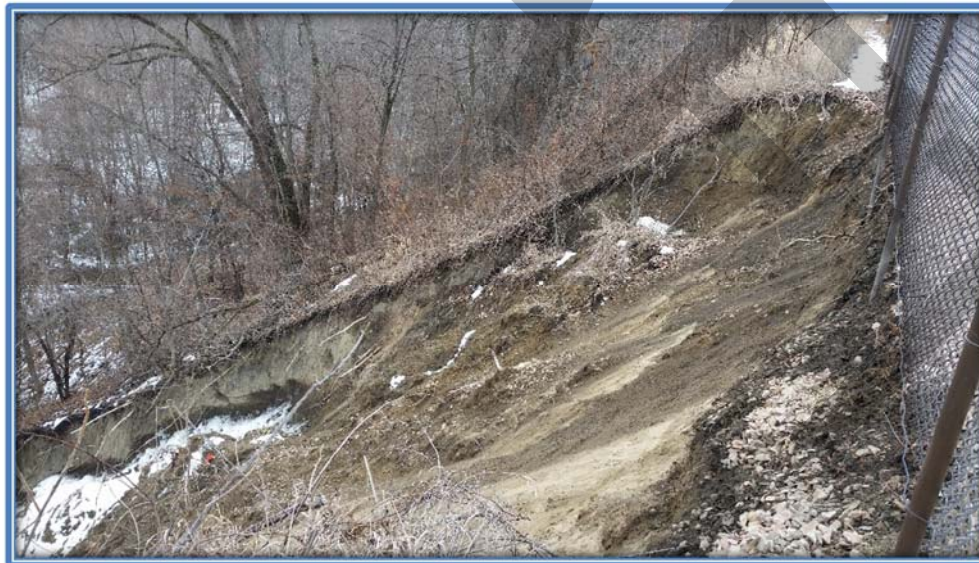
Photograph 2 South Pipe Crossing Damage (looking down-slope from trail)

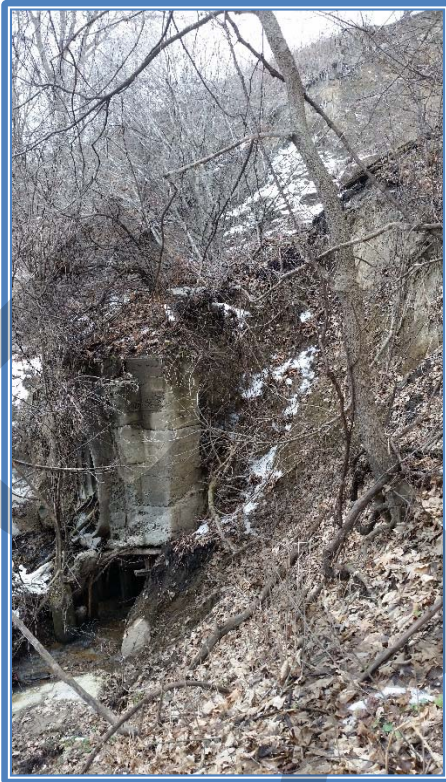
Photograph 3 South Pipe Crossing Damage (headwall)

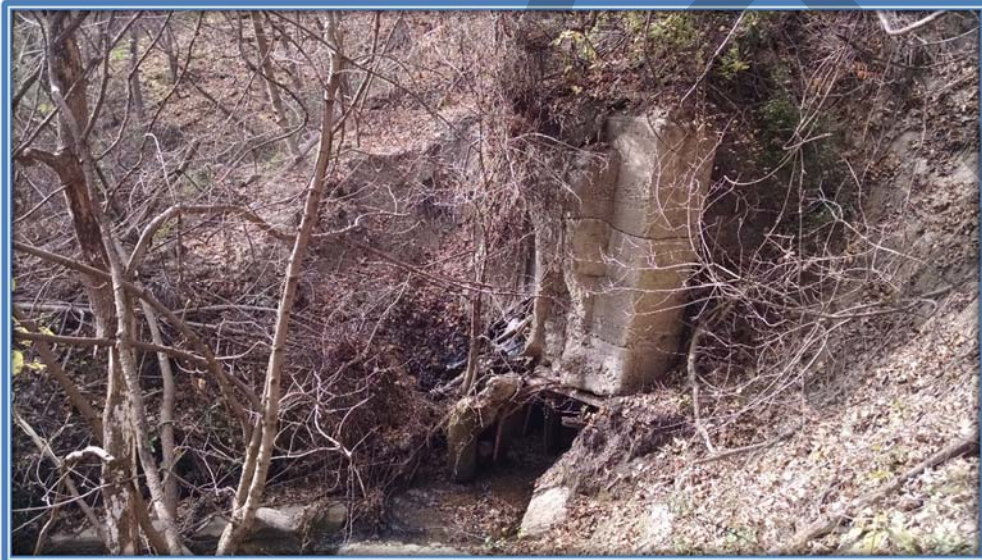
Photograph 4 South Pipe Crossing Damage (headwall damage)

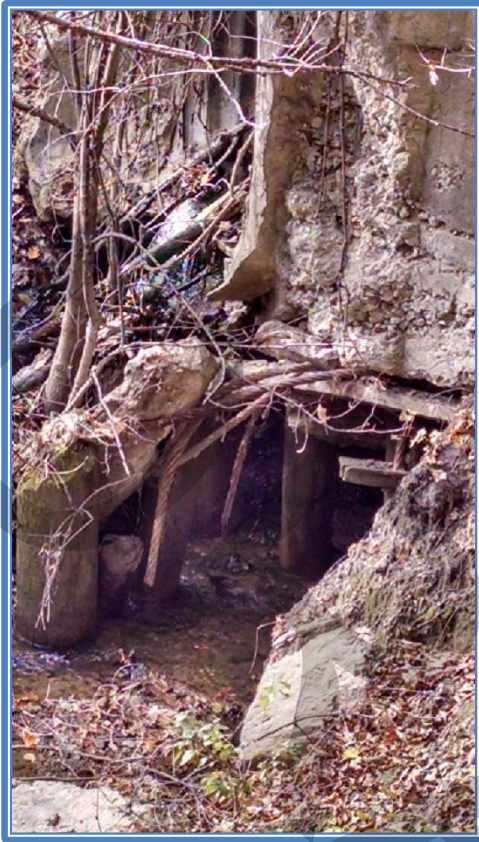
Photograph 5 South Pipe Crossing Damage (headwall damage)

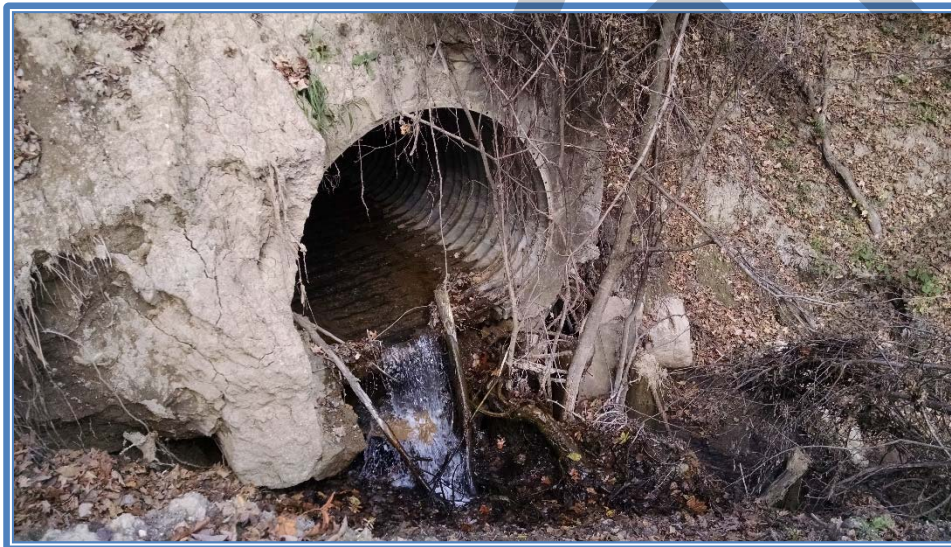
Photograph 6 South Pipe Crossing Damage (CMP exiting toe of slope)

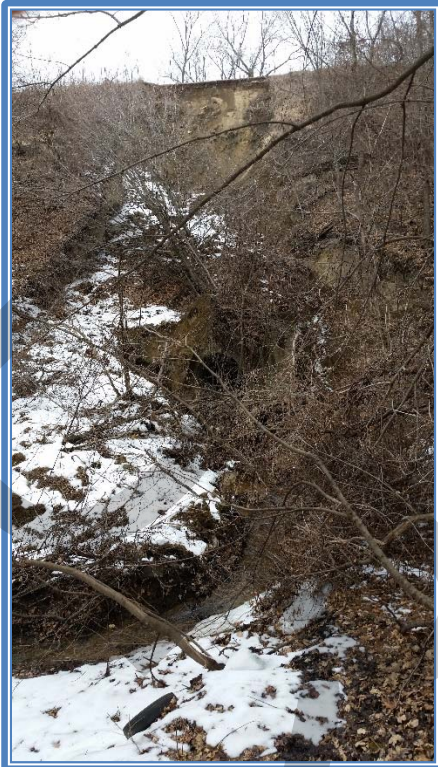
Photograph 7 South Pipe Crossing Damage (looking up-slope from toe)

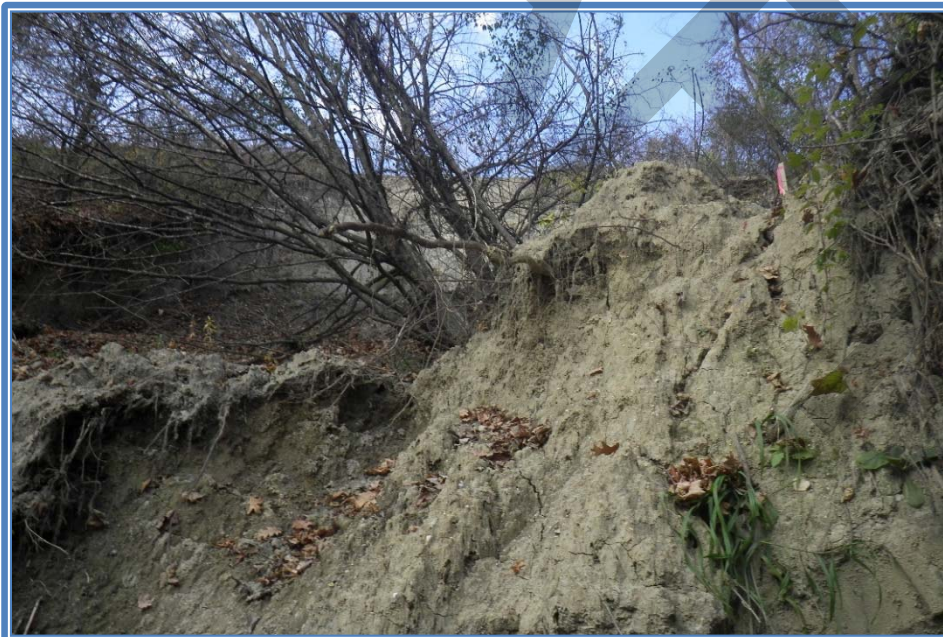
Photograph 8 South Pipe Crossing Damage (looking up-slope from toe)

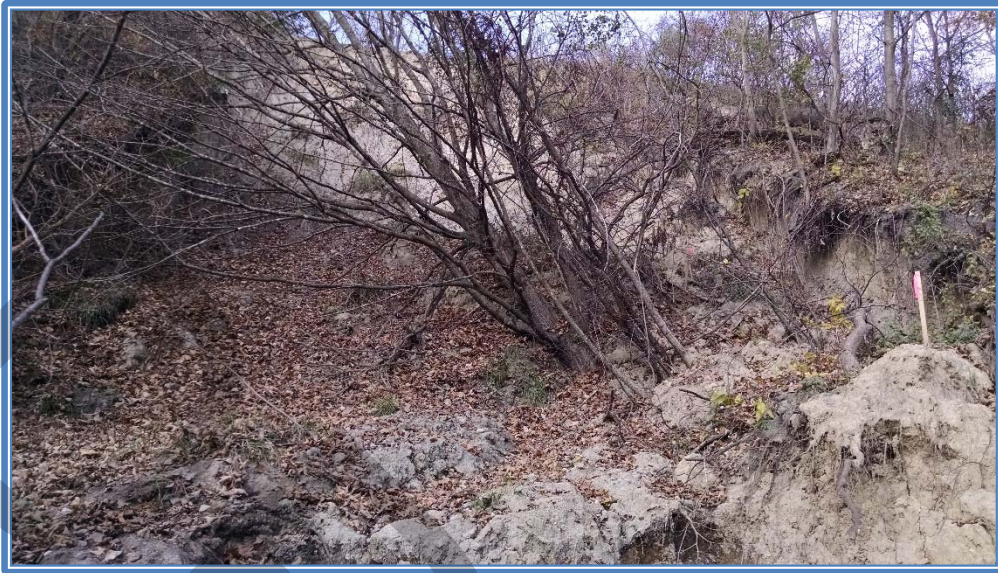
Photograph 9 South Pipe Crossing Damage (looking up-slope from toe)

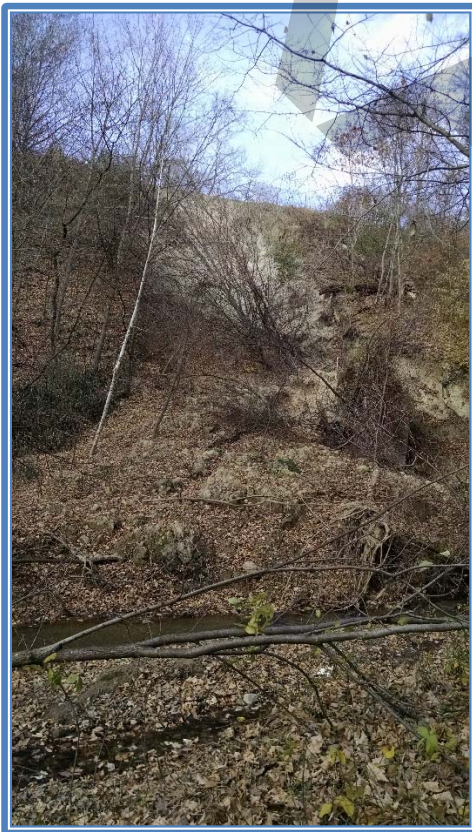
Photograph 10 South Pipe Crossing Damage (looking up-slope from toe)

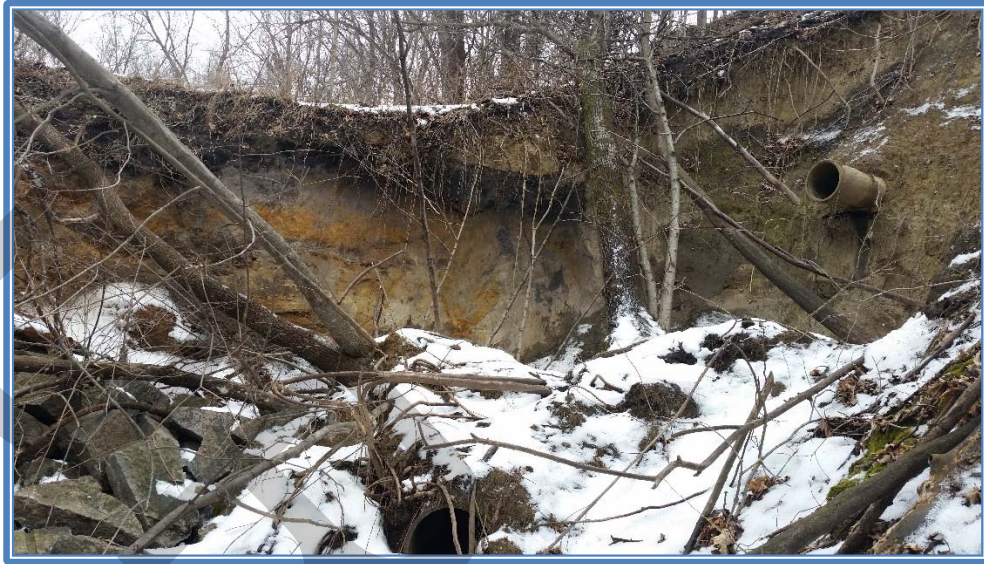
Photograph 11 North Pipe Crossing Damage (looking up-slope from toe)

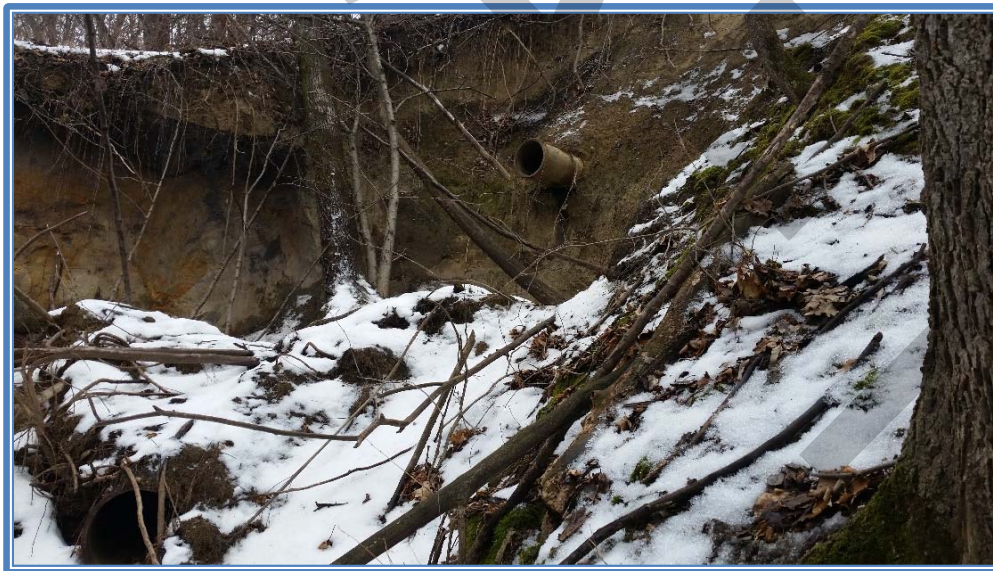
Photograph 12 North Pipe Crossing Damage (looking up-slope from toe)

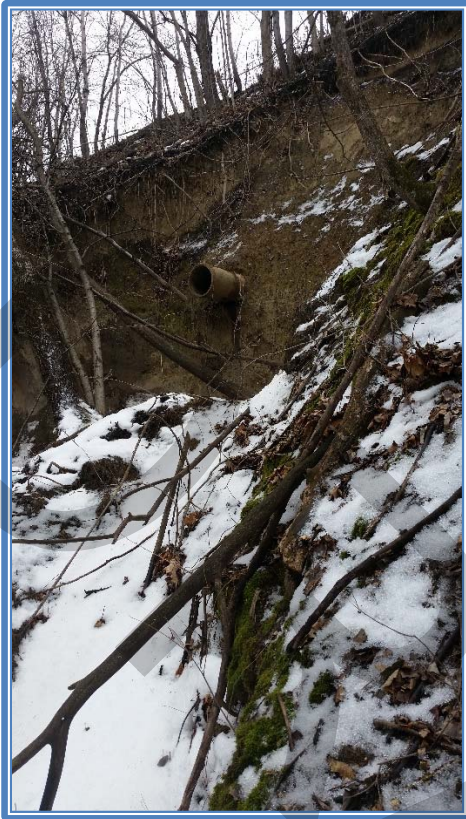
Photograph 13 North Pipe Crossing Damage (looking up-slope from toe)

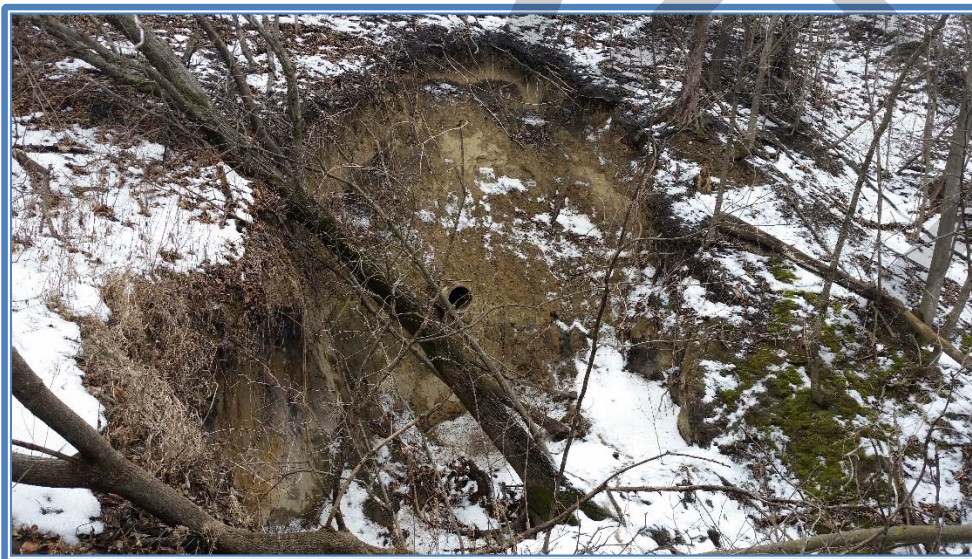
Photograph 14 North Pipe Crossing Damage (looking down from side slope)

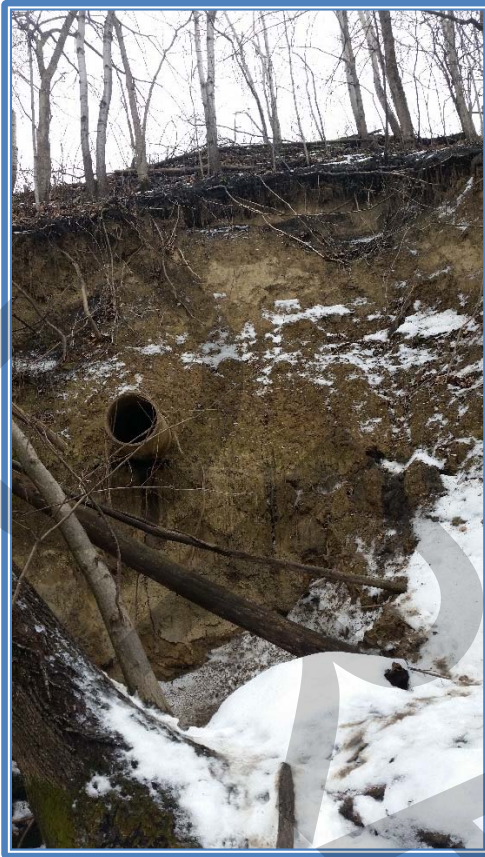
Photograph 15 North Pipe Crossing Damage (looking up-slope from toe)

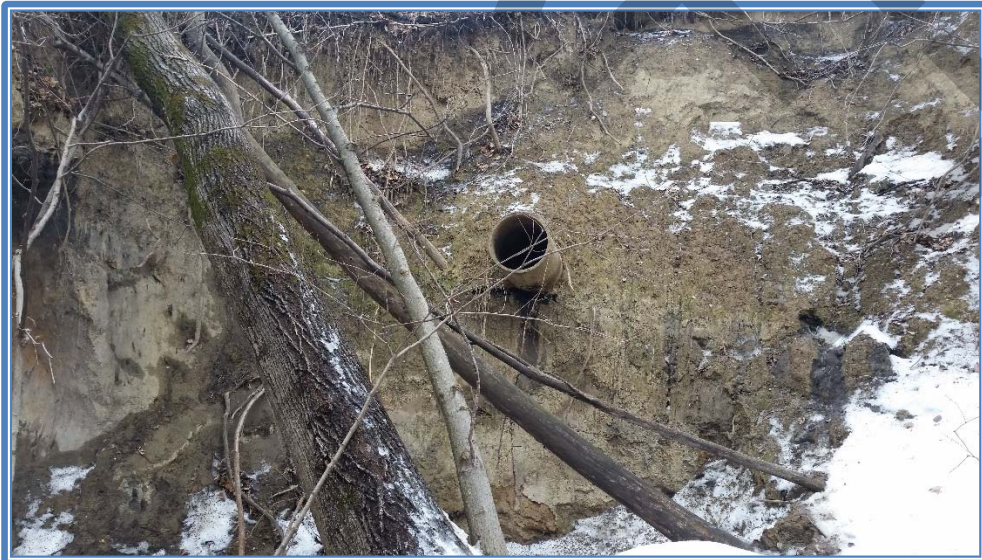
Photograph 16 North Pipe Crossing Damage (looking up-slope from toe)

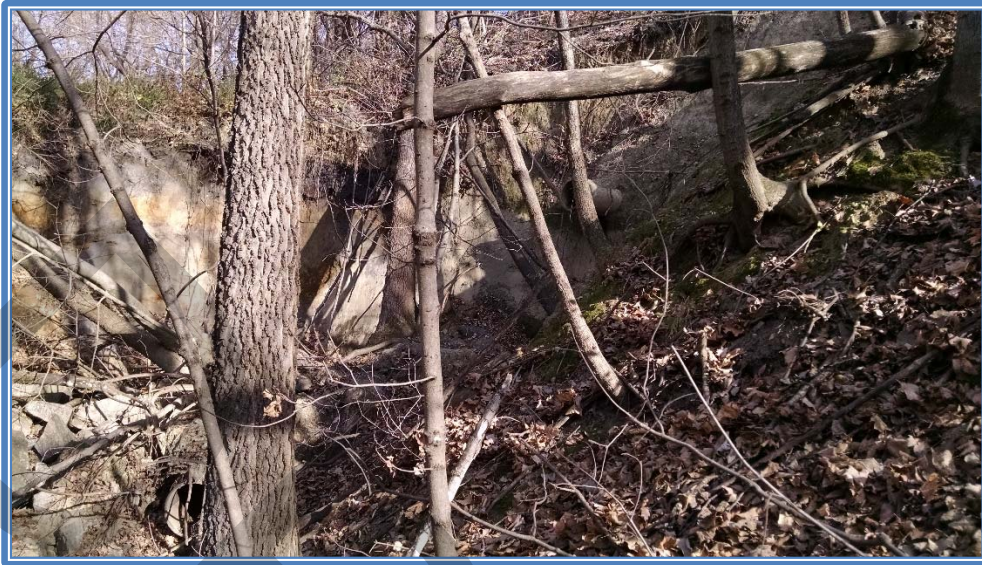
Photograph 17 North Pipe Crossing Damage (looking up-slope from toe)

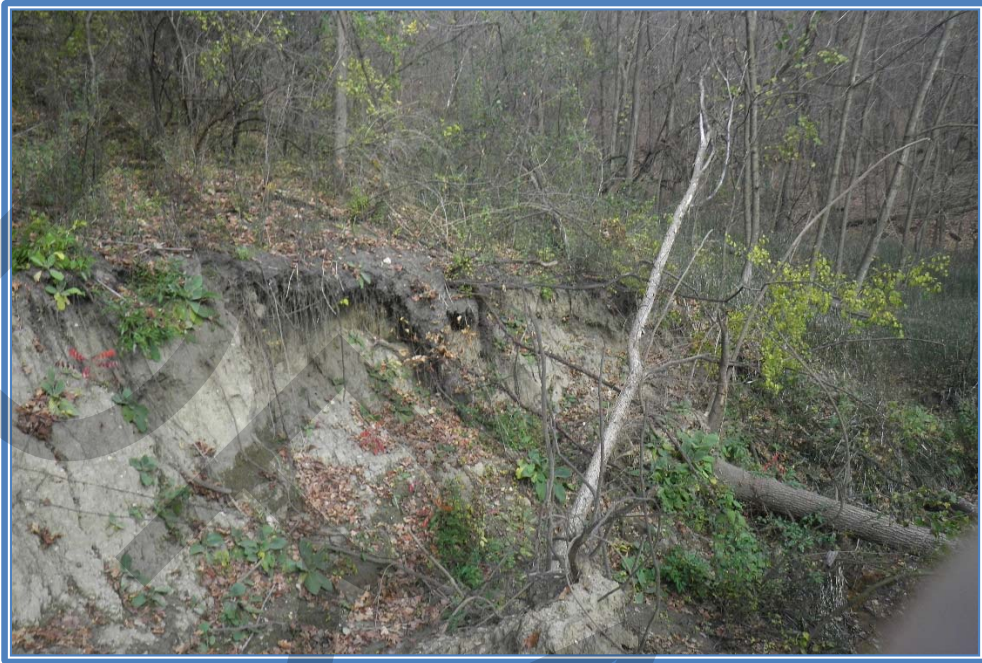
Photograph 18 Northeast Toe Damage

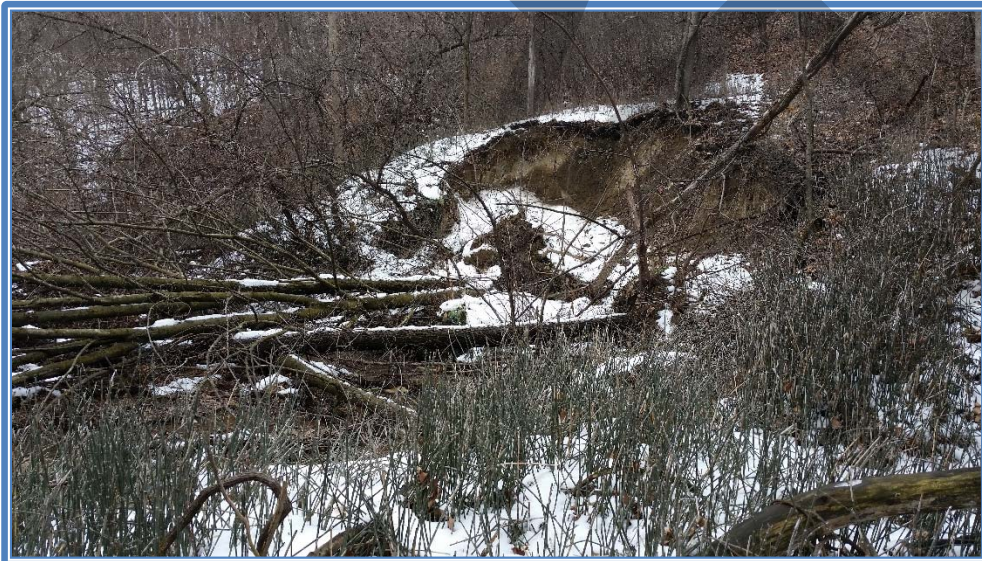
Photograph 19 Northeast Toe Damage

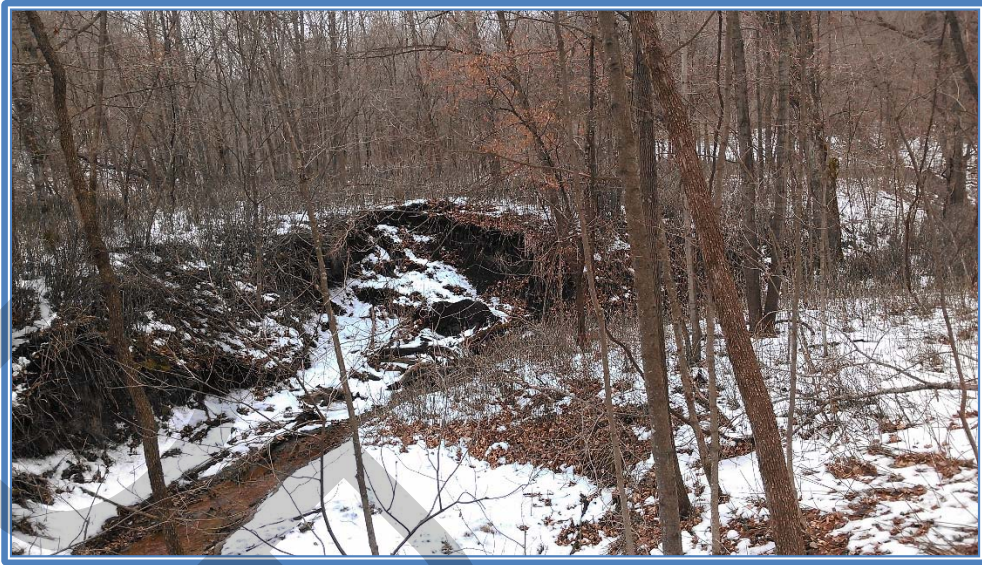
Photograph 20 Southwest Toe Damage

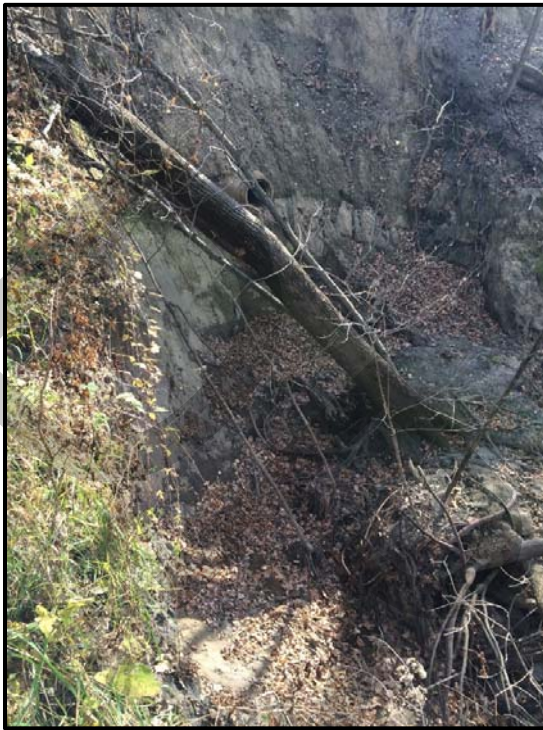
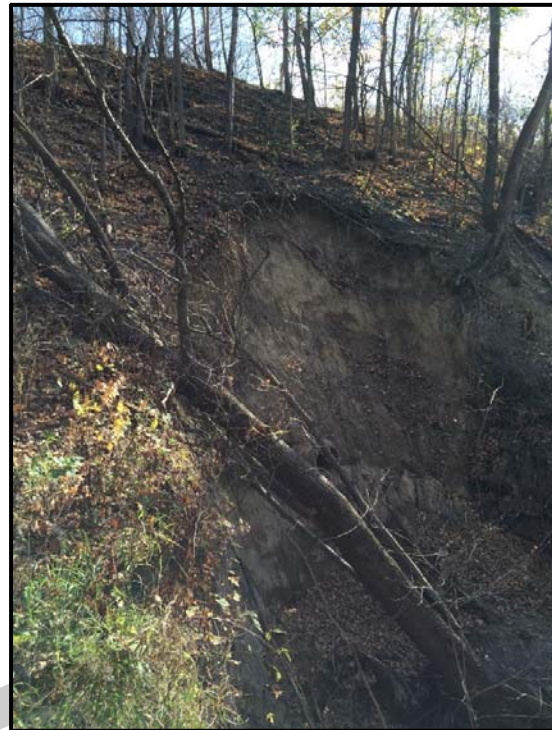
The failure is located where an 18 inch iron and reinforced concrete storm sewer pipe exits the embankment. The failure scarp is approximately 25 feet from the trail and has not yet impacted the trail. However, it is likely that the additional loss of soil around the pipe, and at the toe of the slope, will result in a failure that impacts the trail surface.

The size of the failure, assuming the original slope angle was similar to that of the ground around it, is 60 feet long by 35 feet wide and 12 feet deep. According to our survey and high-definition laser scanning information, assuming that the damaged slope was continuous across the void, approximately 220 cubic yards of in-place fill are needed to reestablish the slope to its original condition. The following captions show the extent of the damage for the North Pipe Crossing where erosion has extended into the embankment toe (**Photograph 1**), causing a progressive failure of the storm sewer pipe, and loss of soil upslope from the pipe outlet (**Photograph 2**).

1. Place drop structure and extend pipe, place erosion control materials
 - The repair requires removing debris from the toe, placing two precast concrete drop structures, extending the 18 inch pipe with 24 inch diameter pipe to the new toe of slope, importing fill to correct the slope, and then placing turf-reinforcement mats and rip-rap to stabilize the slope face and prevent future toe scour.

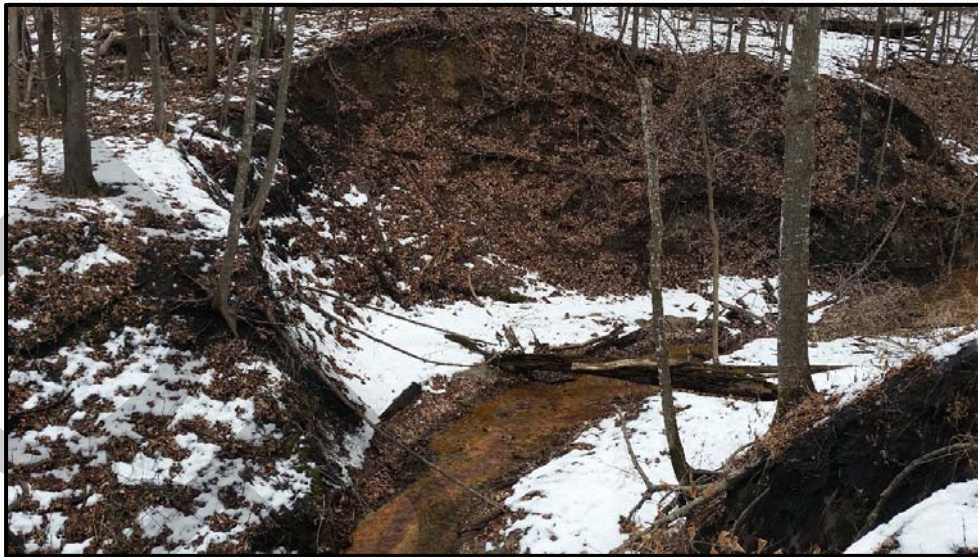
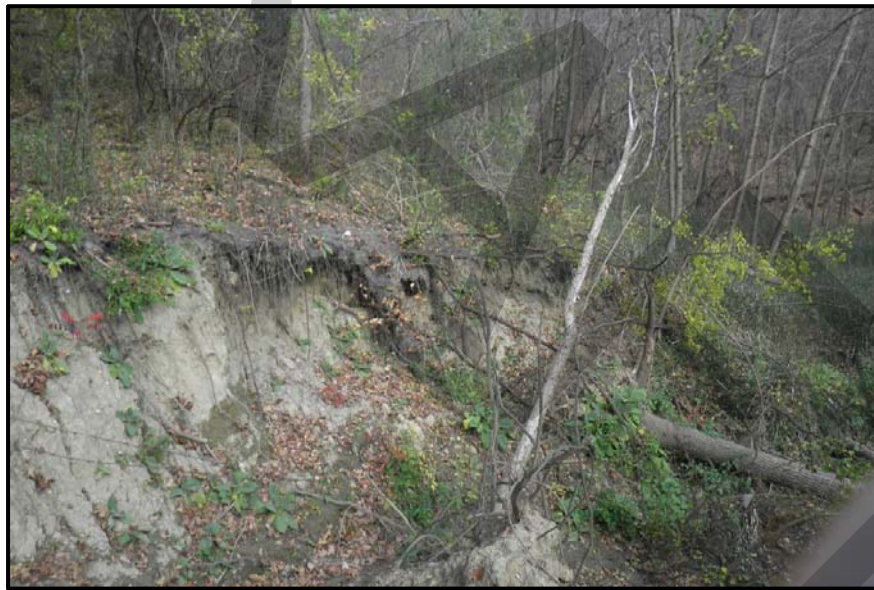
Two erosion areas were identified southwest and downstream from the large slide area (South Pipe Crossing). Analysis of the northeastern area shows the pre-erosion slope conditions were more stable (had a higher factor of safety) than the current toe conditions. The global stability of the slope at this location has a factor of safety of approximately 1.20. Slope stability modeling results for the southwestern area are similar to the northeastern area in that further soil loss will eventually lead to a failure that would impact the trail surface. Global stability analysis of the embankment at this location shows a factor of safety just above 1.0. At both toe damage locations, it is likely that further erosion will continue to occur. These toe damage areas decrease the overall stability of the trail embankment due to the loss of supporting material, and left unrepaired, increase the likelihood of a larger slope failure that would impact the trail surface.

The approximate size of the Northeast Toe Damage area (**Photograph 3**) is 50 feet long, 10 to 20 feet wide, and approximately 8 feet deep. The approximate size of the Southwest Toe Damage area (**Photograph 4**) is 125 feet long, 20 to 30 feet wide, and 8 feet deep. According to our survey and scanning information, and assuming that the damaged slope was continuous across the area, approximately 100 and 450 cubic yards of in-place fill, respectively, are needed to reestablish the slope to its original condition.

The Northeast Toe Damage area will be covered with fill by the South Pipe Crossing repair. The proposed design to repair the Southwest Toe Damage areas is:

1. Replace soil lost to erosion and fortify with erosion prevention measures
 - This process would involve removing debris, importing fill or using borrow material from other portions of the site to re-establish grade. Scour prevention and erosion control measures would be placed (turf-reinforcement mats and rip-rap). The stream

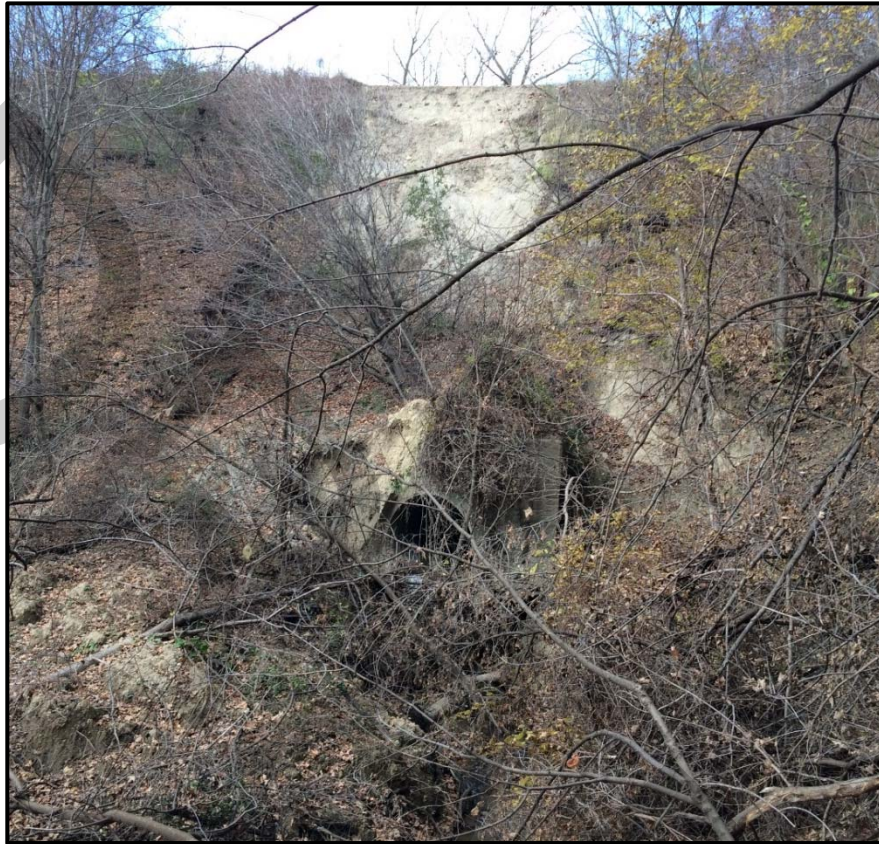
Photograph 5

The South Pipe Crossing Damage area is the largest slope failure along the trail, having the greatest impact to the trail. A tension crack was observed extending from the edge of the observed failure at the edge of the trail northeast along the trail to the nearby park bench, a length of approximately 150 feet.

The embankment is approximately 80 to 90 feet tall with a slope angle of 1.7H:1V to 1.8H:1V adjacent to the damage. The existing slope adjacent to the slide does not meet the stability criteria associated with the standard of practice for geotechnical factors of safety. Therefore, filling the void in the embankment left by the slide and reconstructing the slope to its original angle staying within the existing right of way cannot be designed and constructed to the geotechnical engineering standard of practice with soil or geotextiles¹. Flattening the slope (mass grading), rather than a series of soldier pile walls, was deemed less expensive and appropriate for this repair.

The slide area is about 45 feet wide, approximately 110 feet long with a head scarp 8 feet deep. Damage consisted of partial loss of trail surface, damage to the corrugated metal pipe (CMP) concrete headwall, and erosion at the base of the CMP headwall exposing timber piling supporting the structure. Approximately half of the outlet headwall appears to have been destroyed by debris from the slide. **Photograph 5** shows the extent of the South Pipe Crossing Damage.

- Remove debris from toe, abandon the existing CMP headwall in place, extend the 74 inch by 90 inch CMP to the new toe of slope, reestablish the channel, import fill to flatten the slope to 2.5H:1V and 4H:1V (encompassing the extents of the landslide and tension crack extending to the park bench), and place erosion control materials (turf-reinforcement mats and rip-rap).
- This repair will be performed using a staged construction approach. The first lift (Lift #1) will place fill at a 4H:1V slope to an elevation of 775 feet. Lift #2 will be constructed to an elevation of approximately 810 feet and Lift #3 to an elevation of 834 feet connecting to the trail surface at the top of the embankment. Lift #2 and #3 will be placed at a slope of 2.5H:1V.

The design to repair the South Pipe Crossing Damage will include importing fill material to flatten the slope to 2.5H:1V and 4H:1V, abandoning the existing CMP headwall in place, extending the 74 inch by 90 inch CMP to the new toe of slope, reestablishing the channel, and placing erosion control materials (turf-reinforcement mats and rip-rap). This repair will be performed using a staged construction approach. The total cost of this option is around \$1,344,000 based on a preliminary opinion of construction costs, which could vary up to \$1,680,000 with a 20% contingency. Assumptions and category discussions are provided above. A summary of the costs are provided in **Large Table 1**.
