APPENDIX J3 NOISE

To:	Kathryn O'Brien		
From:	Tim Casey and Elliott B. Dick	Project:	Central Corridor Light Rail Transit
cc:			
Date:	October 31, 2008	Job No:	65891

Re: Transit train horns and bells simulation at Minnesota Public Radio

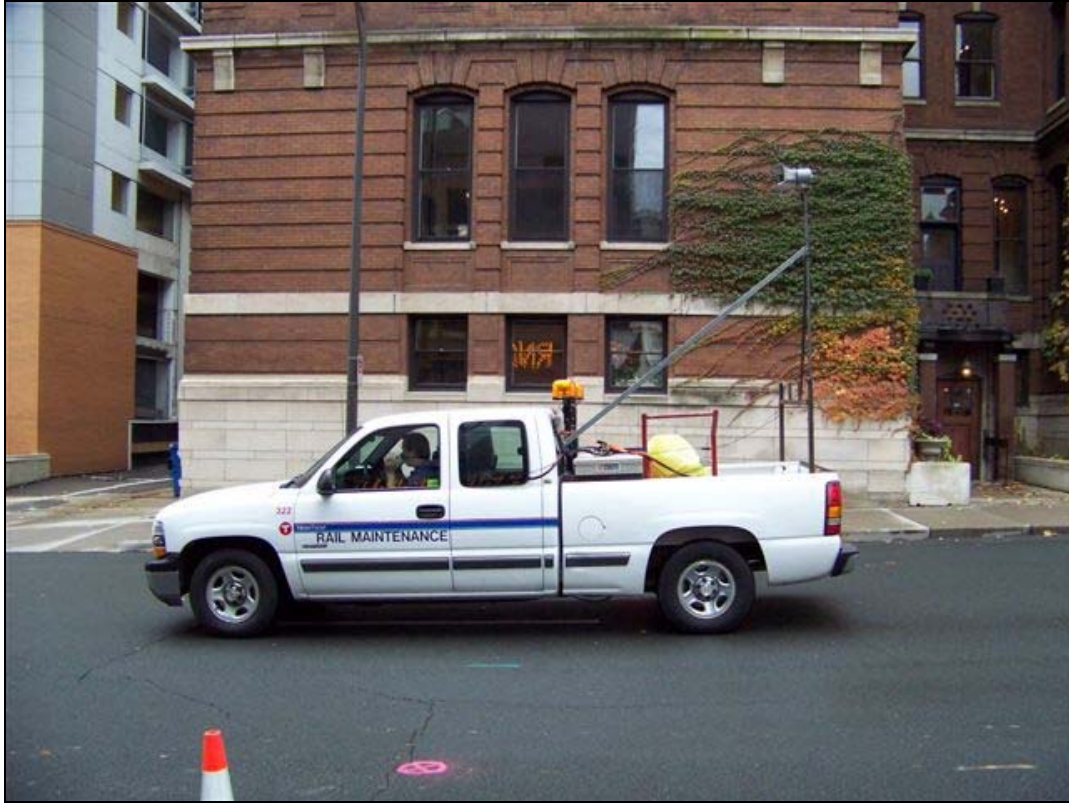
Figure 1

Metro Transit LRV Horn and Bell Simulation Vehicle

The first audible warning simulation device tested in the manner described above was inconsistent with the actual LRV. Specifically the noise levels matched reasonably well, but the horn pitch sounded somewhat different, and the measured spectrum content was notably different. HDR observed a slight frequency shift between the two signal sources which may present a minor problem, but more concerning was that the mock-up's horn emitted a narrow-band tone compared with the actual horn in use, which spans at least two whole octaves. The explanation was that the mock-up was originally made before Metro Transit bought any trains for HLRT, and it used a signal generator for another transit system. Consequently the signal generator in the mock-up was different from the ones in trains. This mock-up was rejected and Metro Transit staff set about the task of building a second mock-up using actual HLRT components.

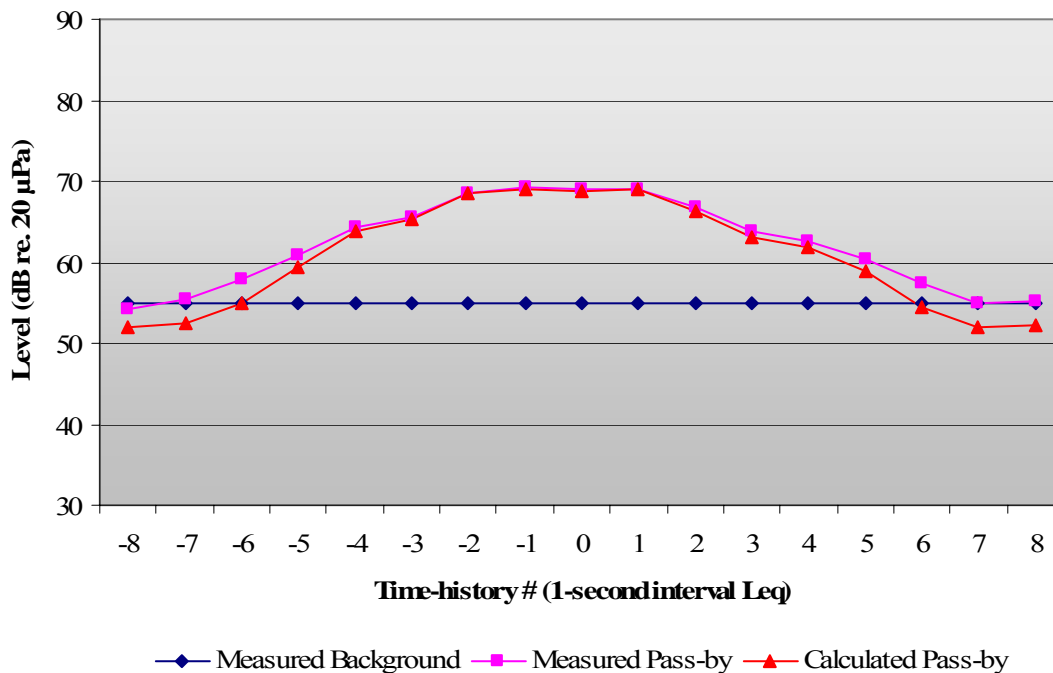
Time histories of each pass-by measurement were evaluated for extraneous, unrelated noise events. The bounds of each time history were hand-picked for each pass-by, to reflect a reasonable event time history. An example of a pass-by is shown below, along with the background noise and the final corrected level.

Typical LRT Pass-by

The exposure level is symbolized as L_{ex} in Kinlser & Frey (4th edition, 2000, pp. 368) and defined therein as “The level of the time integral of the squared A-weighted sound pressure over a stated time referenced to $(1\text{ s}) \times (20\ \mu\text{Pa})^2$.” Because the time history was measured in 1-second

intervals, this simplified the calculation of SEL from L_{eq} – simply the energy sum of the time history. This was used as the overall SEL of the event.

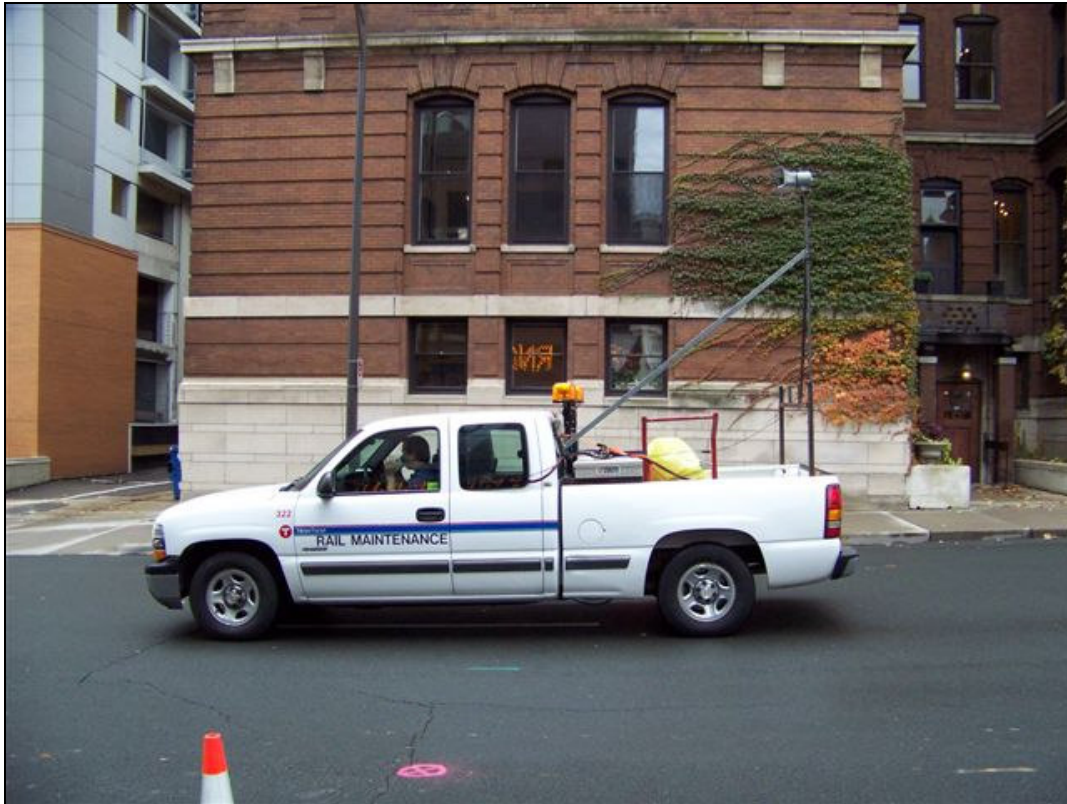
Figure A.1

Metro Transit LRV Horn and Bell Simulation Vehicle

One measurement of the LRV high horn demonstrates the directivity of the horn and bell source; it is 19.2 dBA down at 90° from on-axis.

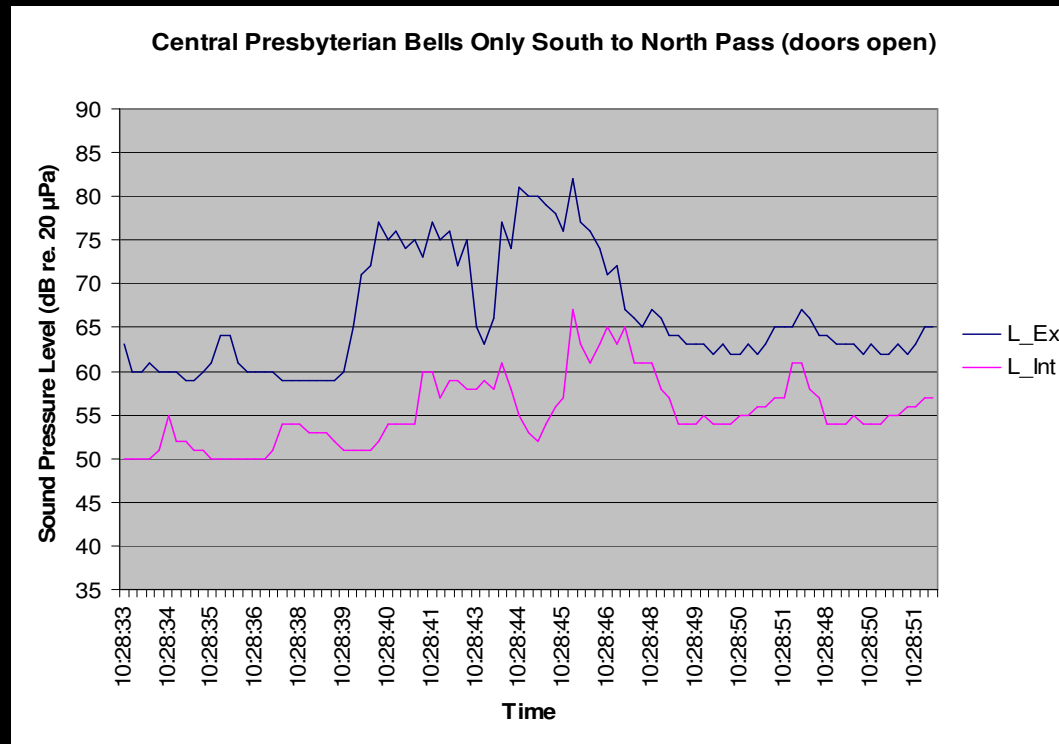
Results from Central Pres, Bells Only, Doors Open

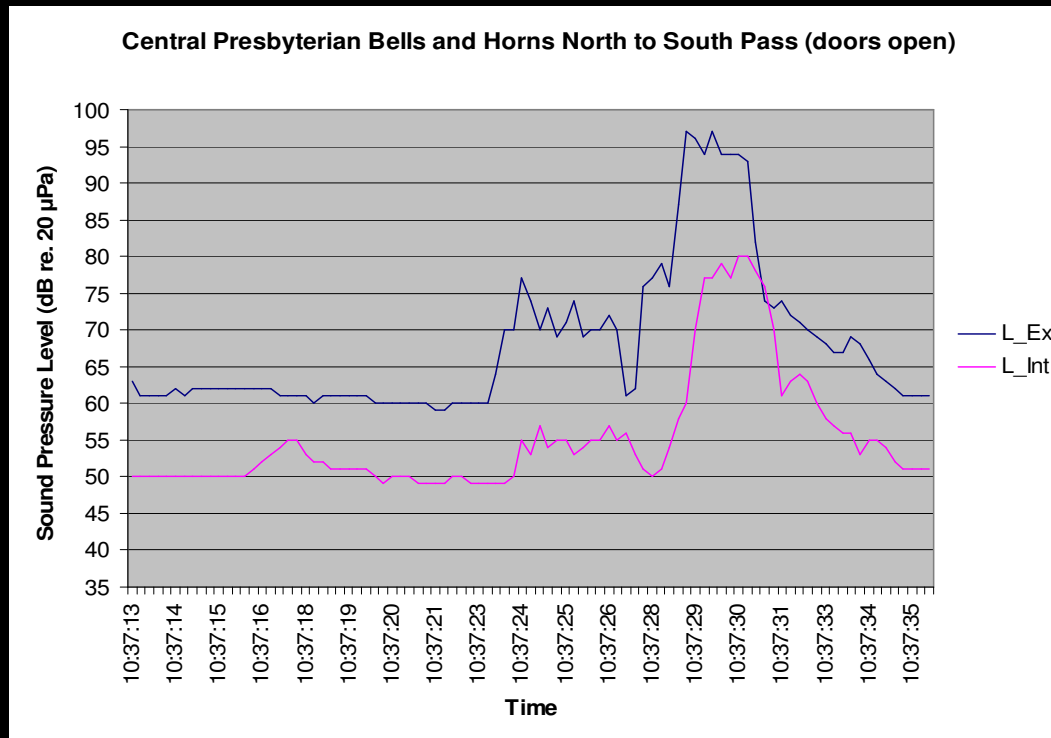
Results from Central Pres, Bells and Horns, Doors Open

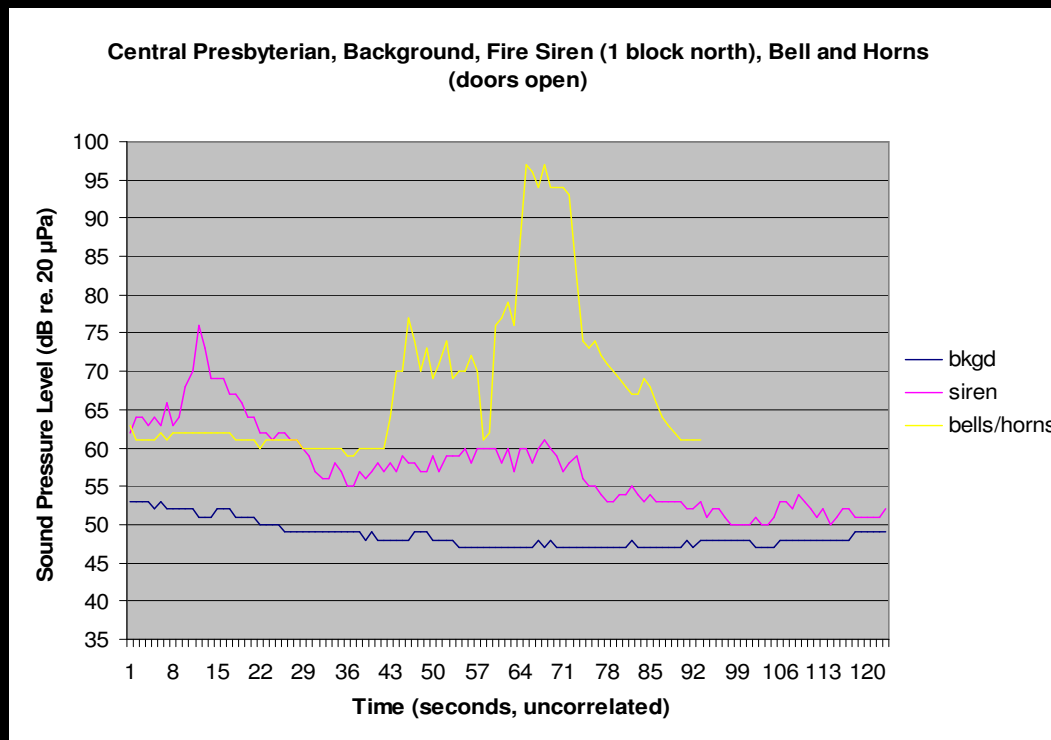
Results from Central Pres, Composite (no time correlation)

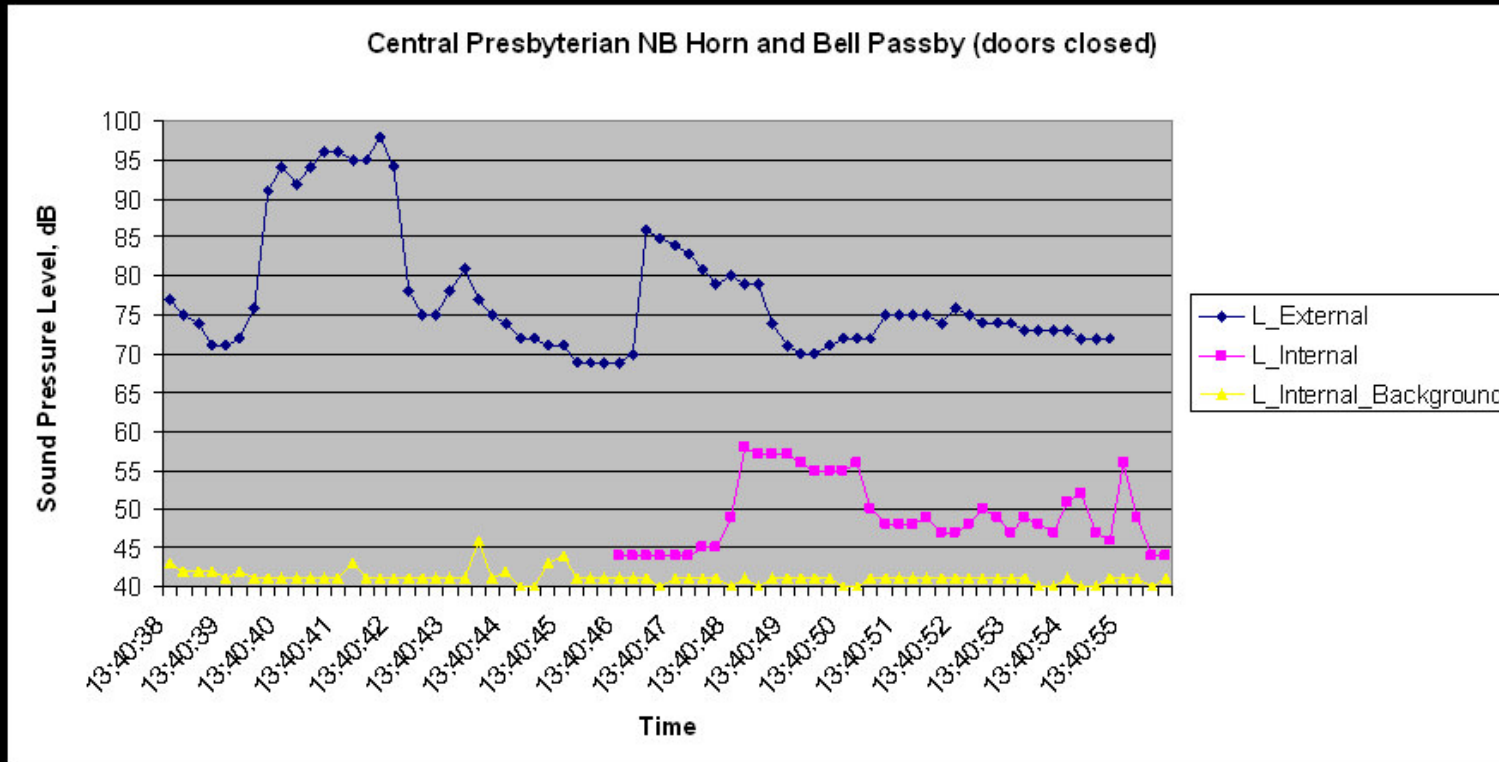
Results from Central Pres. NB Horn and Bell Passby, Doors Closed

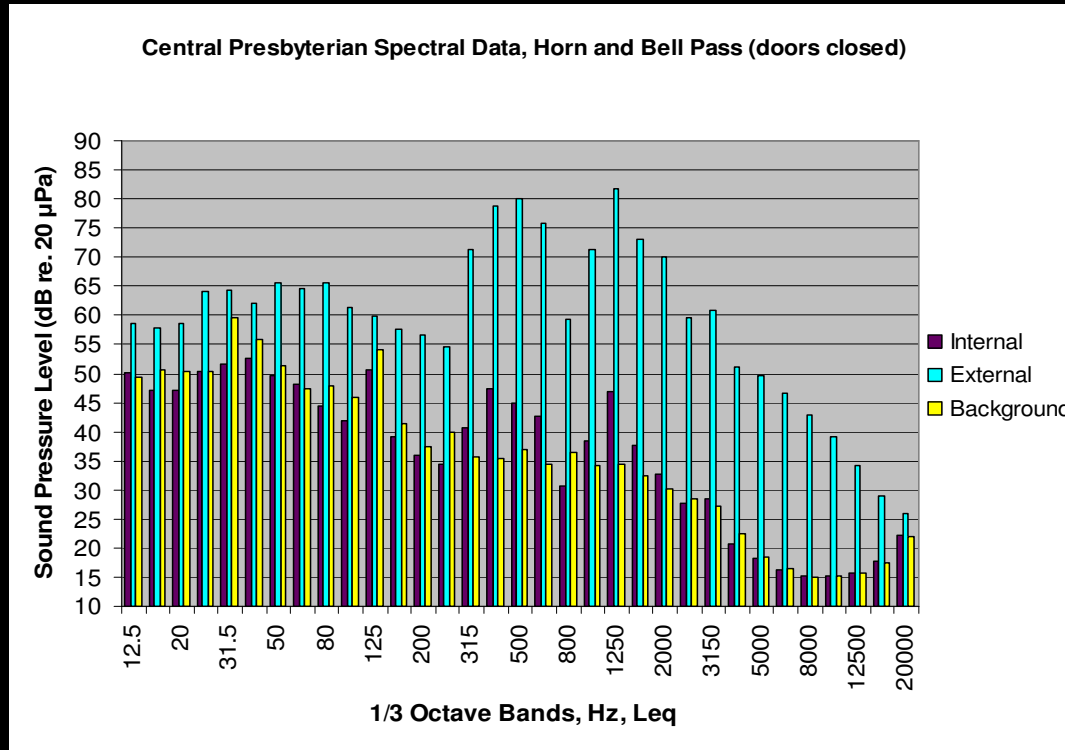
Results from Central Pres, Horns and Bells, Octave Band Analysis and Comparison

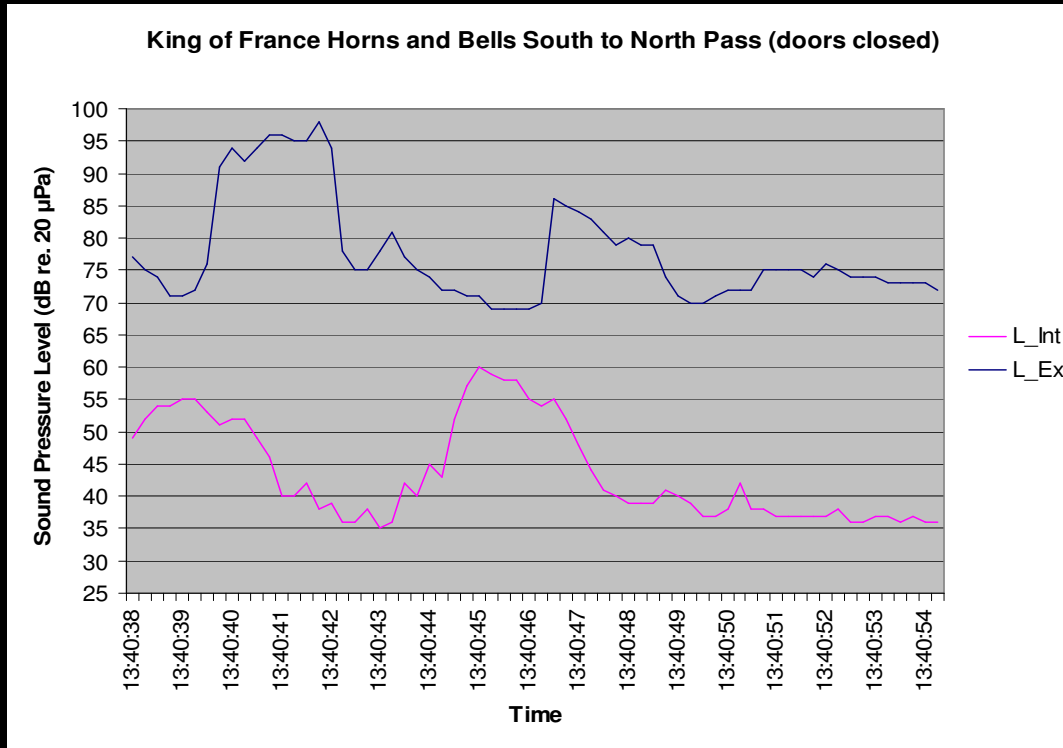
Results from Louis King of France, Horns and Bells, Doors Closed

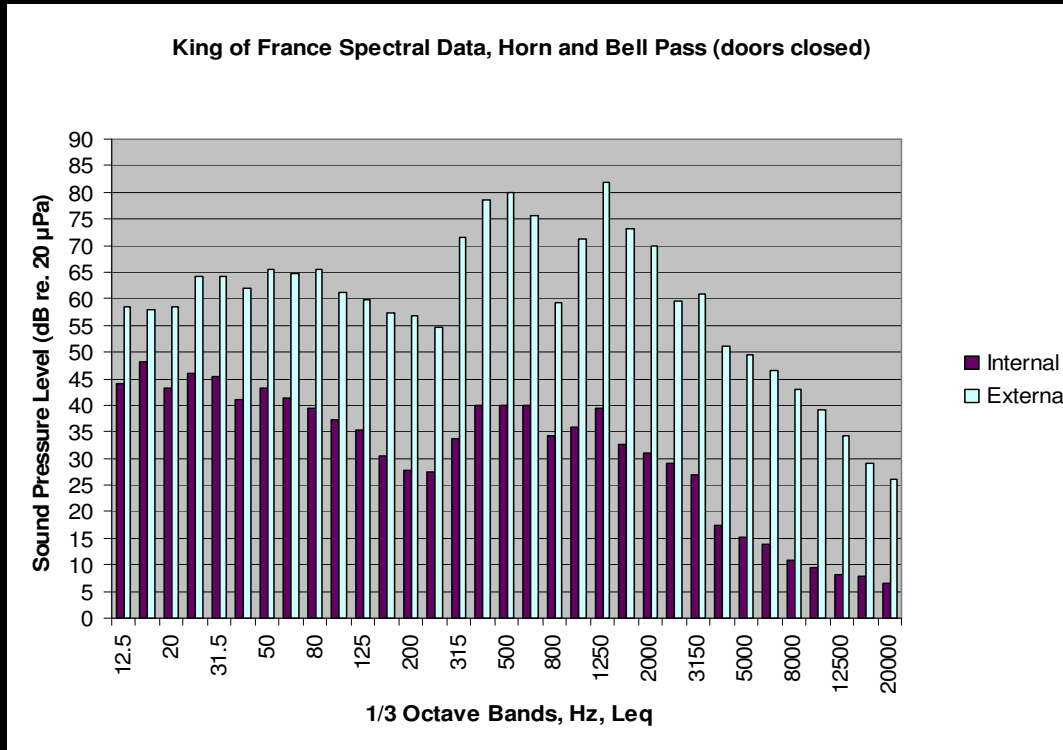
Results from Louis King of France, Horns and Bells, Spectral Comparison, Doors Closed

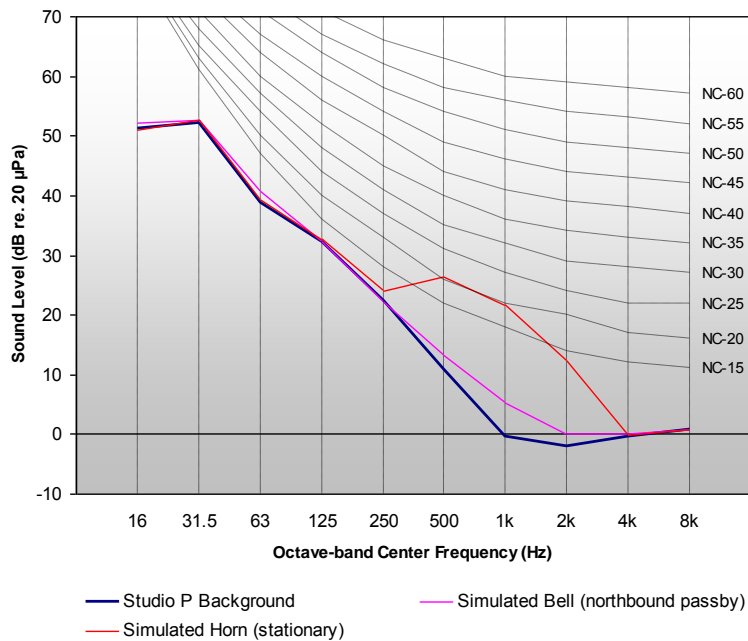
Results of HDR horn and bell simulation for Studios H, I, and P found that horns are audible inside all studios; bells, as calibrated for this simulation session, are not audible in Studio H or I, and were not observed in Studio P despite being measurable in Studio P. Figure 1 displays data collected during this exercise. These data indicate the following in regard to Studio P:

- The sound level of the simulated LRV bells during a northbound passby is 1 dBA above the interior ambient noise floor of Studio P.
- The sound level of the simulated LRV bells during a northbound passby is 2 to 6 dB above the ambient interior noise floor in the 500 Hz, 1 kHz and 2 kHz octave-bands.
- The sound level of the simulated LRV horns stationary in front of Studio P is up to 7 dBA above the interior ambient noise of Studio P.
- The sound level of the simulated LRV horns stationary in front of Studio P is 14 to 22 dB above the ambient interior noise floor in the 500 Hz, 1 kHz and 2 kHz octave-bands.
- The simulated horns and bells mainly affect the 500 Hz, 1 kHz and 2 kHz octave-bands.

Figure 1
Results in Studio P

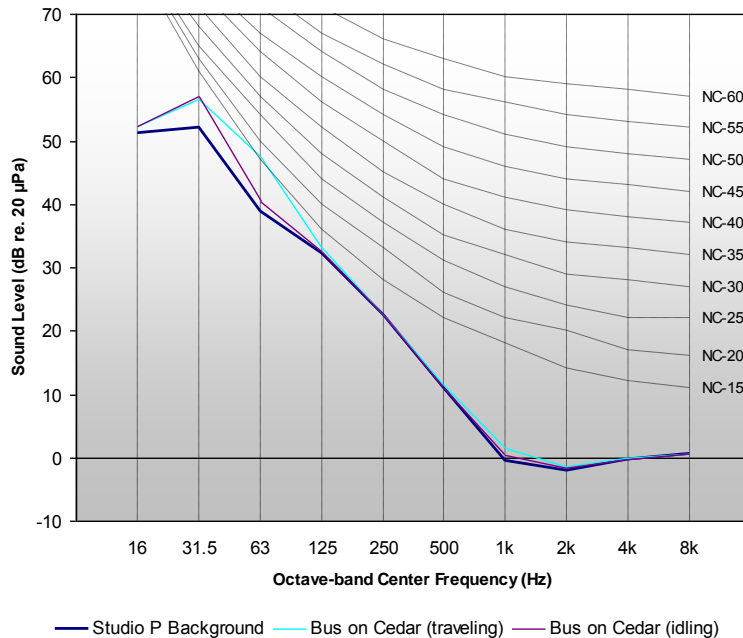
Figure B.1

An event observed in the Studio P data, a transit bus passed on Cedar, idled at the corner for greater than one minute, and then proceeded travel. This is shown in Figure B.1, and the data indicate the following in regard to Studio P:

- The sound level of buses traveling on Cedar Street is 4 to 7 dBA above the ambient interior noise floor.
- The sound level of buses idling on Cedar Street is 1 dBA above the ambient interior noise floor.

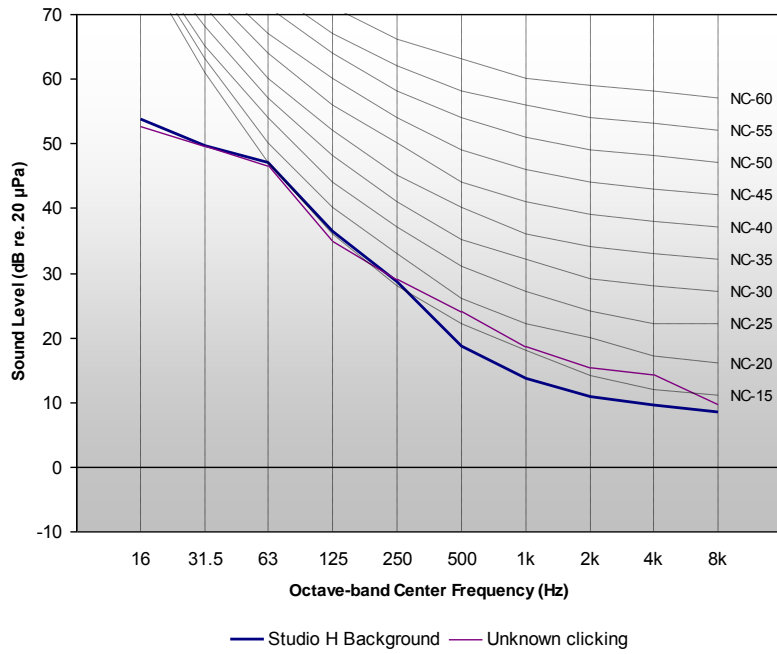
Figure B.2

The time-history of the Studio H showed an intermittent noise. Its duration was less than one second, and repeated in 8 to 30 second intervals – possibly a clicking from the studio equipment. These events were found to be similar in frequency content, and all the distinct events of this type were averaged. This is shown in Figure B.2, and the data indicate the following in regard to the unknown clicking:

- The sound level of the unknown clicking is 1 dBA above the ambient interior noise floor.
- The sound level of the unknown clicking increases the ambient interior noise floor by 5 dB or more between the 500 Hz and 4 kHz octave-bands.

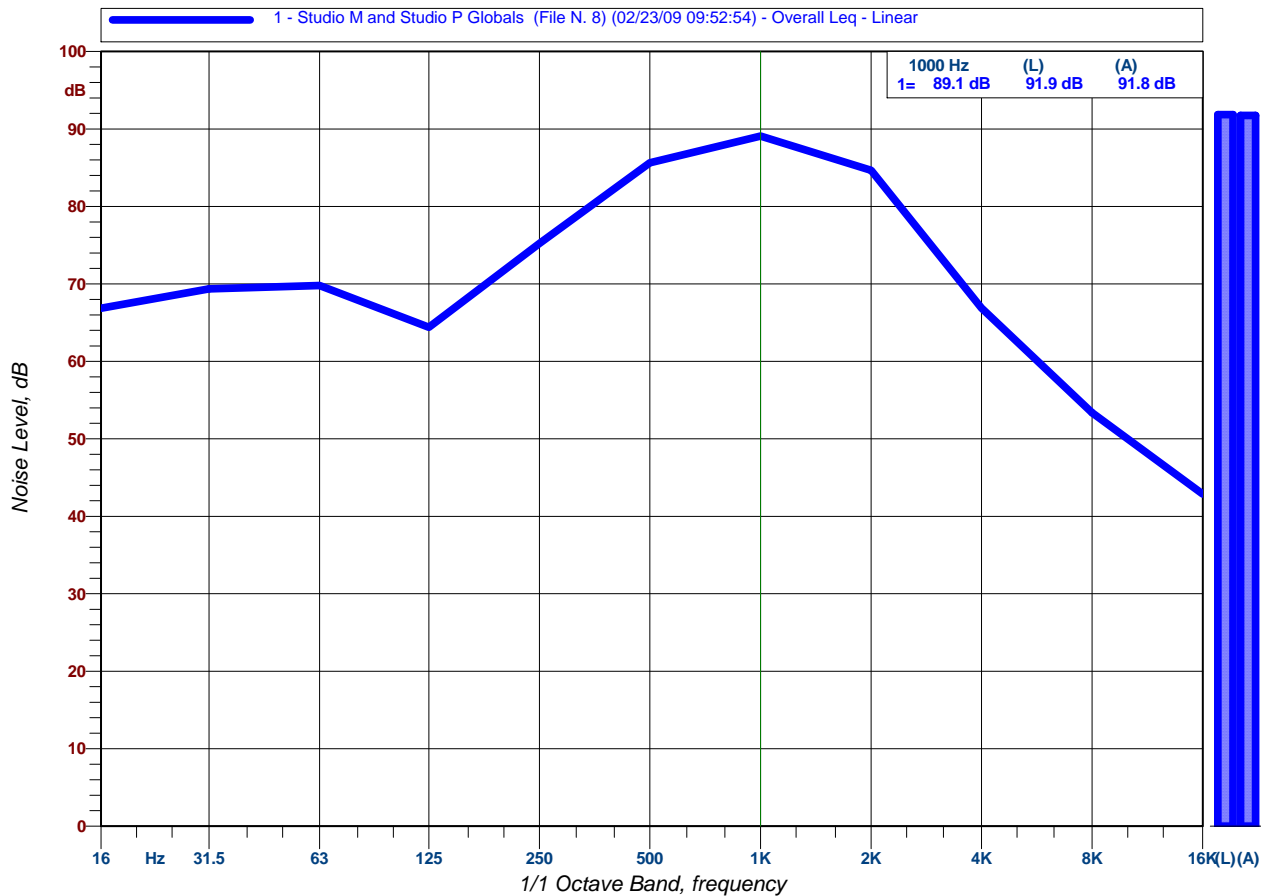
Test Conditions:
- High Horn at 100 feet

Overall Leq: 91.8 dBA
LMax: 95.4 dBA

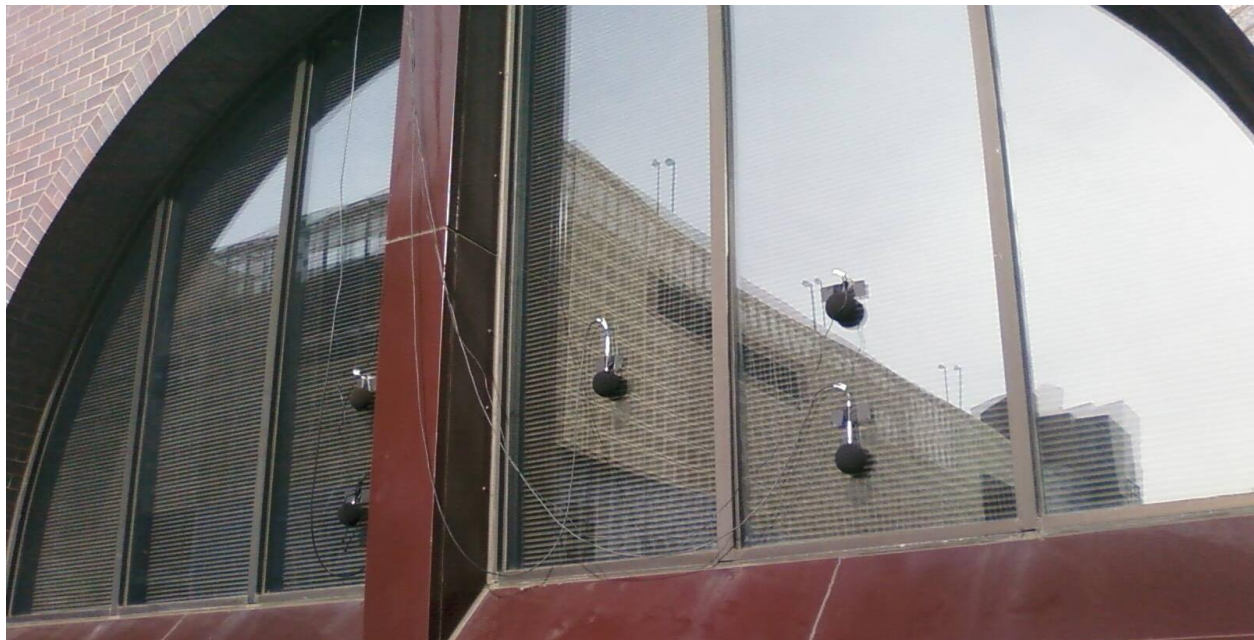
Exterior microphones for the Studio MMW window were spaced approximately 30" apart. Logistic limitations prohibited a broader spacing of the microphones (the cherry-picker bucket couldn't reach any higher). Figure 1 shows microphone locations and orientations on the Studio MMW window.

Figure 1 – Studio MMW exterior microphone locations

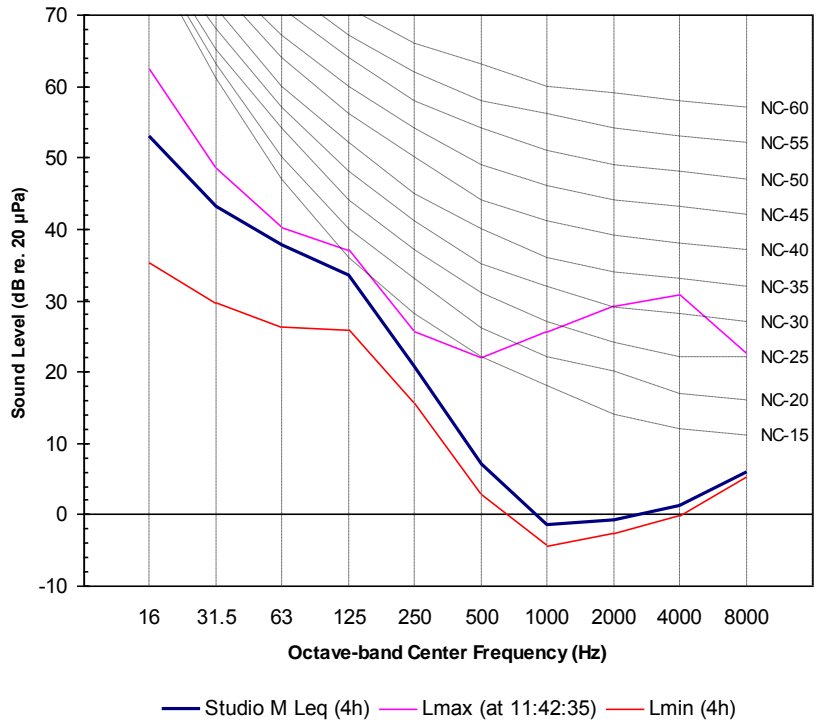
Whole Octave Results in Studio MMW against Noise-Criteria Curves

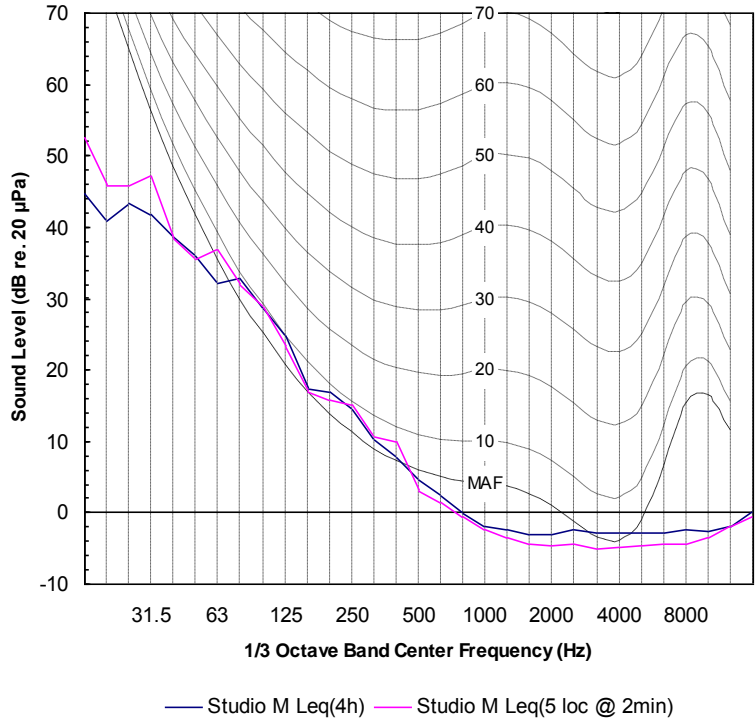
Four-Hour Average versus Spatial Average Comparison in Studio MMW

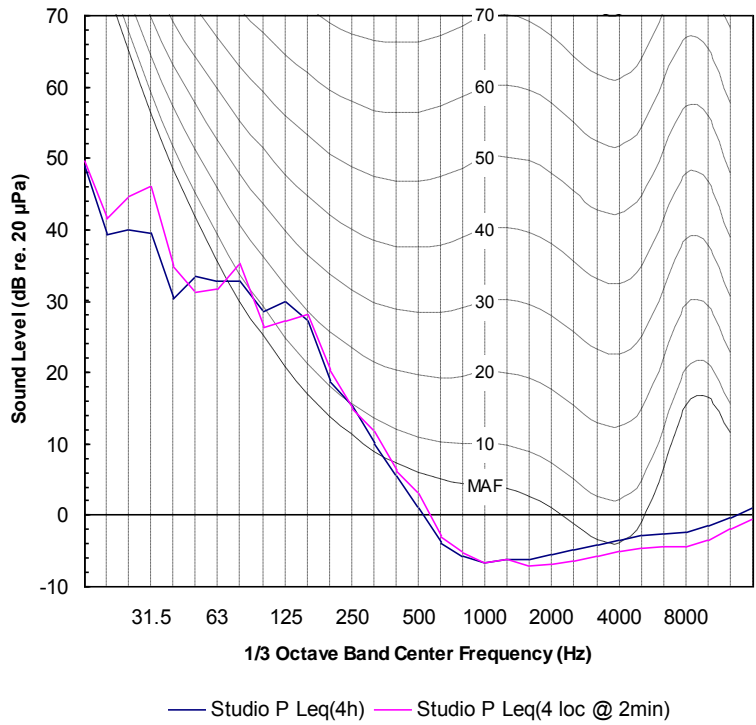
Four-Hour Average versus Spatial Average Comparison in Studio P

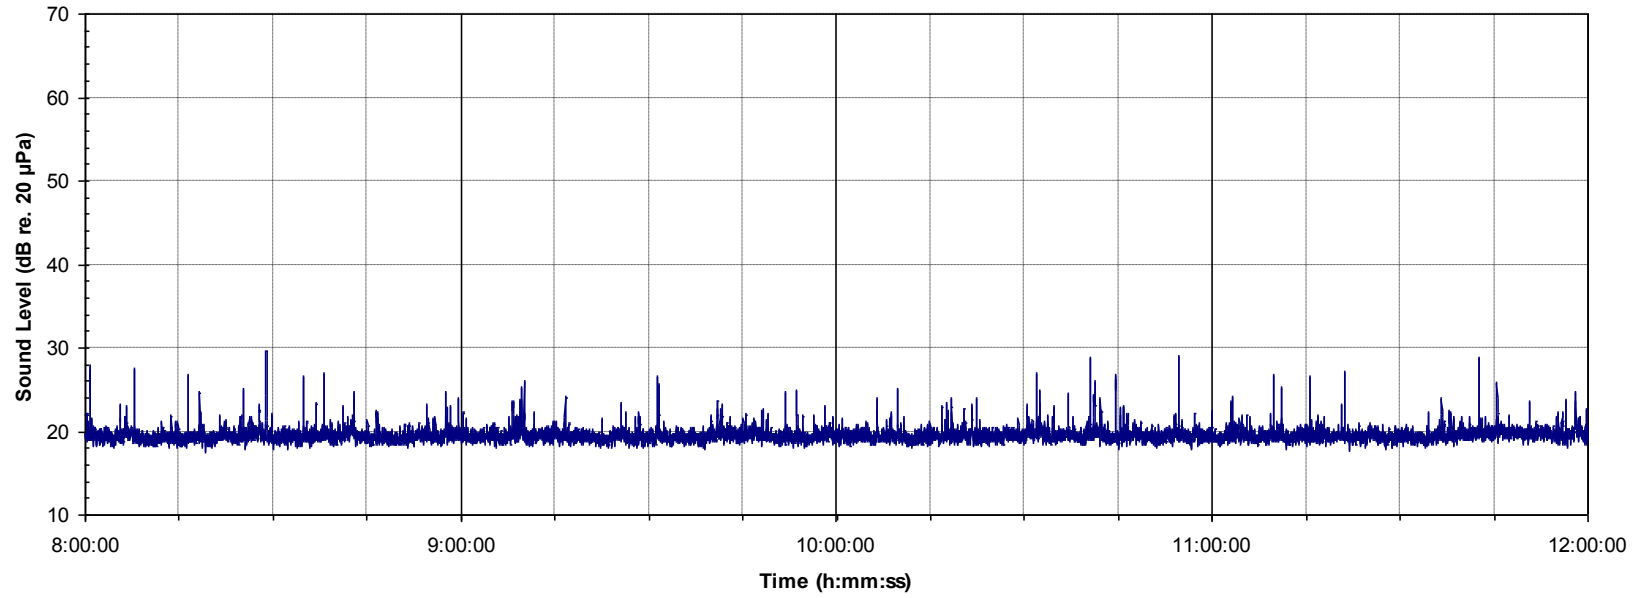
A-weighted 4-hour Time History/Profile in Studio P
