APPENDIX J4 VIBRATION

MEMORANDUM

Subject: Vibration Measurements and Predictions for Central Corridor LRT Project

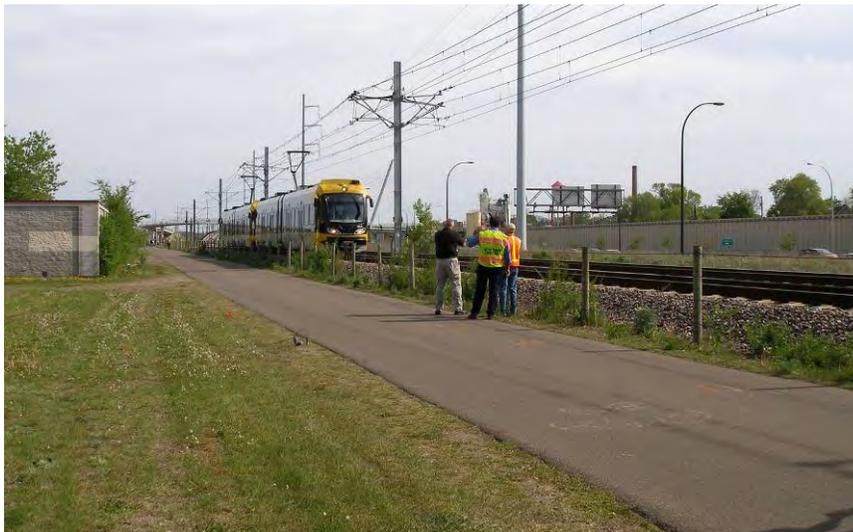
Figure 7: Photograph of 24th Street Site Looking South

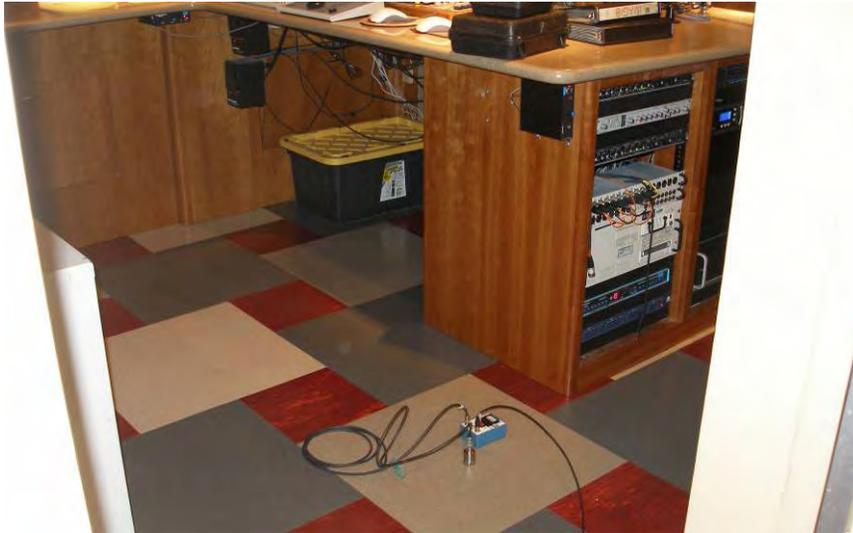
Figure 151: Indoor Accelerometer at KSTP Television Studio
