# Kenilworth Corridor Vegetation Inventory

March 19, 2014

Southwest LRT Project Technical Report

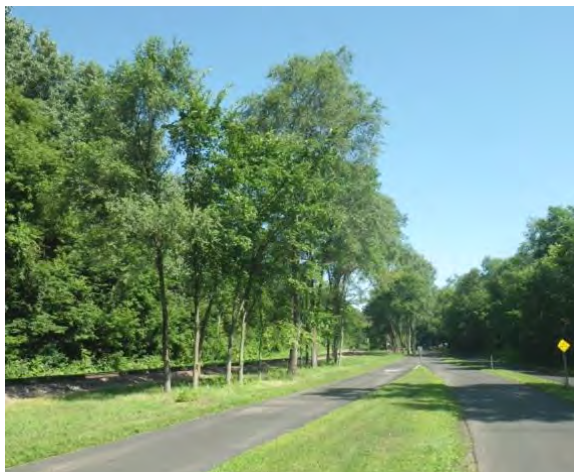
a. View looking north of the Burnham Road Bridge

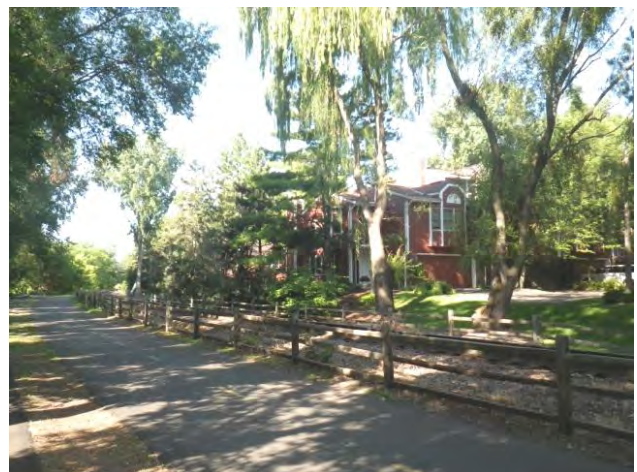
b. View looking southerly, south of Cedar Lake Pkwy

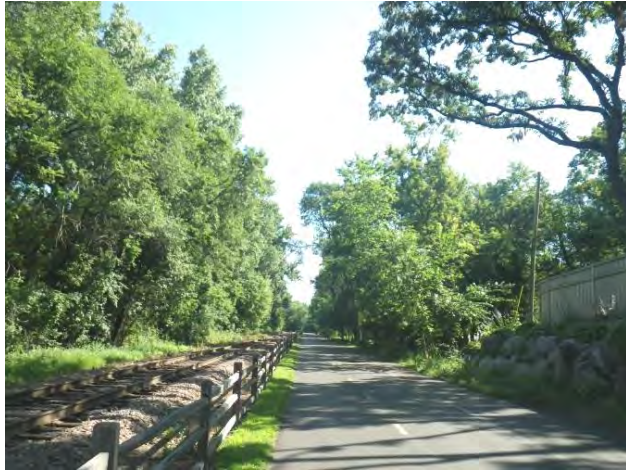
c. View looking north from Cedar Lake Parkway

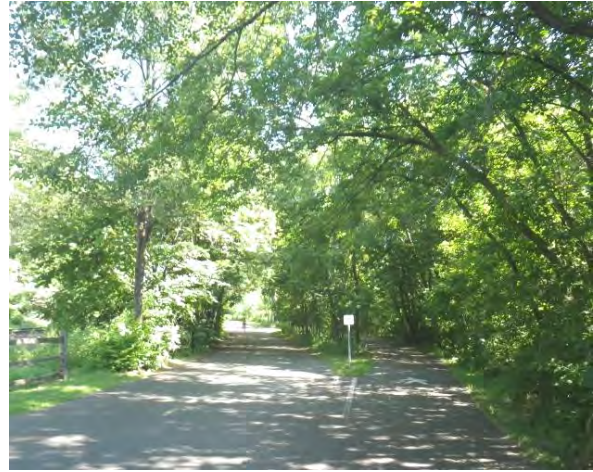
d. View looking northerly, north of channel crossing

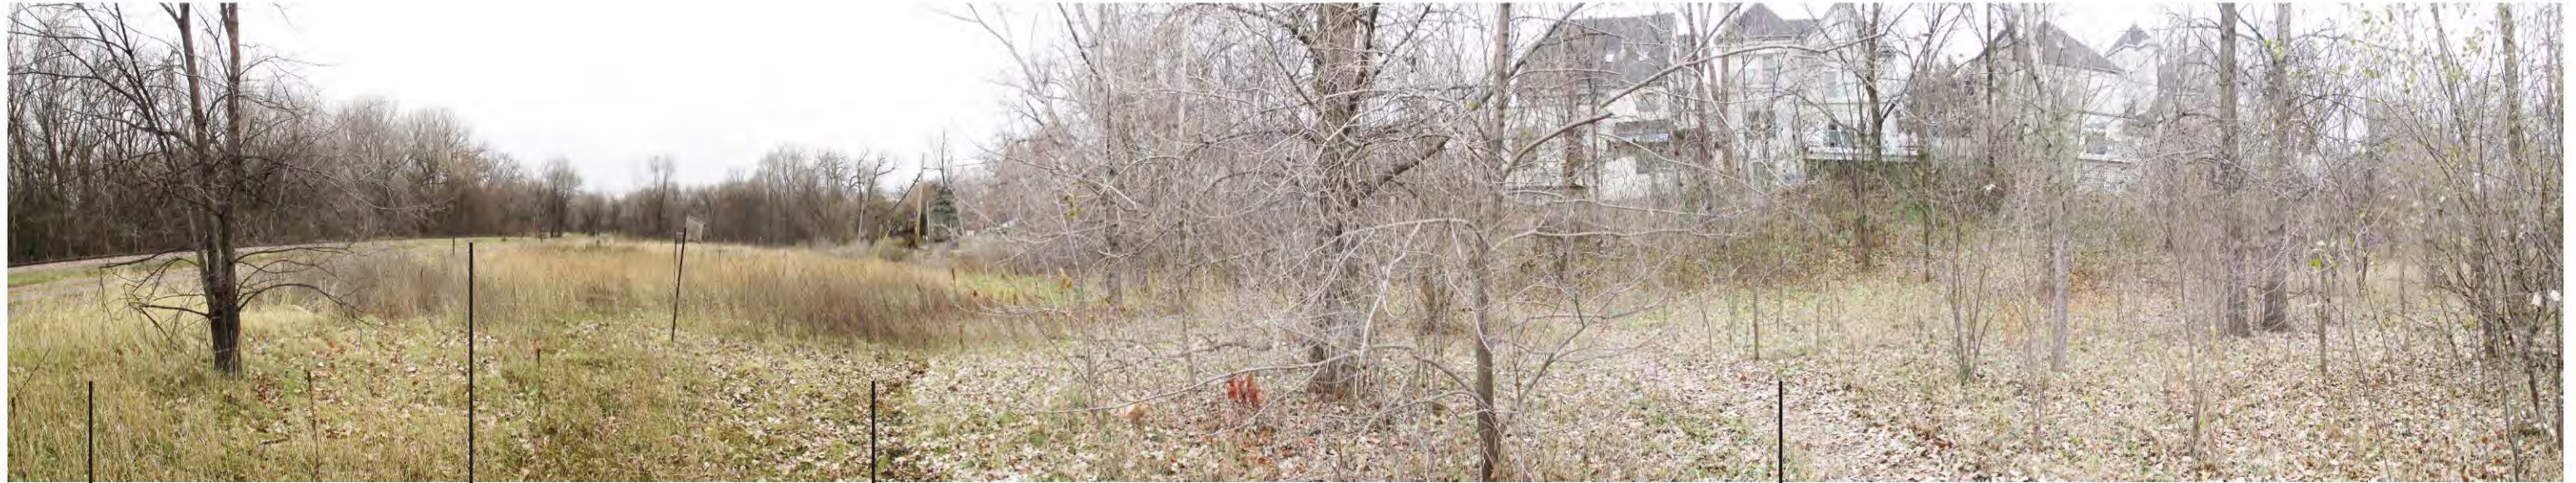
### VEGETATION INVENTORY SUMMARY

AREAS	ACRES	PERCENT OF VEGETATED AREA
LIMITS OF SURVEY AREA	44	
TOTAL EXISTING NON-VEGETATED AREAS (TRACK BALLAST, ROAD, TRAIL)	10 (23%)	
TOTAL EXISTING VEGETATED AREAS	34 (77%)	100%
NATIVE VEGETATION / RESTORATION AREA	3	9%
MAINTAINED VEGETATION	9	26%
UNMAINTAINED VEGETATION	2	6%
TREE AND VEGETATION AREA	20	59%

1. Approximately 18% (6 ACRES) of the total vegetated areas is buckthorn; which is located within the tree and vegetation area.

### TREE INVENTORY SUMMARY

TOTAL SIGNIFICANT TREES WITHIN THE SURVEY AREA		480						
TREES BY SIZE (INCHES DBH)	TOTAL PER SIZE	PERCENT BY SIZE						
12-24	443	92%						
25-36	27	6%						
37+	10	2%						
TREES BY SPECIES (13 SPECIES ARE REPRESENTED)								
SPECIES	QTY	PERCENT	SPECIES	QTY	PERCENT	SPECIES	QTY	PERCENT
ASH	6	1%	ELM	121	25%	SPRUCE	15	3%
ASPEN	19	4%	HACKBERRY	3	1%	WILLOW	5	1%
BASSWOOD	10	2%	MAPLE	4	1%	WALNUT	1	1%
BOXELDER	46	10%	OAK	8	1%			
COTTONWOOD	230	48%	PINE	12	2%

The results of the tree survey and vegetation inventory are illustrated graphically and tabulated on the attached data summary sheet. In addition to the detailed information identified on that sheet, the following additional information is provided:

Tree Survey: A total of 480 Significant Trees were identified within the study area. The predominant tree types include cottonwood, elm, and boxelder– all softwoods and considered native to the region. Approximately 80% of the trees inventoried are one of these three species. Trees in the Corridor are generally in good health, and range in size from the Significant Tree minimum of 12-inch DBH to 66-inch DBH, with a great majority (over 90%) of trees under 24-inch DBH.

Vegetation Inventory: Over 75% of the 44 acre study area is represented in the four categories listed in Section 4 above. The remaining approximately 25% is covered by freight ballast and track, trail or other paved surfaces. Of the vegetated areas, approximately half are covered in tree vegetation, which includes trees, understory plants and unmaintained groundcover and grasses. Buckthorn, identified as an invasive species, was found to be significantly represented within this area.

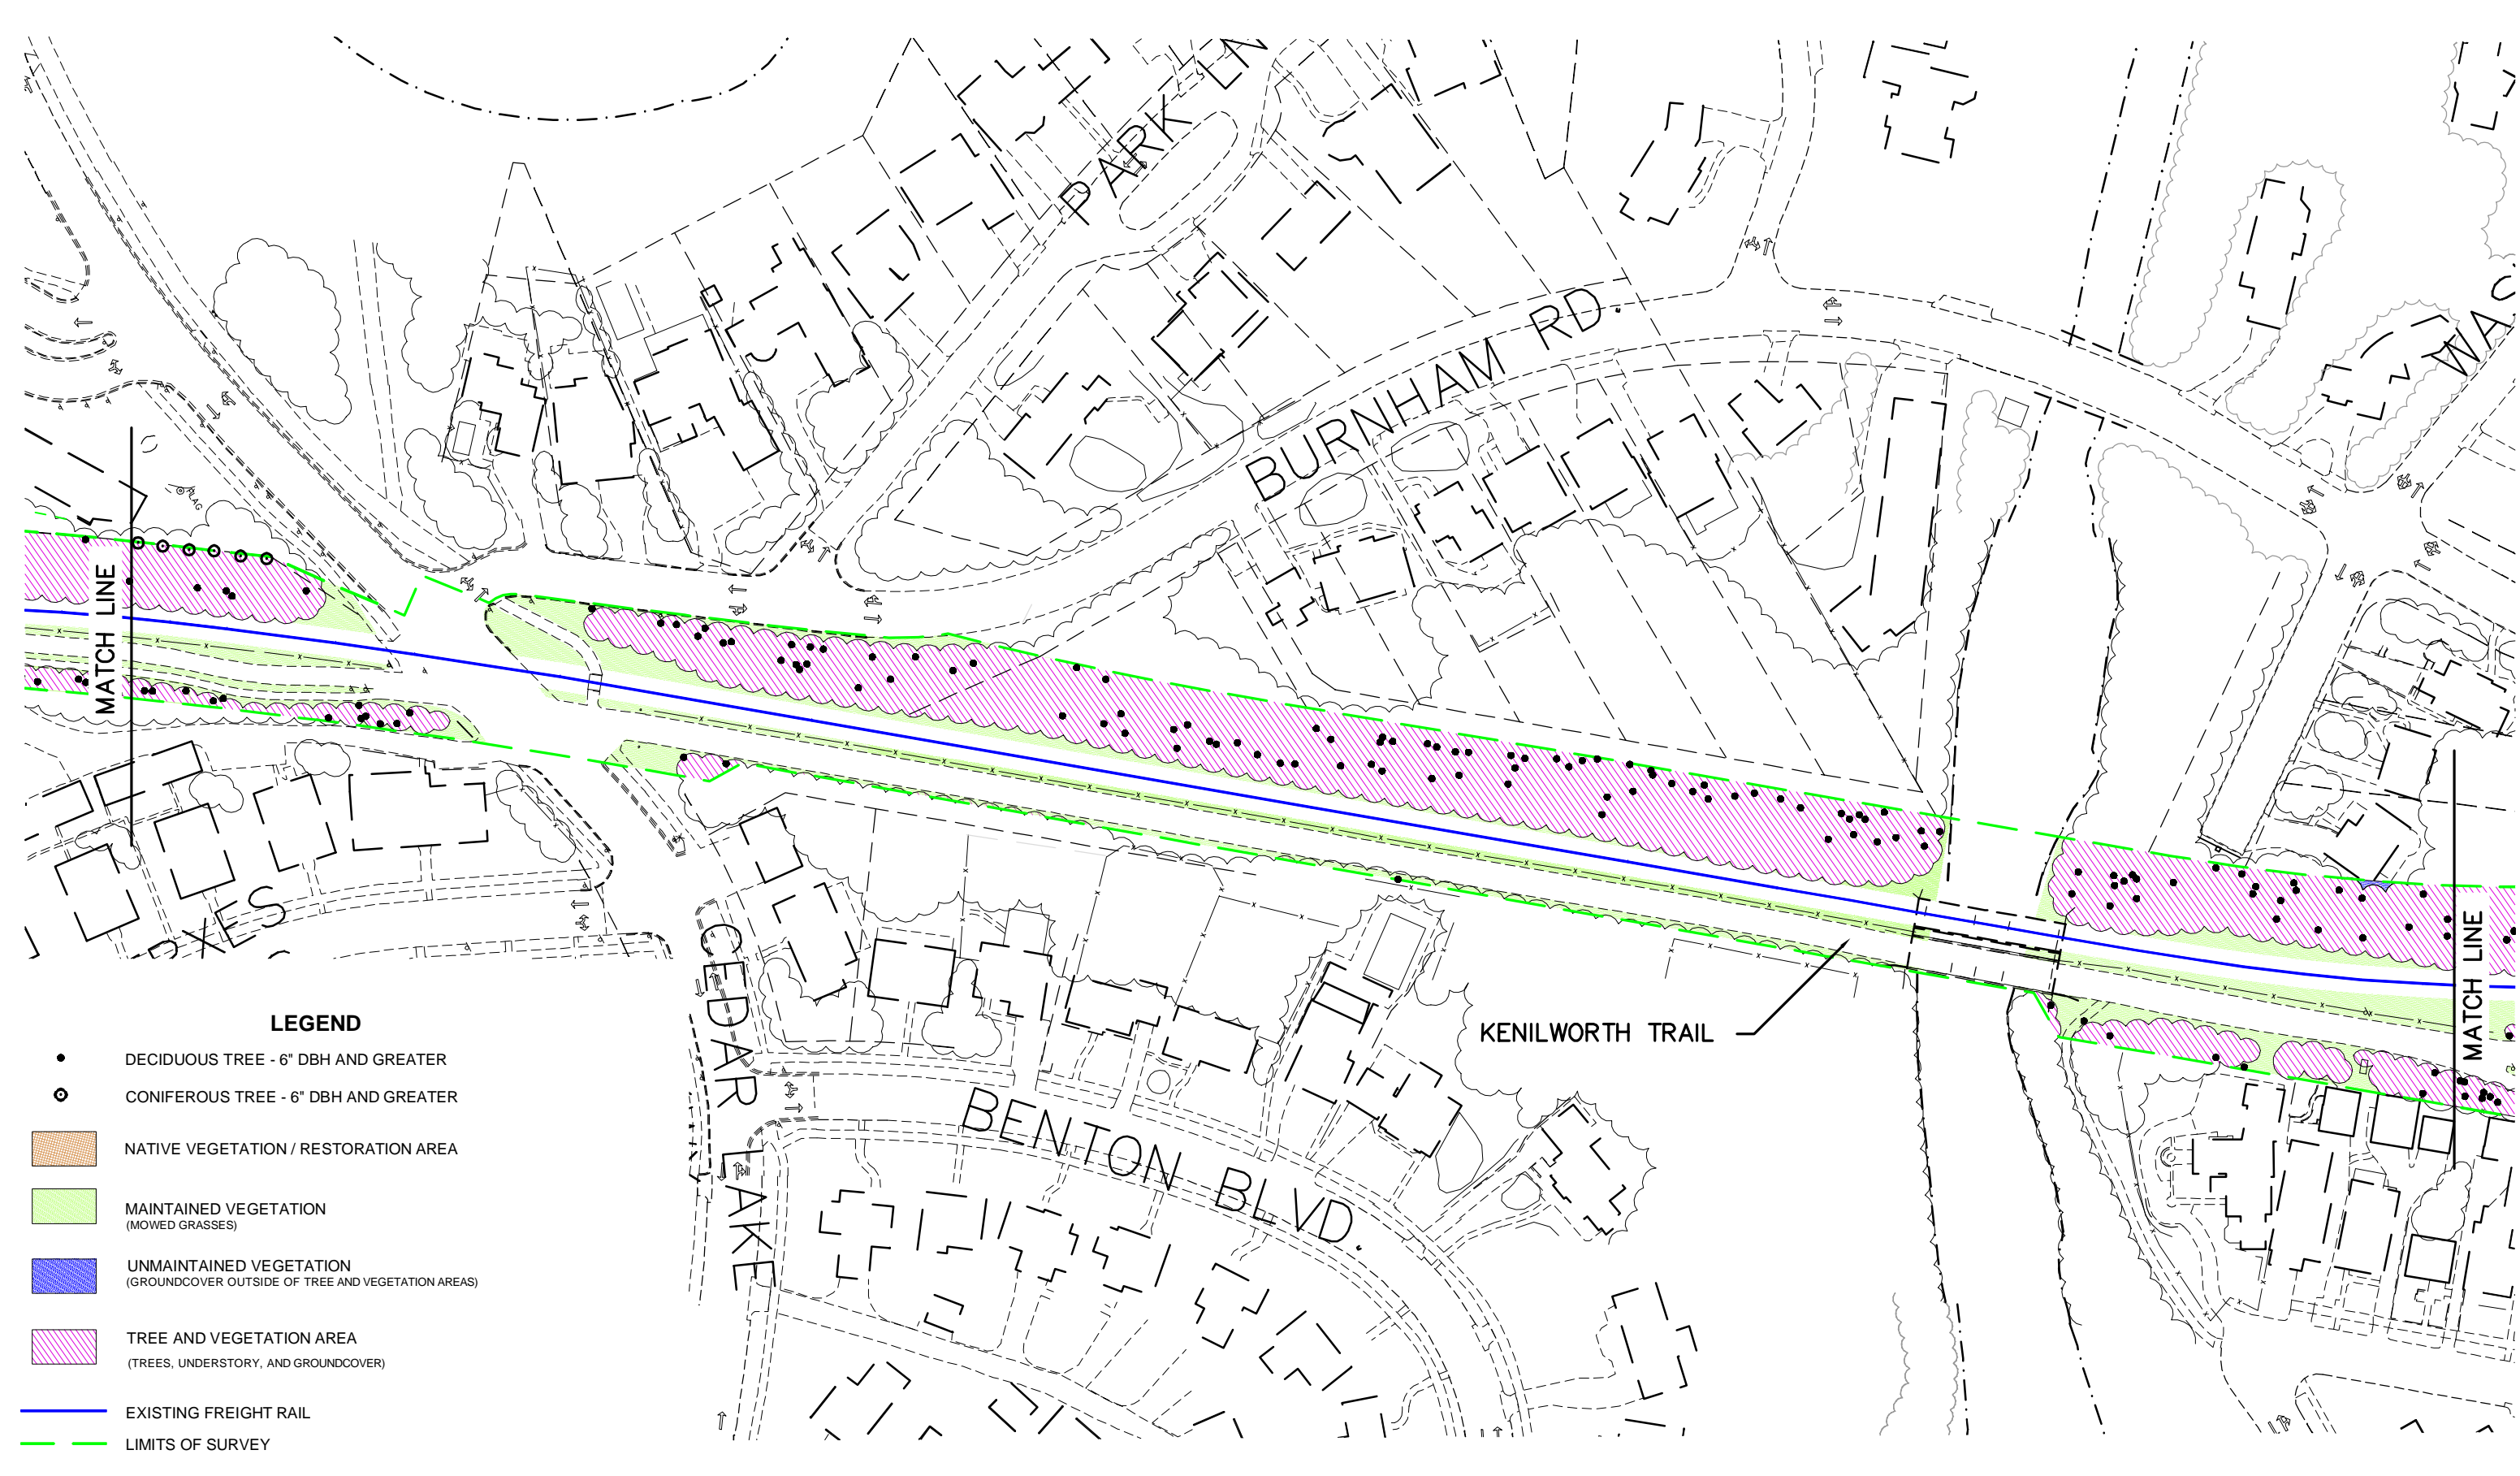
KENILWORTH CORRIDOR VEGETATION & TREE INVENTORY - TREES 6" DBH AND GREATER  
SHEET 3 of 8

Sheet 3 shows various vegetation types in the area surrounding the Cedar Lake and Kenilworth Corridor intersection, along with existing freight rail, trails, streets, and the limits of the survey. Vegetation types include deciduous trees, coniferous trees, native vegetation/restoration area, maintained vegetation, unmaintained vegetation, and tree and vegetation area.

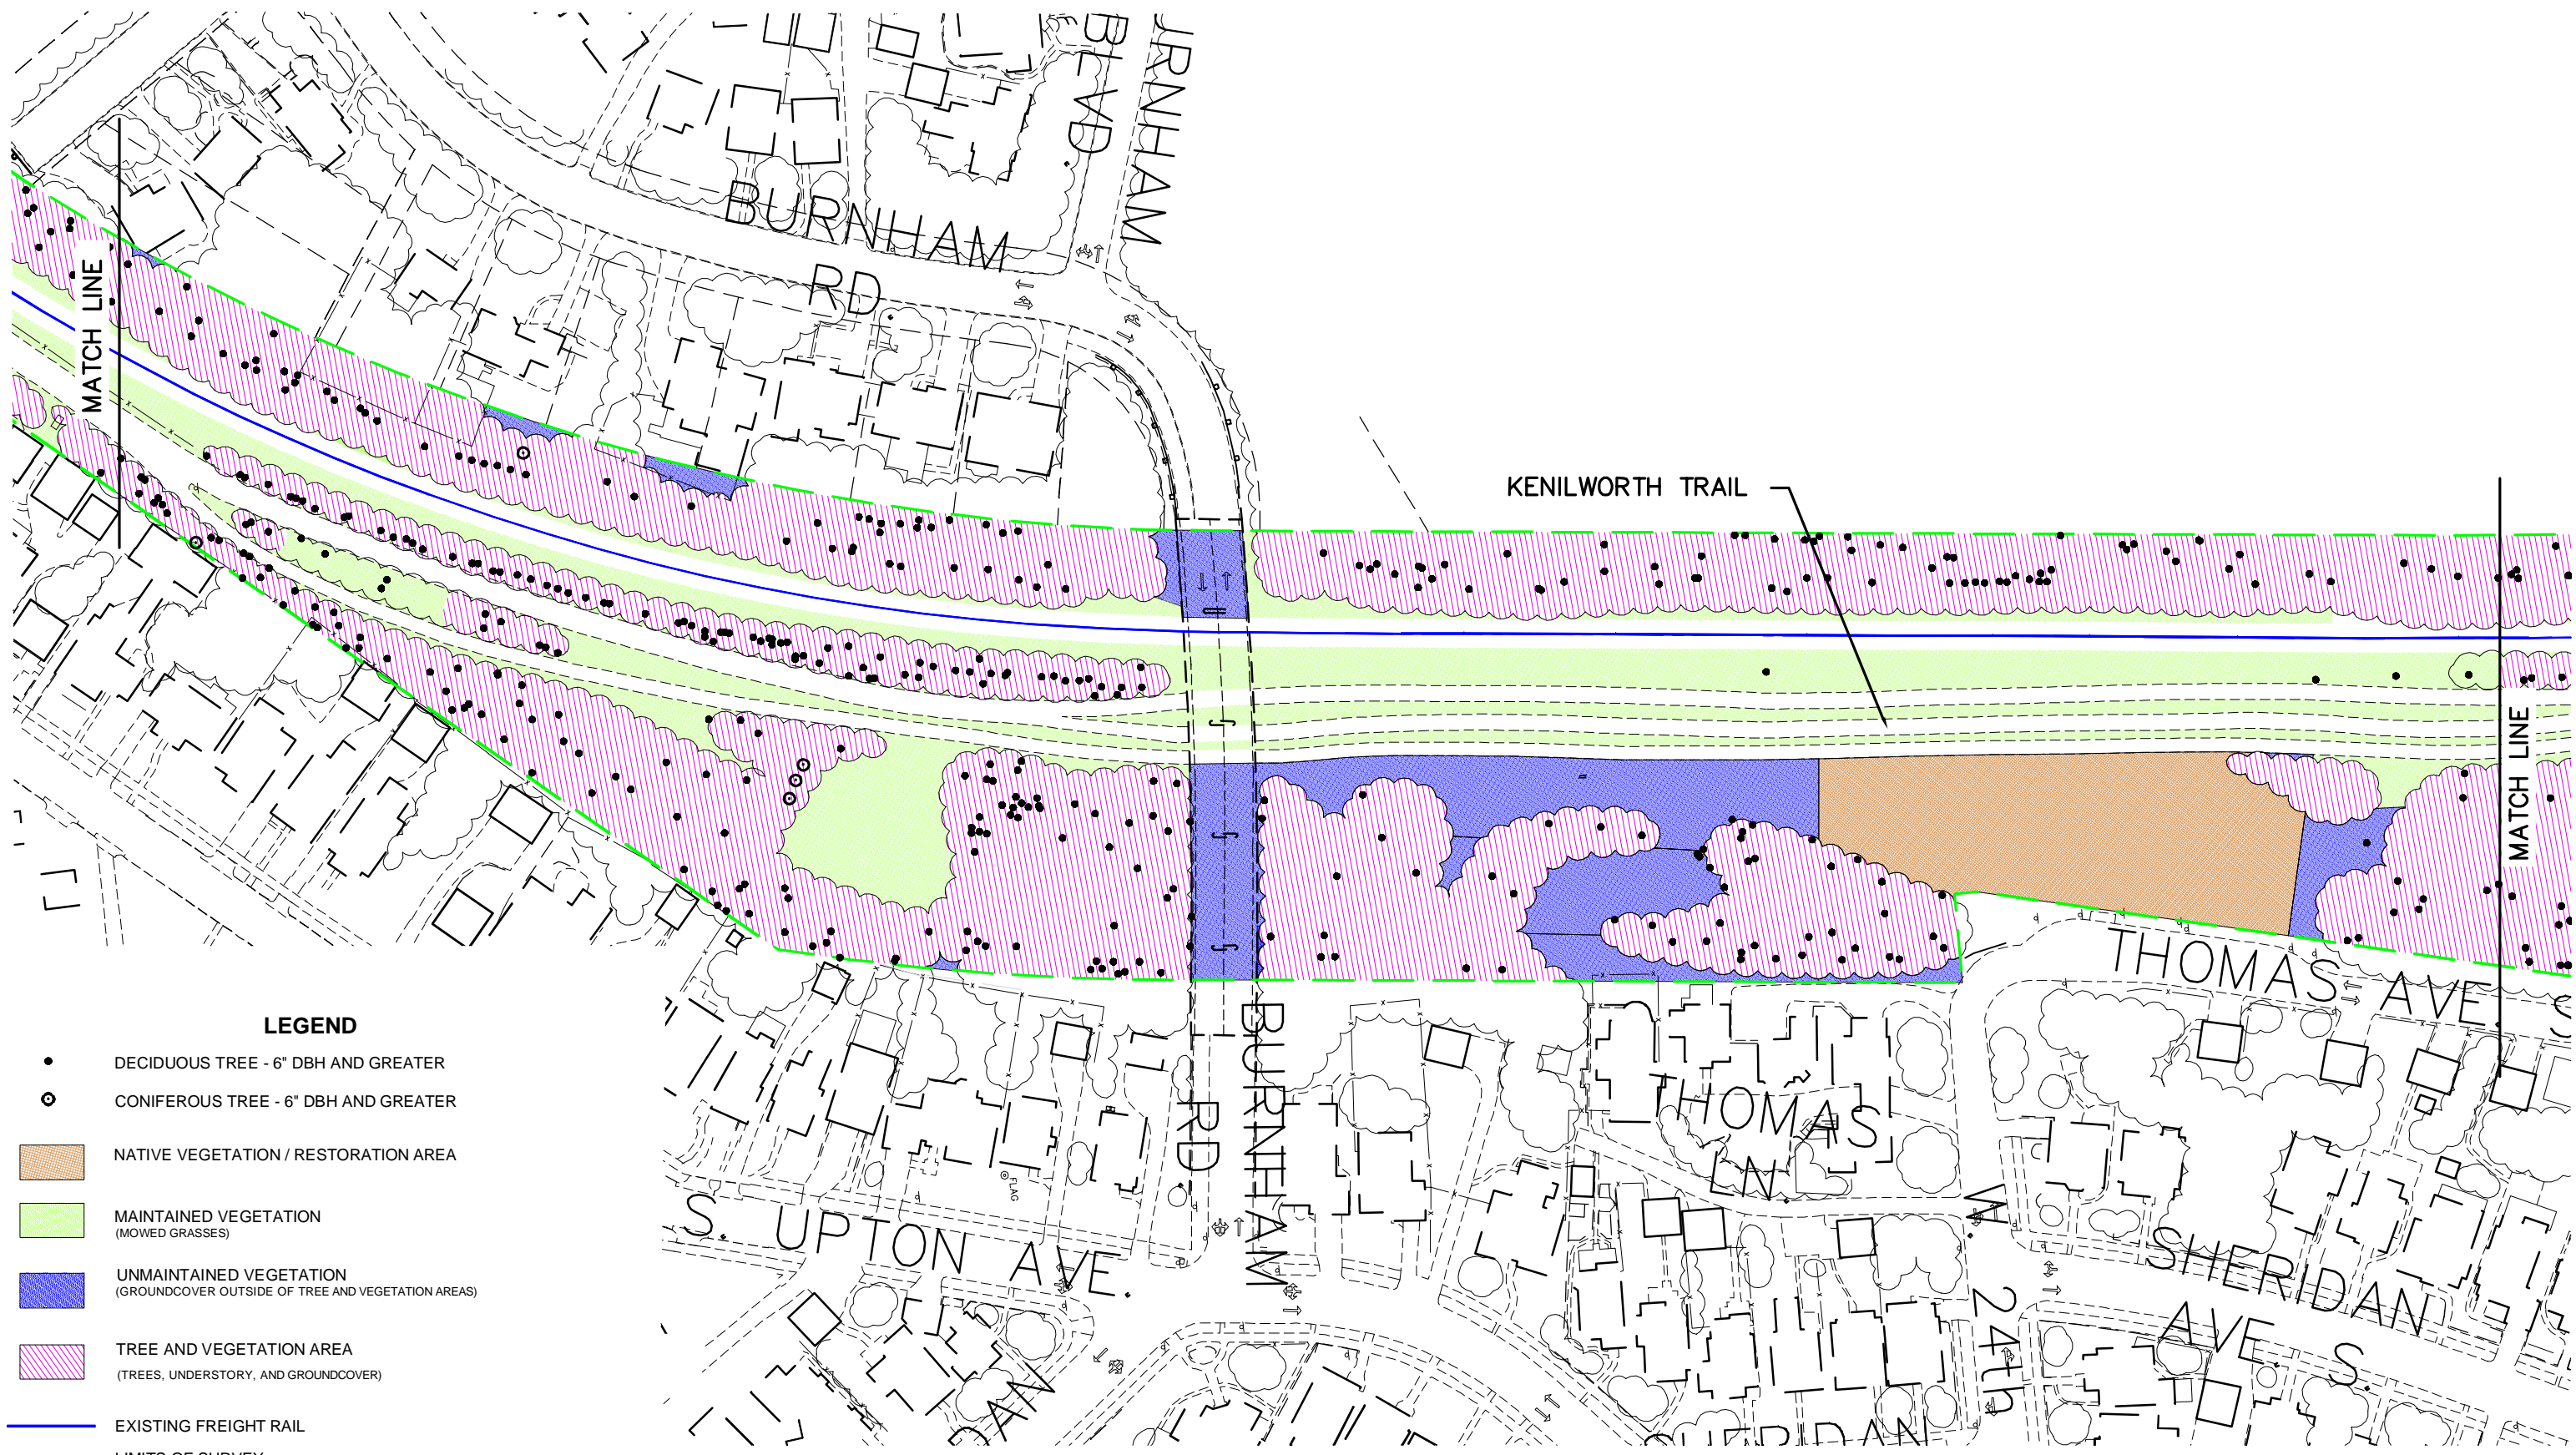
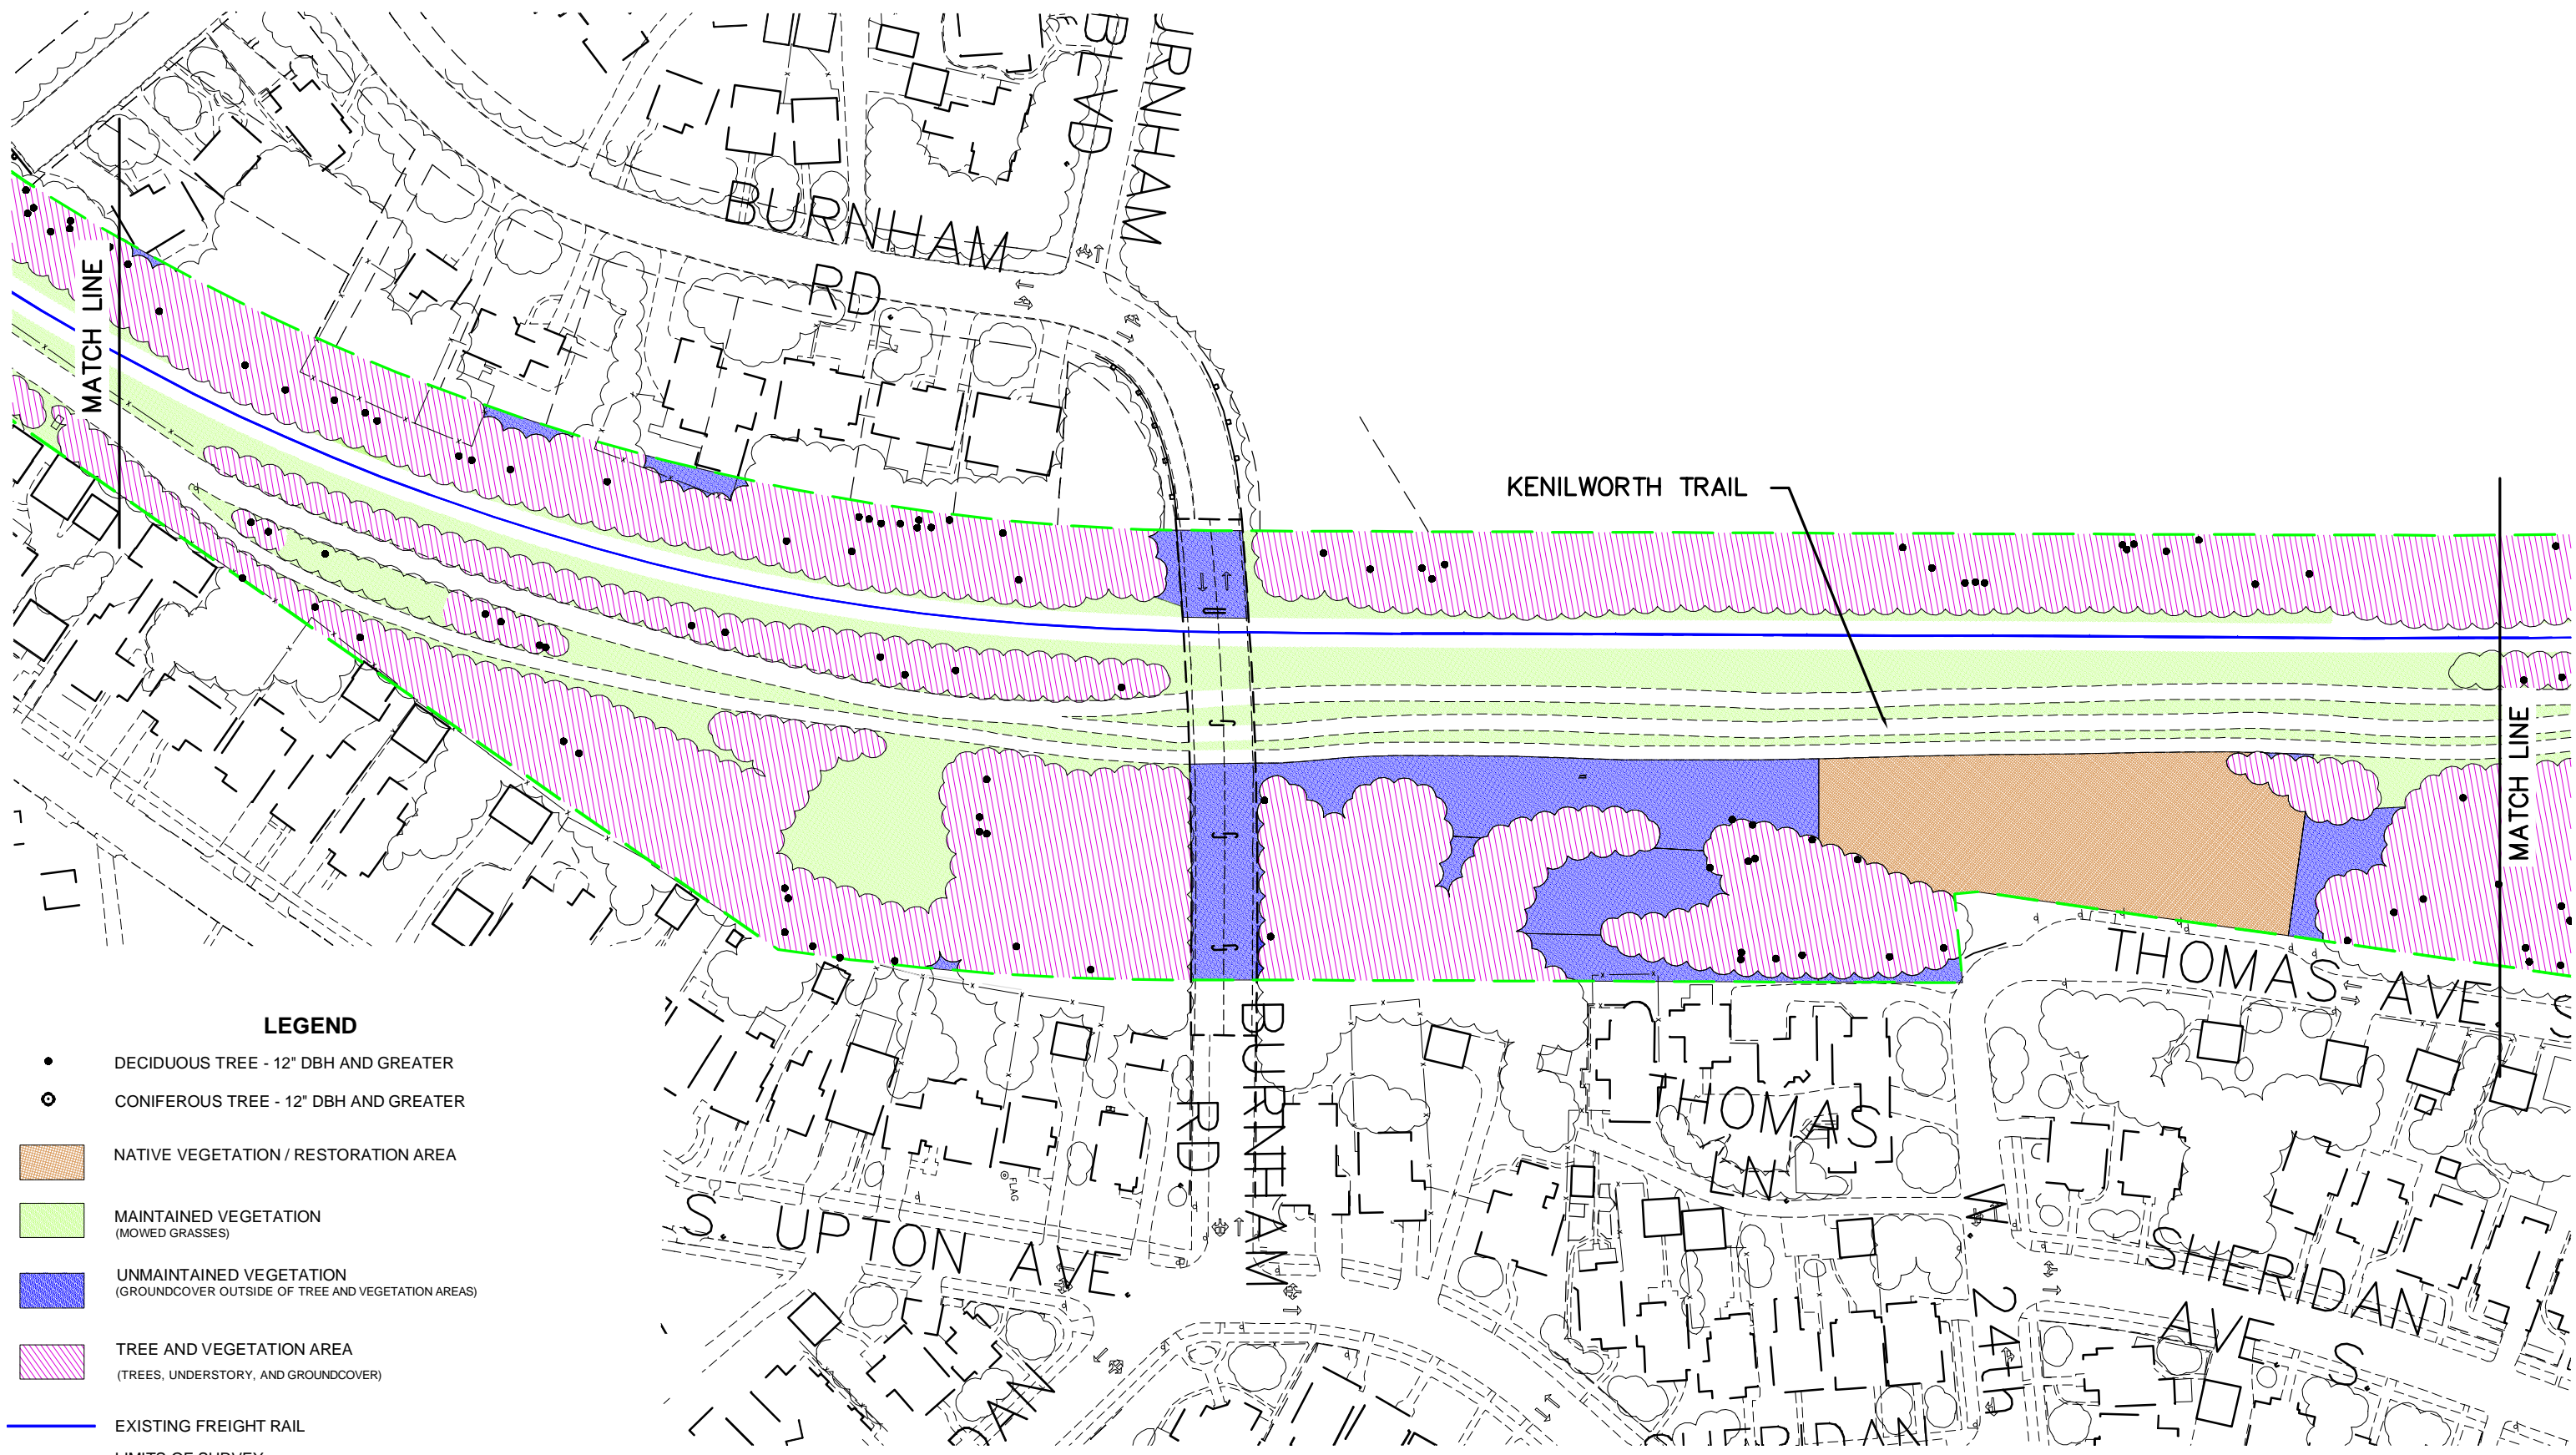
KENILWORTH CORRIDOR VEGETATION & TREE INVENTORY - TREES 6" DBH AND GREATER  
SHEET 4 of 8

Sheet 4 shows various vegetation types in the area surrounding the Burnham Road and Kenilworth Corridor intersection, along with existing freight rail, trails, streets, and the limits of the survey. Vegetation types include deciduous trees, coniferous trees, native vegetation/restoration area, maintained vegetation, unmaintained vegetation, and tree and vegetation area.

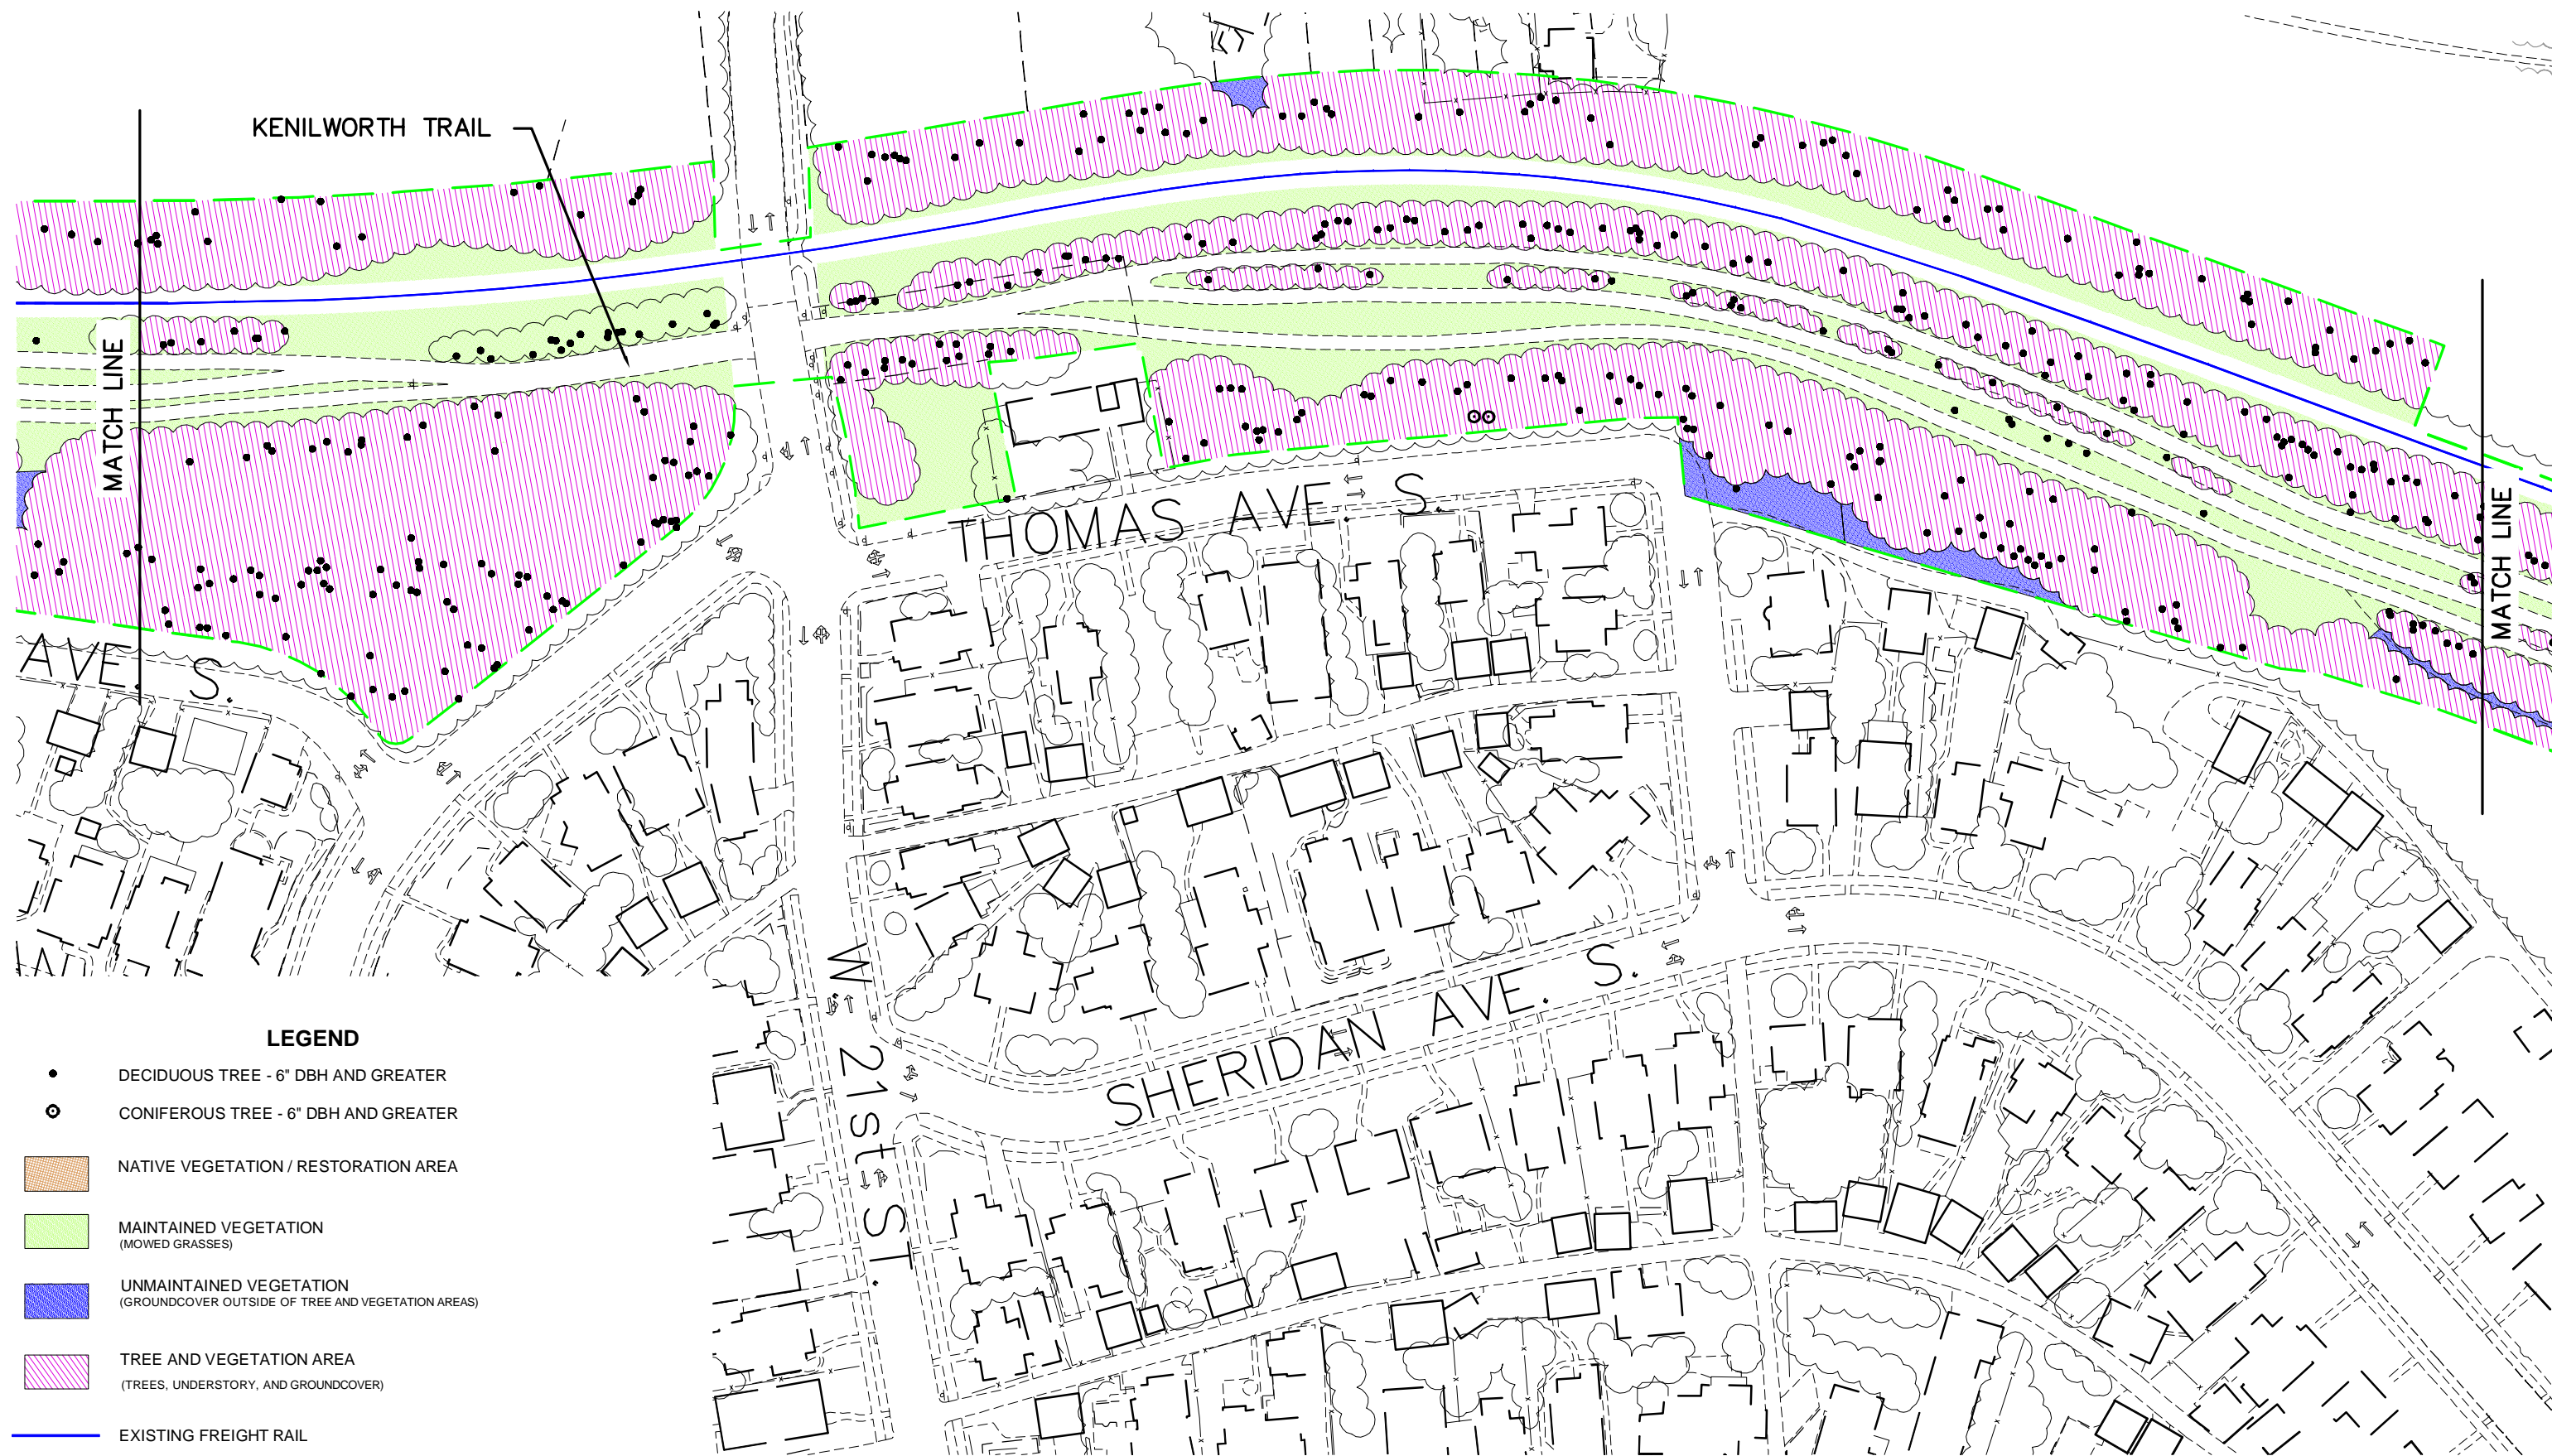
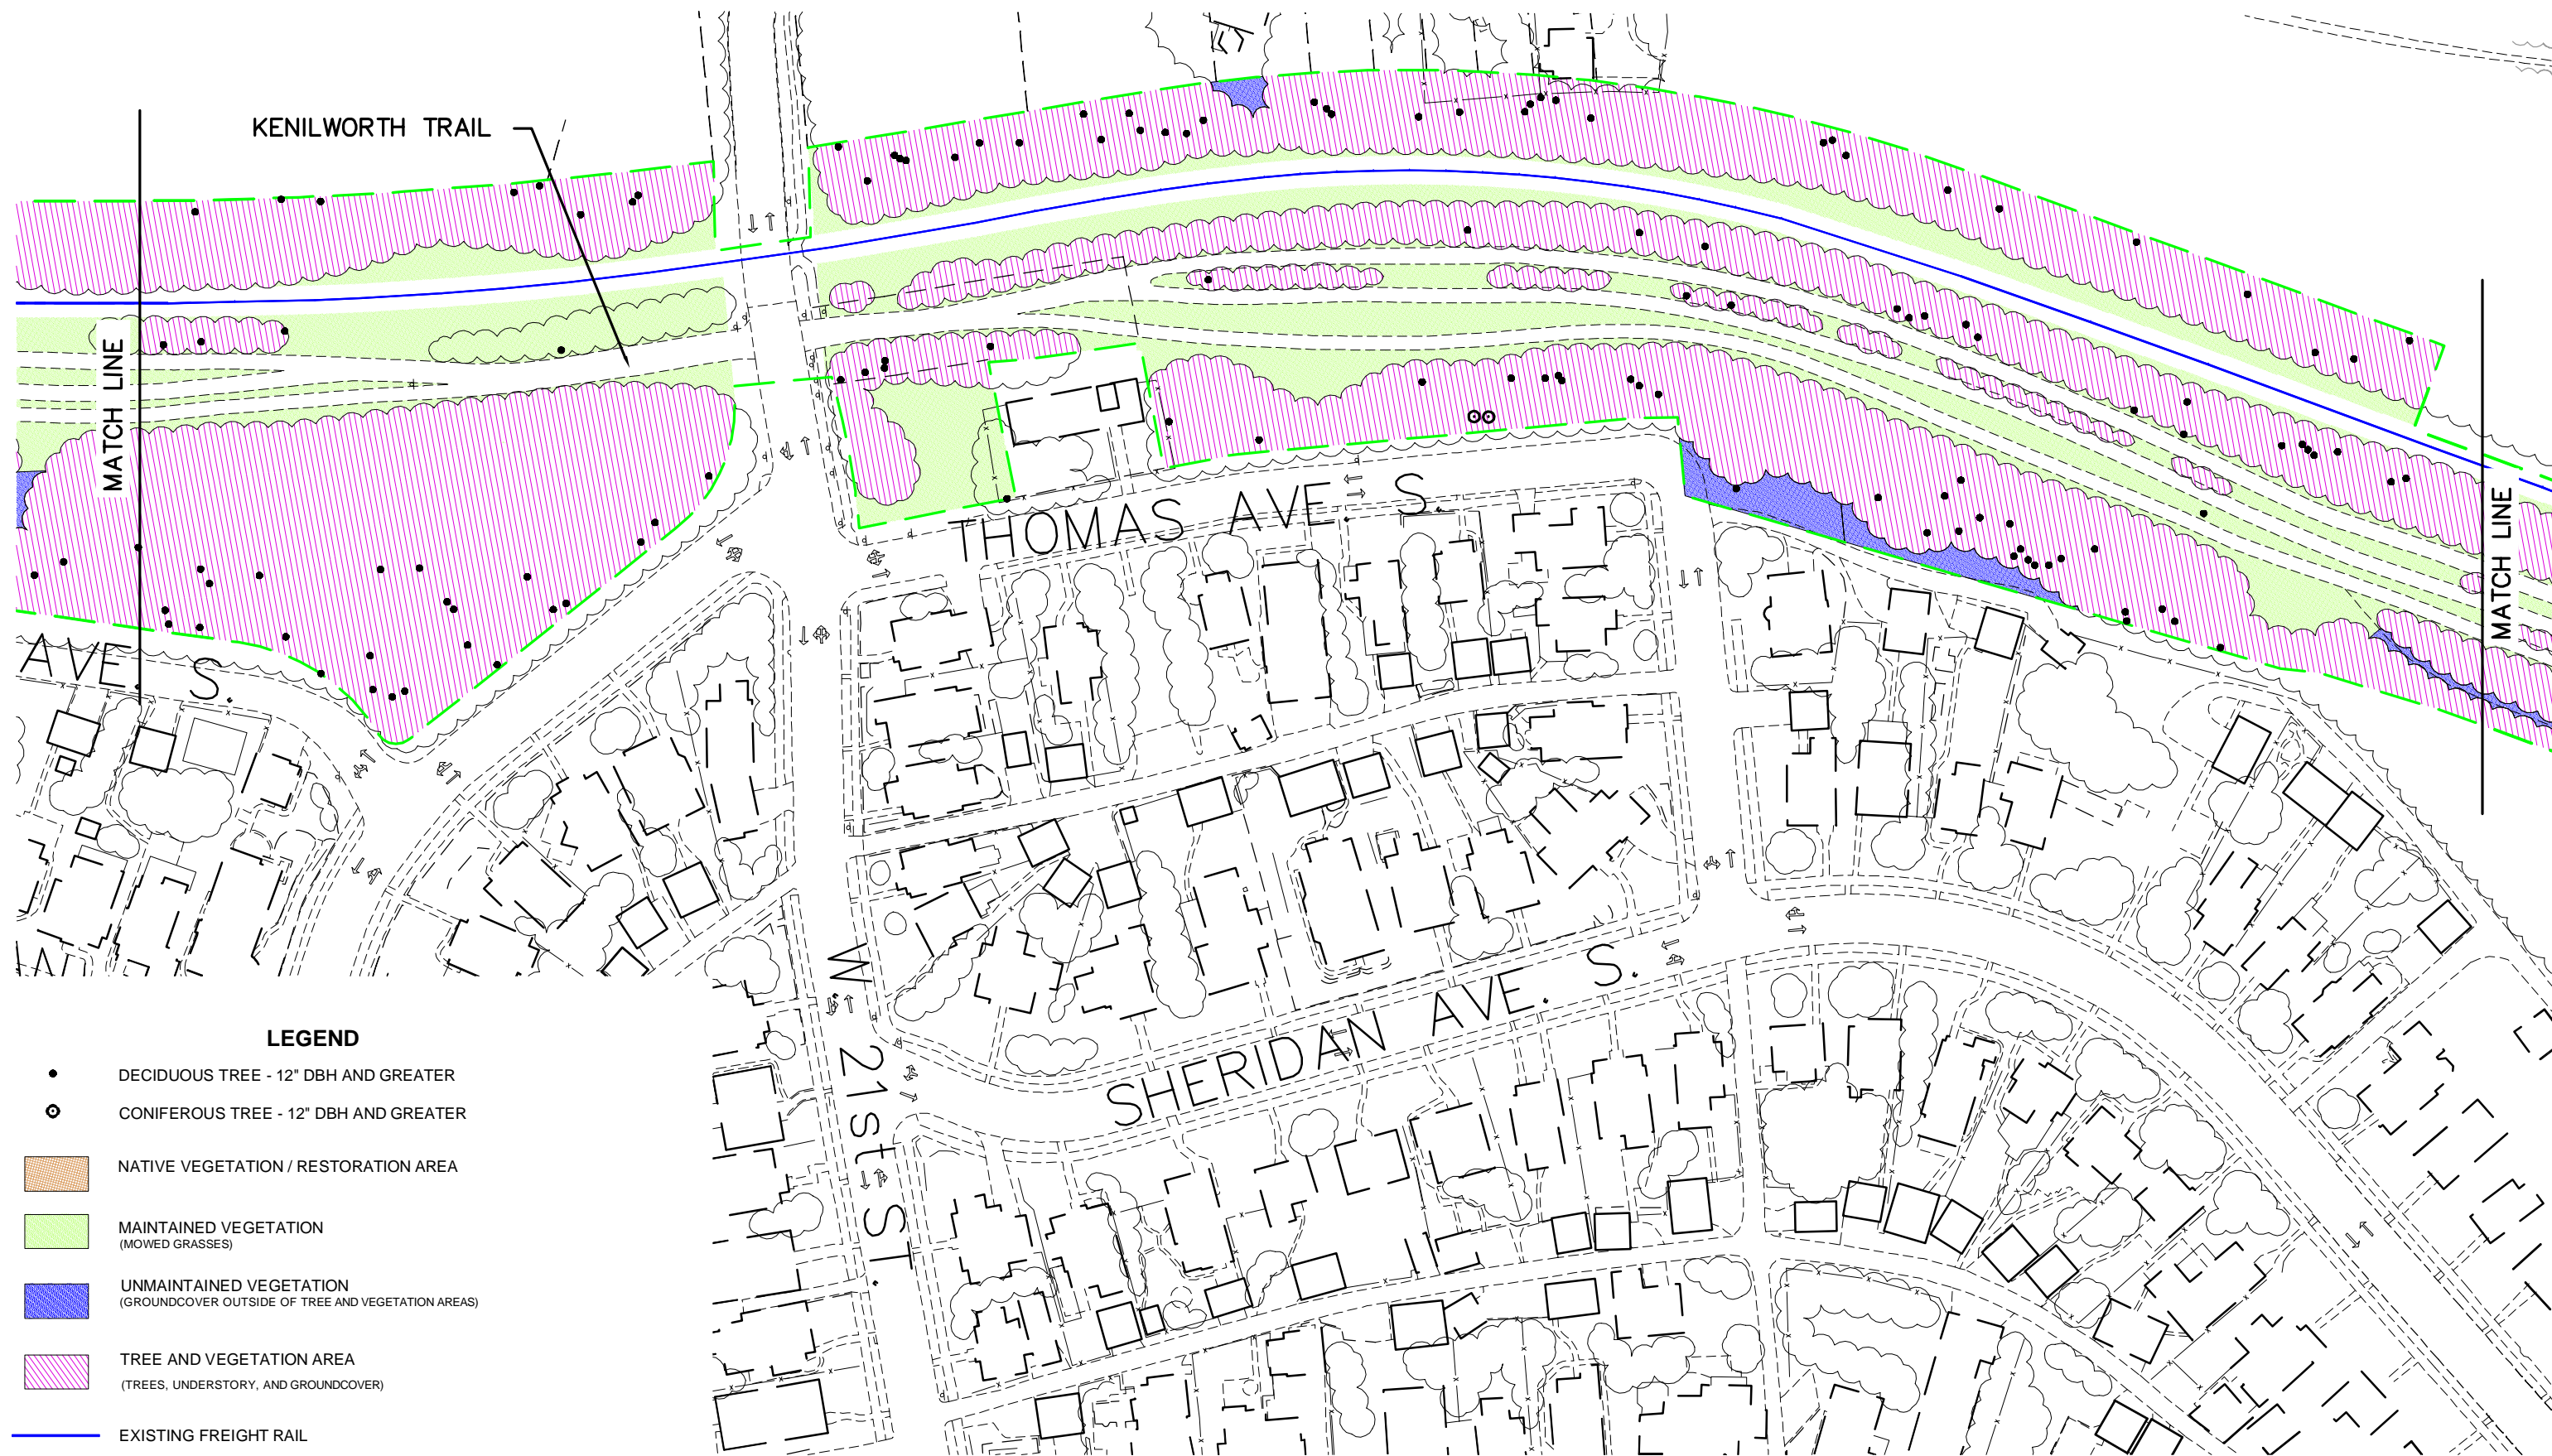
**SOUTHWEST LIGHT RAIL**  
 KENILWORTH CORRIDOR VEGETATION & TREE INVENTORY - TREES 6" DBH AND GREATER  
 SHEET 5 of 8

Sheet 5 shows various vegetation types in the area surrounding the West 21<sup>st</sup> Street and Kenilworth Corridor intersection, along with existing freight rail, trails, streets, and the limits of the survey. Vegetation types include deciduous trees, coniferous trees, native vegetation/restoration area, maintained vegetation, unmaintained vegetation, and tree and vegetation area.
