# Kenilworth Corridor Vegetation Inventory

March 19, 2014

Southwest LRT Project Technical Report

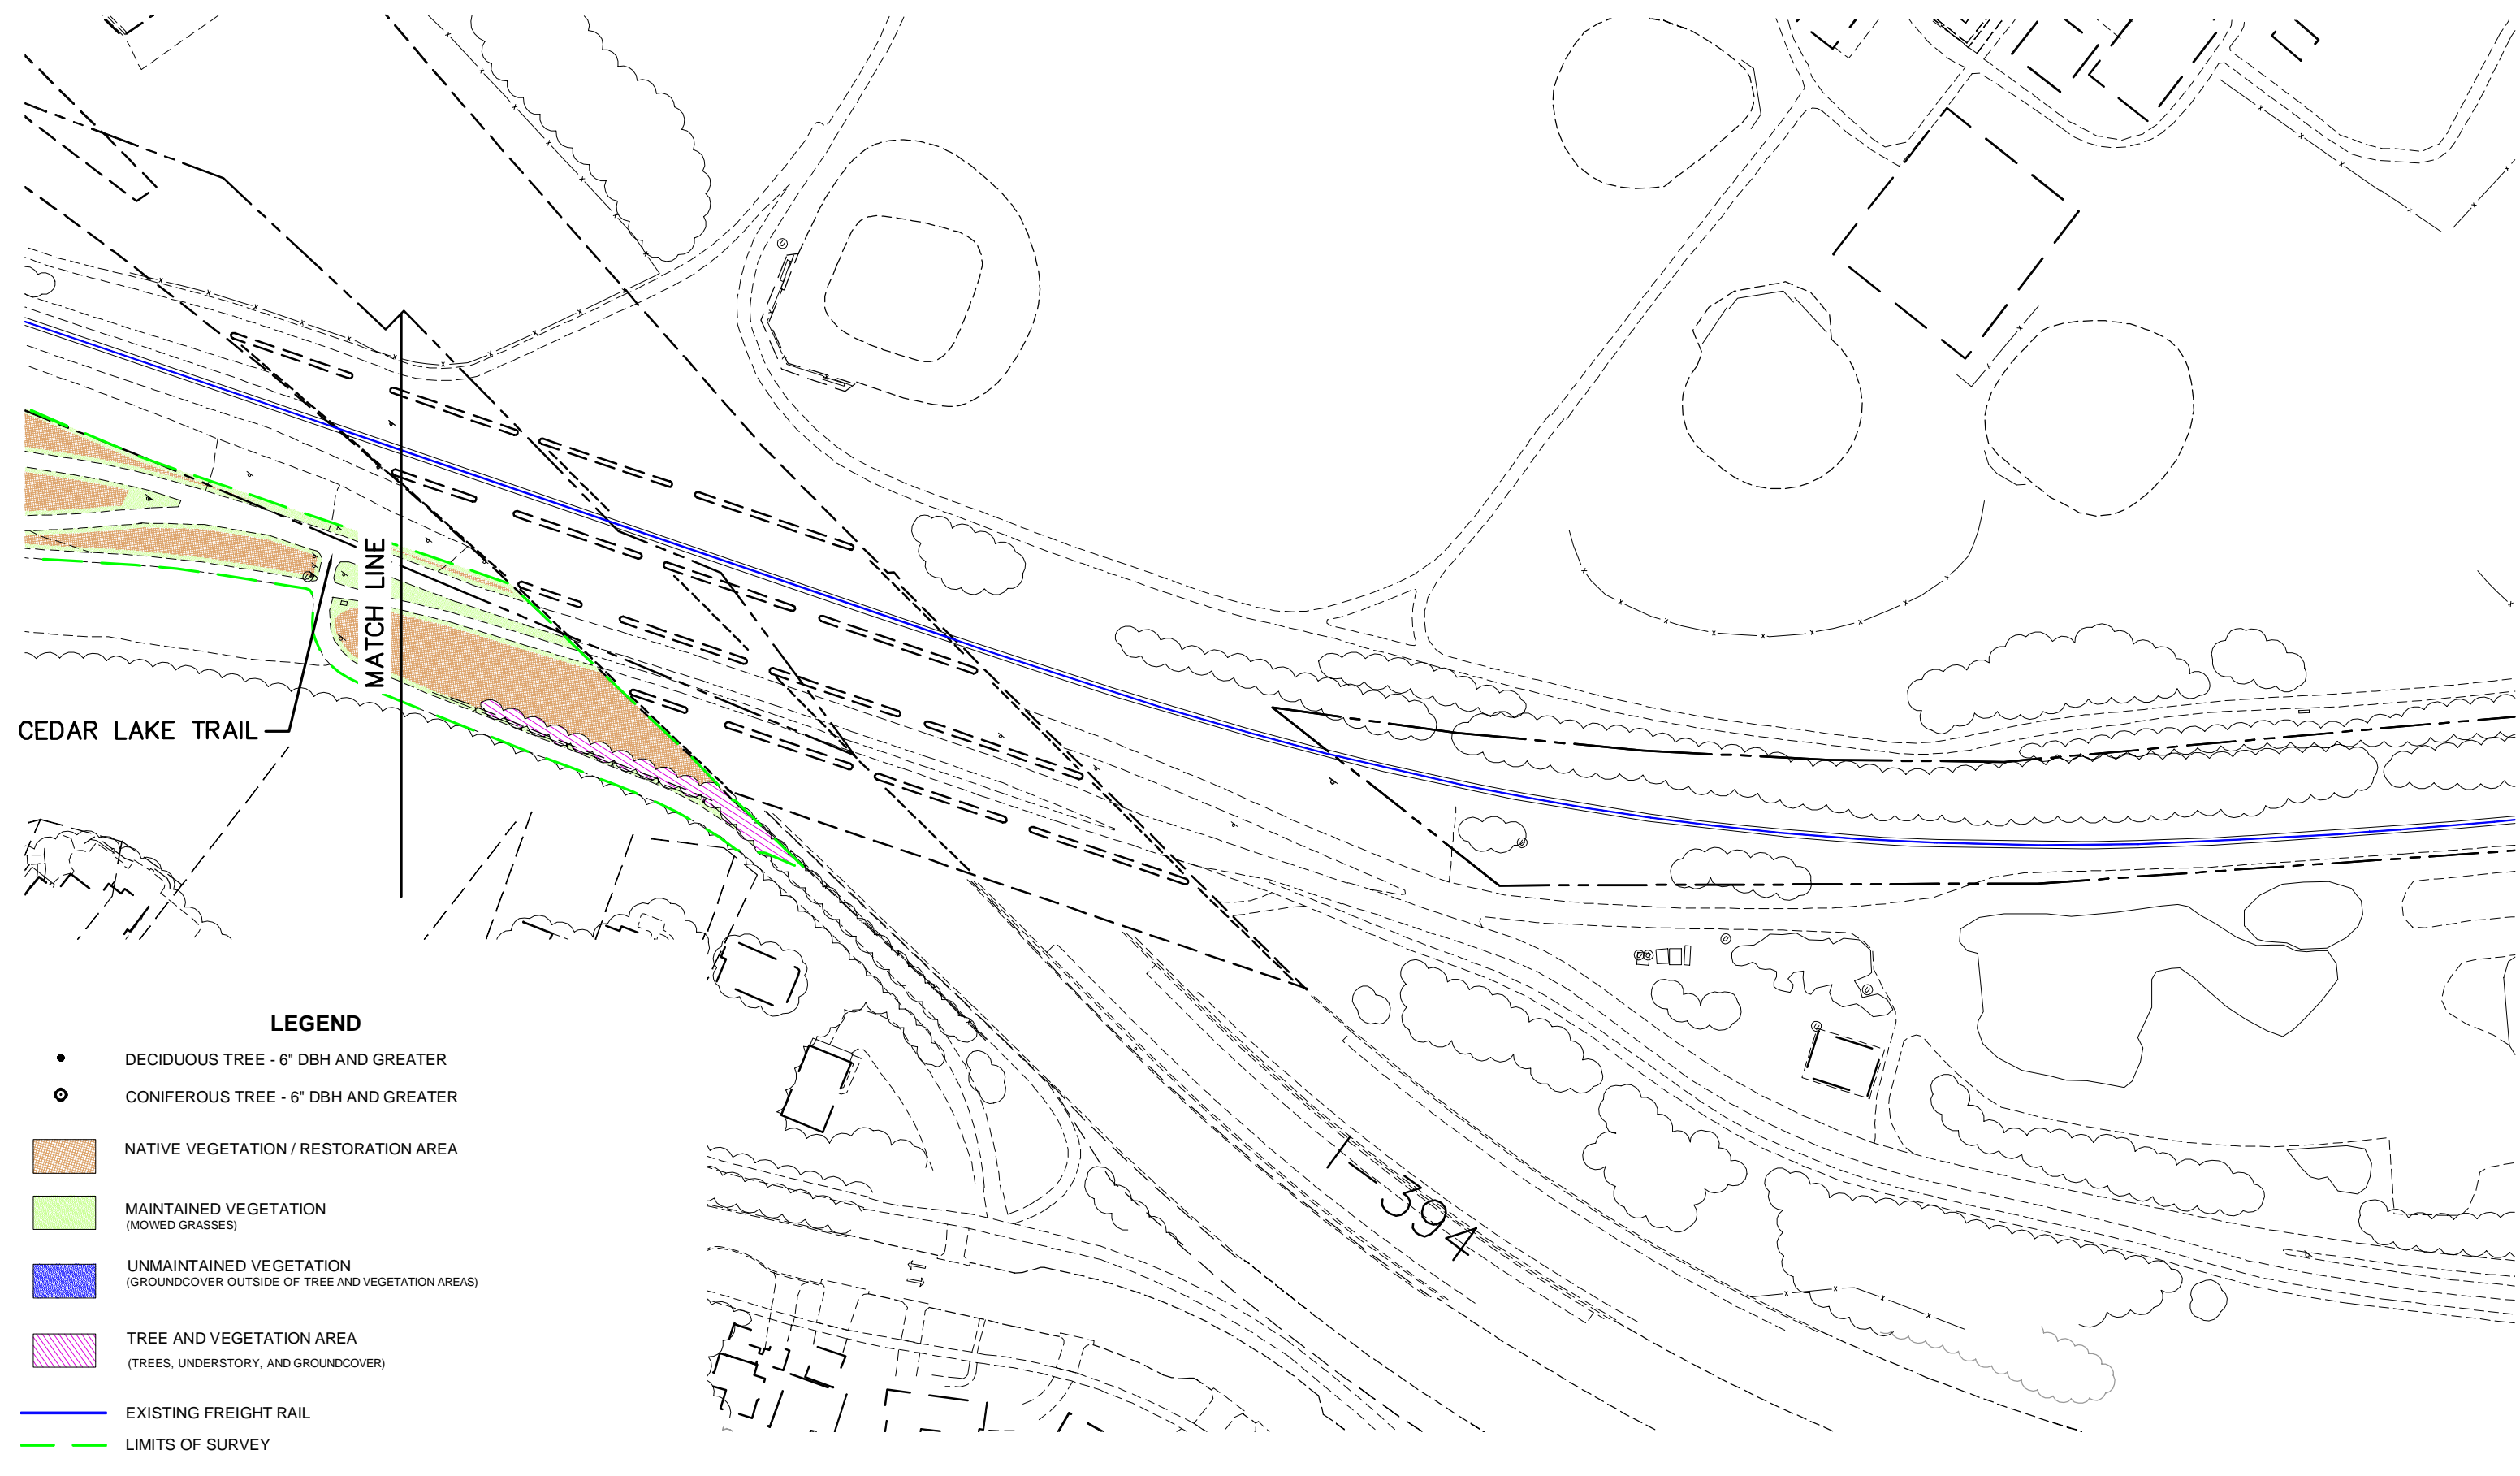
**SOUTHWEST LIGHT RAIL**  
 KENILWORTH CORRIDOR VEGETATION & TREE INVENTORY - TREES 6" DBH AND GREATER  
 SHEET 8 of 8

Sheet 8 shows various vegetation types in the area surrounding the I-394 and Kenilworth Corridor intersection, along with existing freight rail, trails, streets, and the limits of the survey. Vegetation types include deciduous trees, coniferous trees, native vegetation/restoration area, maintained vegetation, unmaintained vegetation, and tree and vegetation area.
