# **Modified Phase I Environmental Site Assessment**

## ***Southwest Light Rail Transit - Segment A and Freight Rail Co-location***

Hennepin County, Minnesota

August 2013

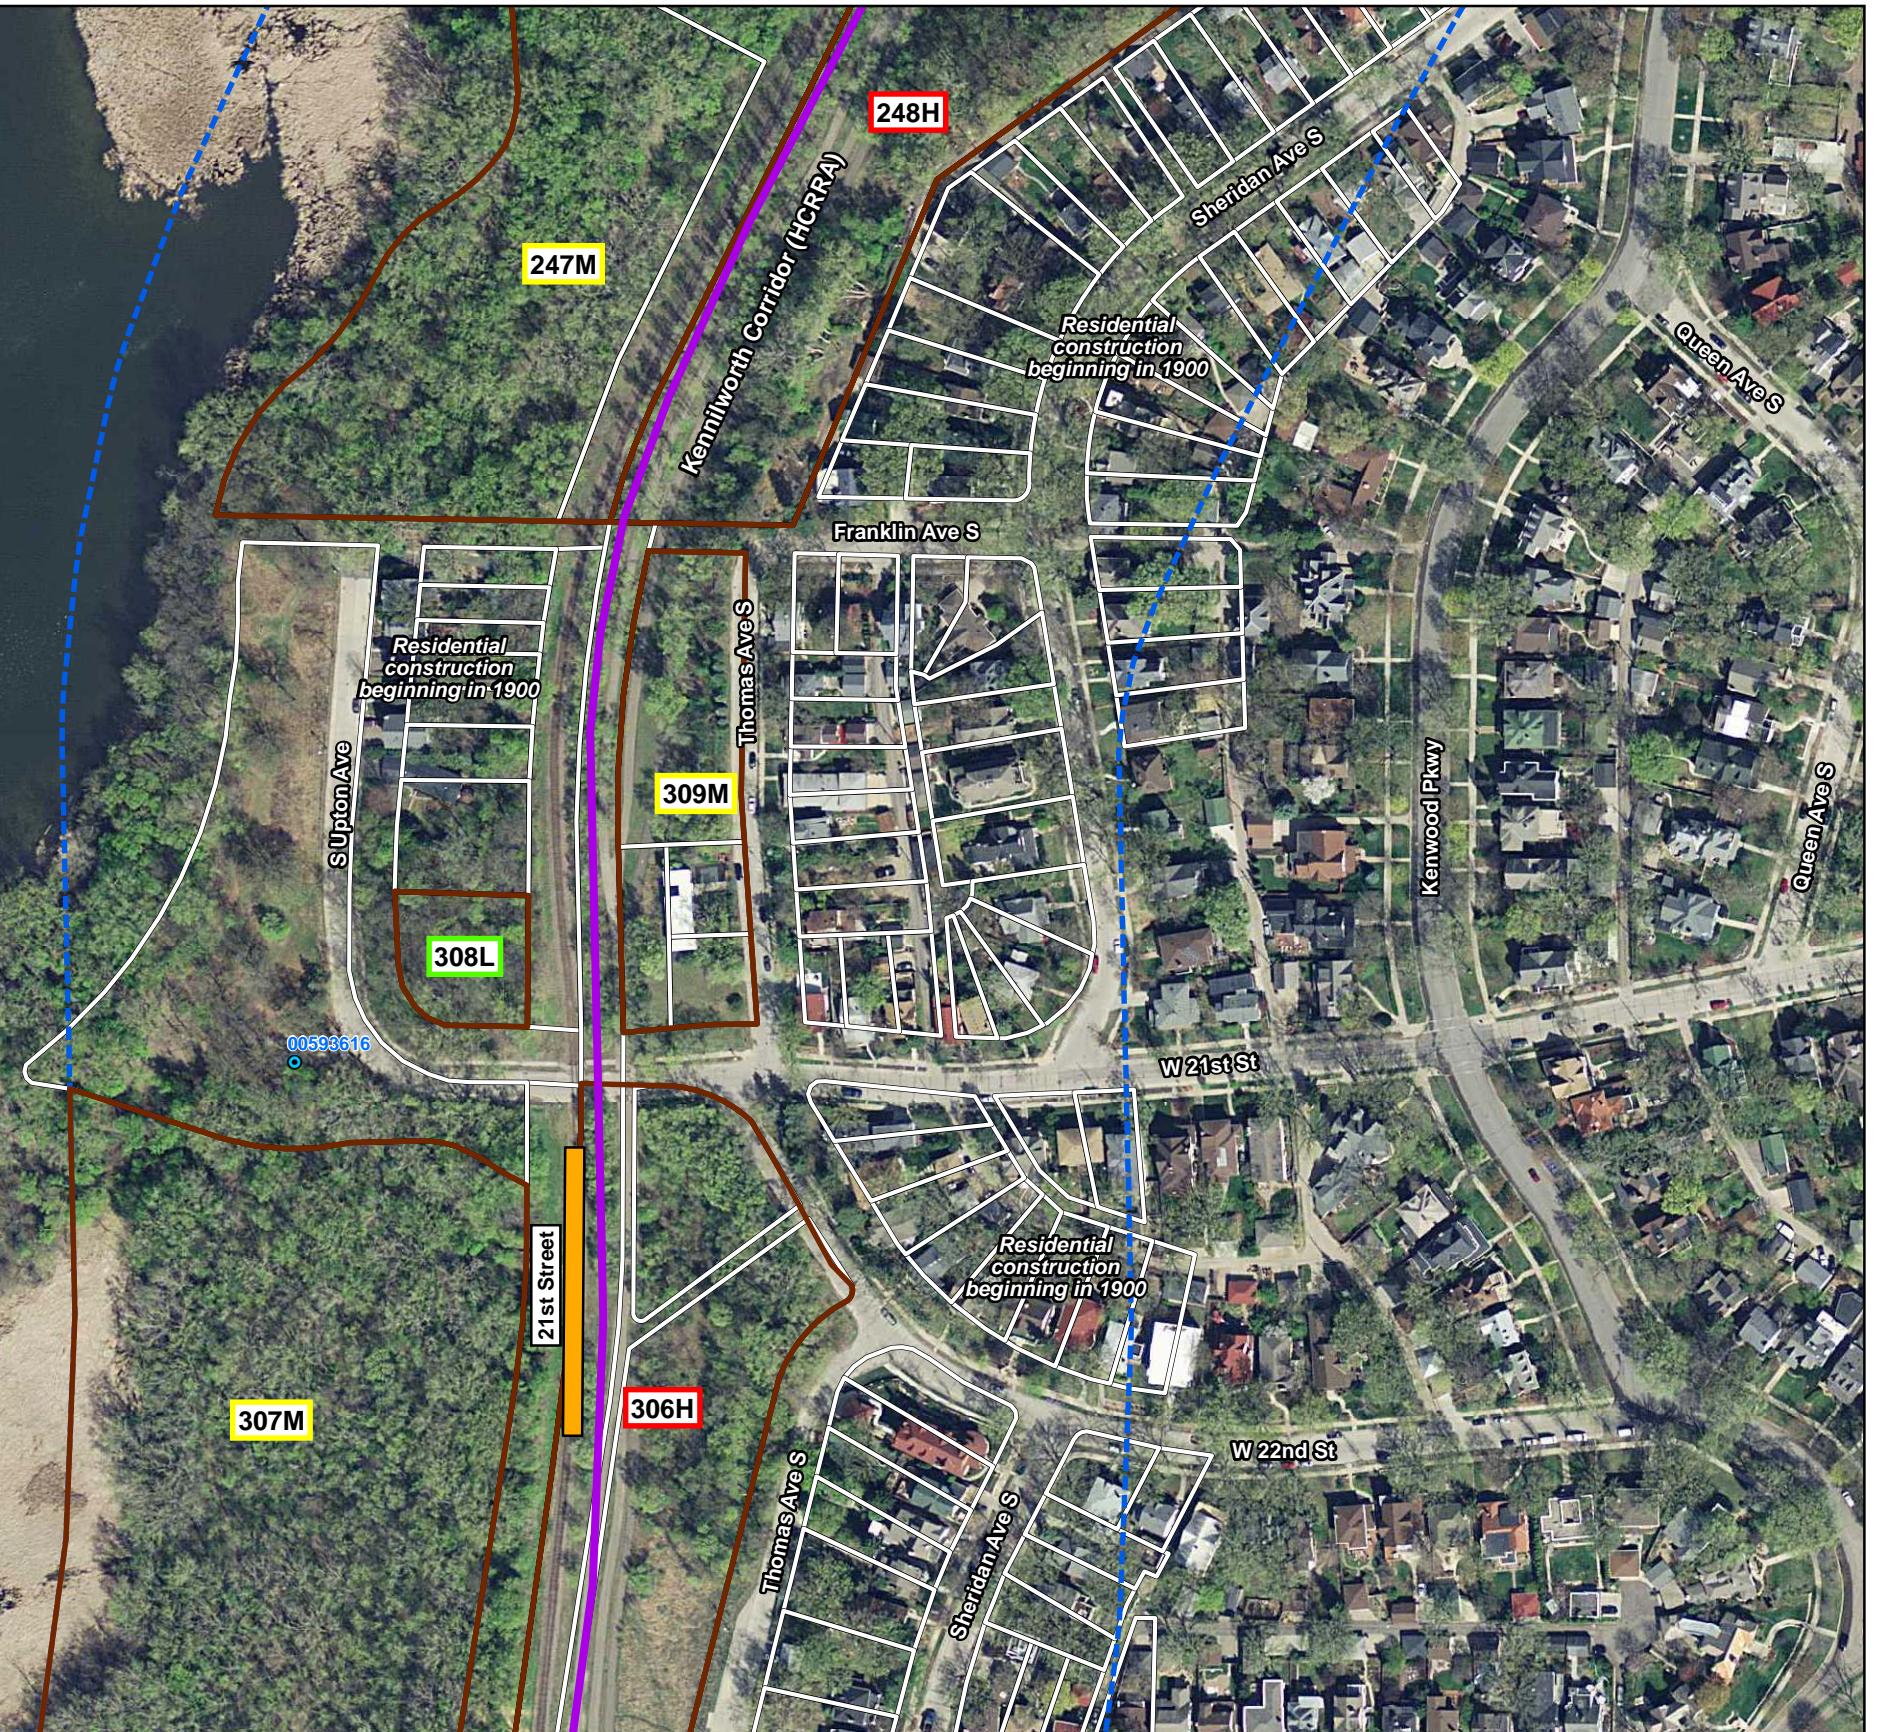
Figure 3-4

SEH ID	Current Use	Rank	Ranking Rationale
247	Active railroad, paved trails, grassy and wooded areas	Medium	Historic ice house (paint/blacksmith shop), rail yard, surface disturbances.
248	Vacant land/trails, residential homes	High	Historic rail yard/round house (tanks, machine/repair/paint shops, acetylene manufacturing, pits, etc.), closed LUST, evidence of dumping.
306	Railroad, bike paths, wooded areas	High	Historic railroad corridor, historic rail yard, CERCLIS NFRAP.
307	Wooded recreational area	Medium	Fill material of unknown origin, discarded demolition debris (concrete) and slag, stressed vegetation.
308	Undeveloped, wooded property	Low	Former structure with unknown use, closed MDA reported emergency incident.
309	Residence and wooded area.	Medium	Historic rail corridor, historic ground disturbance.

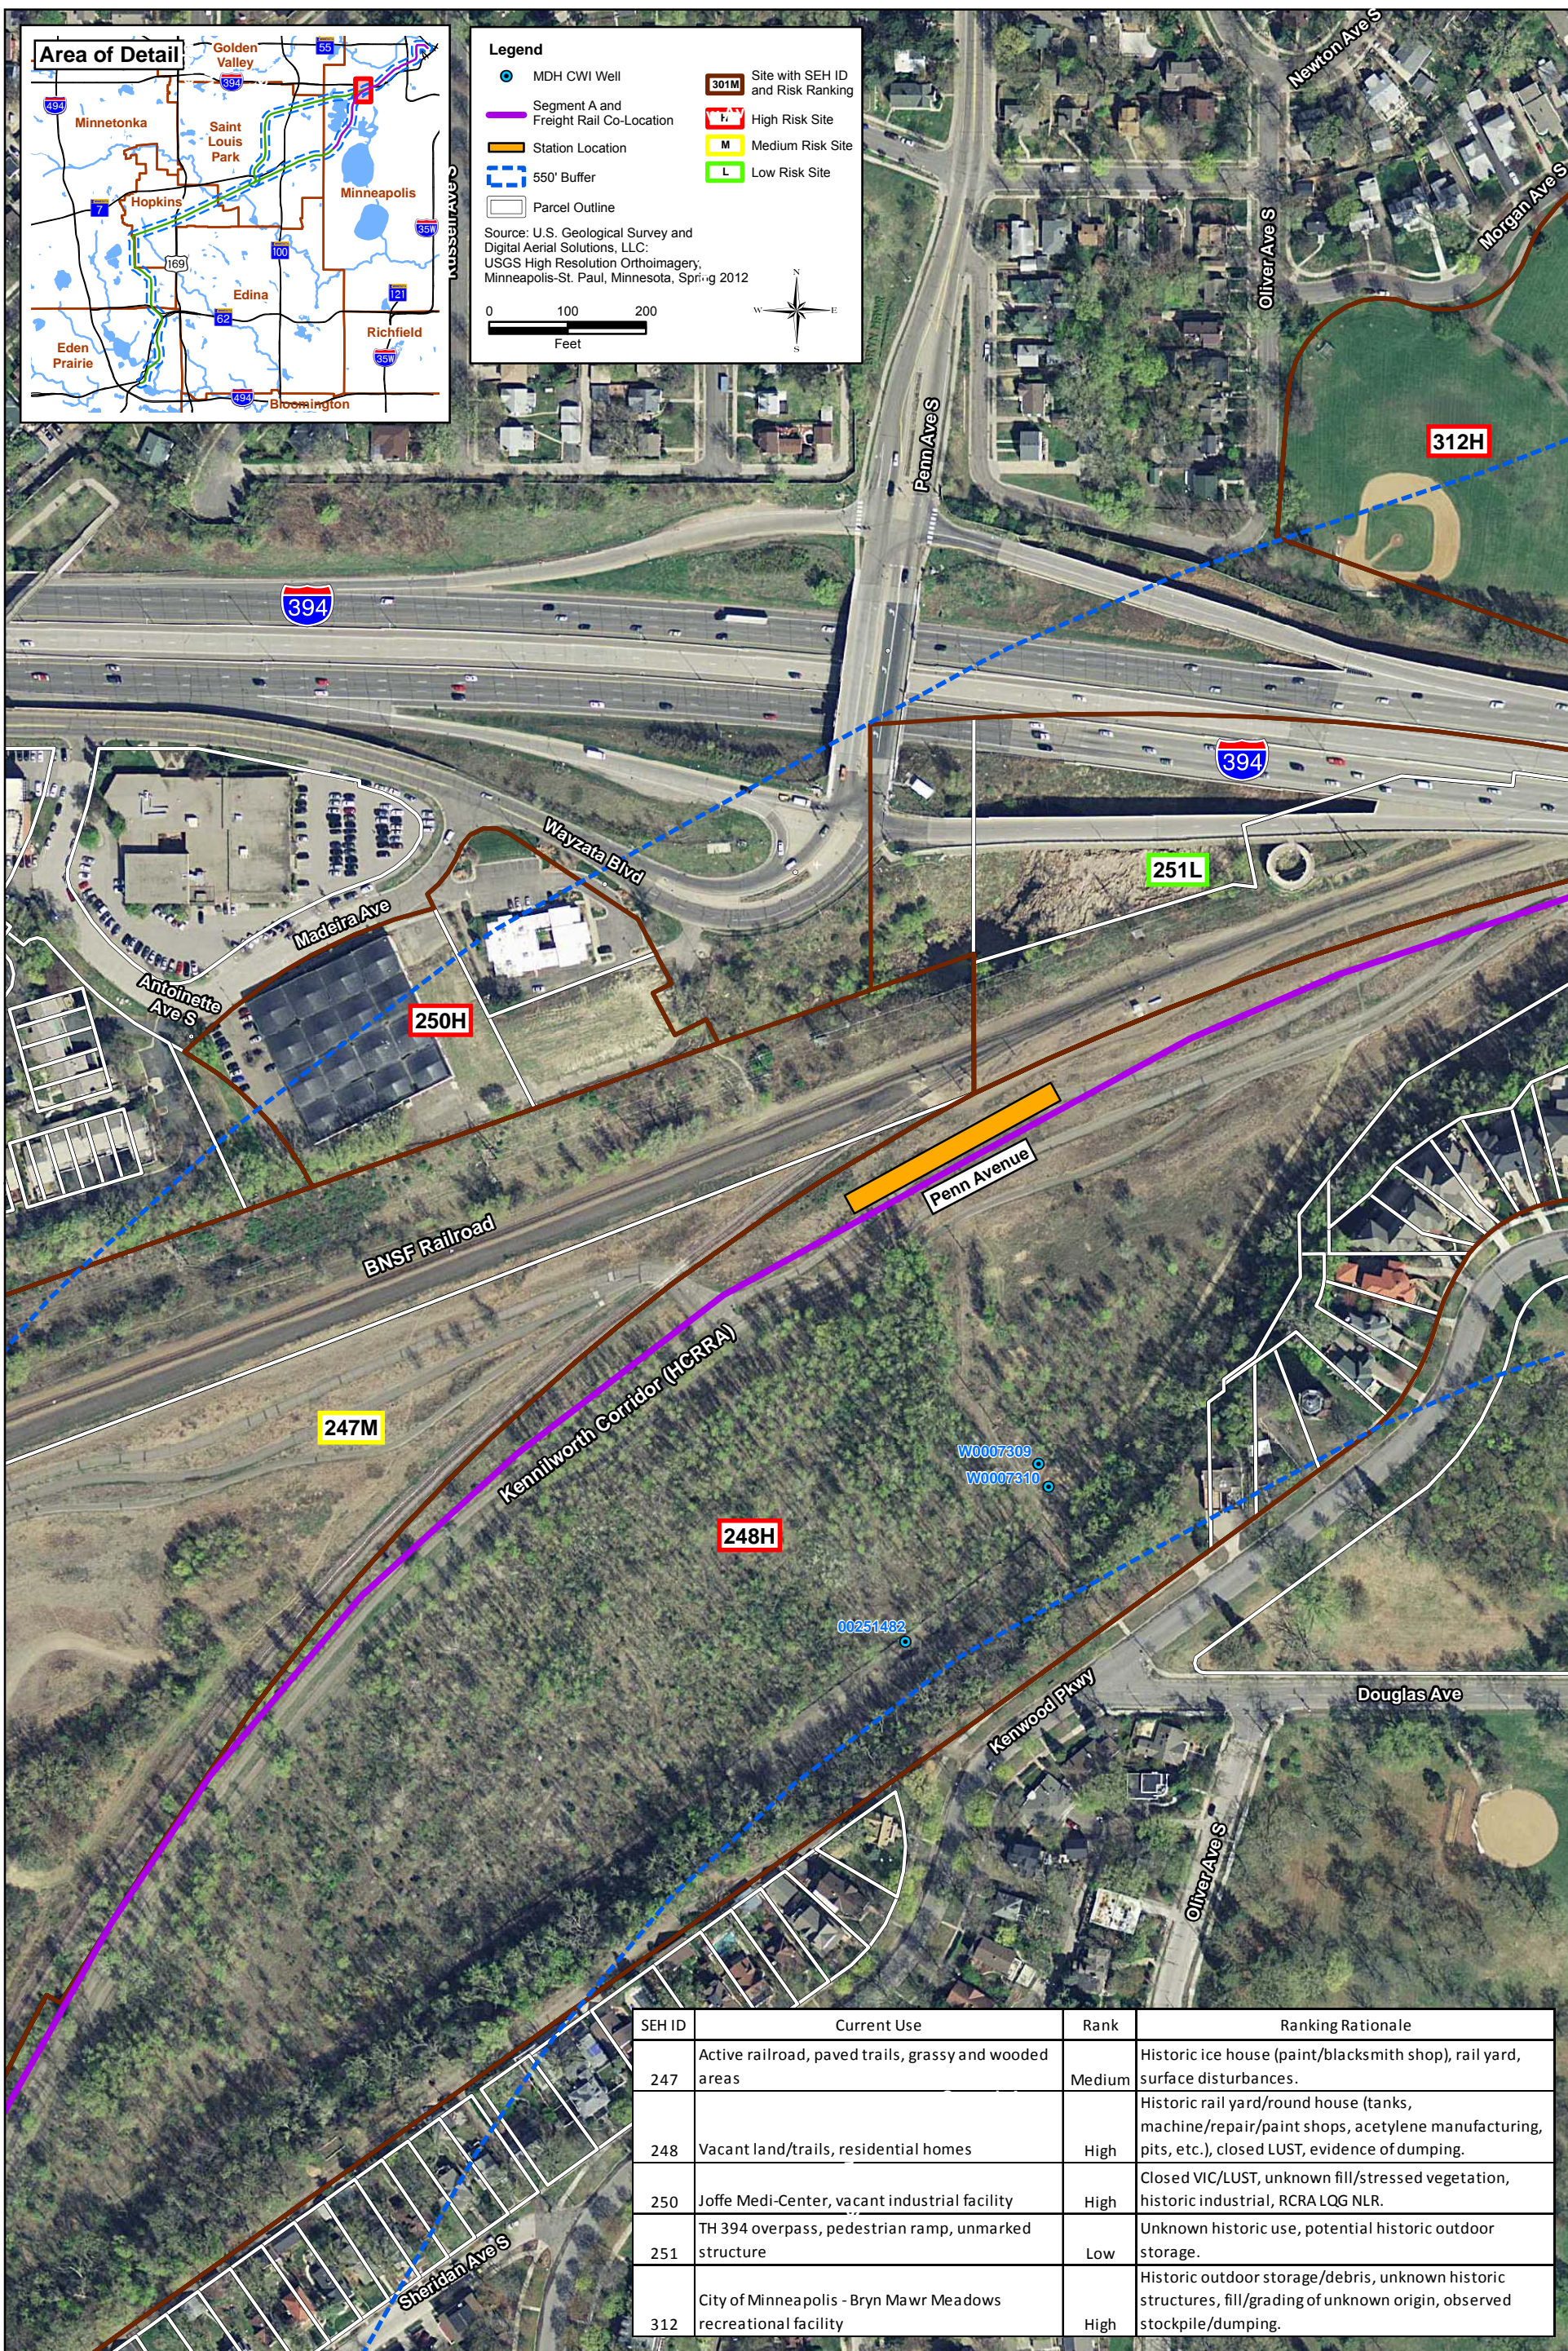
Figure 3-5

**PROJECT CORRIDOR FEATURES**

SEH ID	Current Use	Rank	Ranking Rationale
248	Vacant land/trails, residential homes	High	Historic rail yard/round house (tanks, machine/repair/paint shops, acetylene manufacturing, pits, etc.), closed LUST, evidence of dumping.
251	TH 394 overpass, pedestrian ramp, unmarked structure	Low	Unknown historic use, potential historic outdoor storage.
310	Abandoned structure	Low	Abandoned structure with unknown historic use.
311	Well House	Low	Well located on-site.
312	City of Minneapolis - Bryn Mawr Meadows recreational facility	High	Historic outdoor storage/debris, unknown historic structures, fill/grading of unknown origin, observed stockpile/dumping.
313	City of Minneapolis	Medium	Closed LUST, outdoor storage/construction materials, stockpiles, debris.
314	TH 394 overpass and ramps with outdoor storage below	Medium	Outdoor storage, historic surface disturbances.

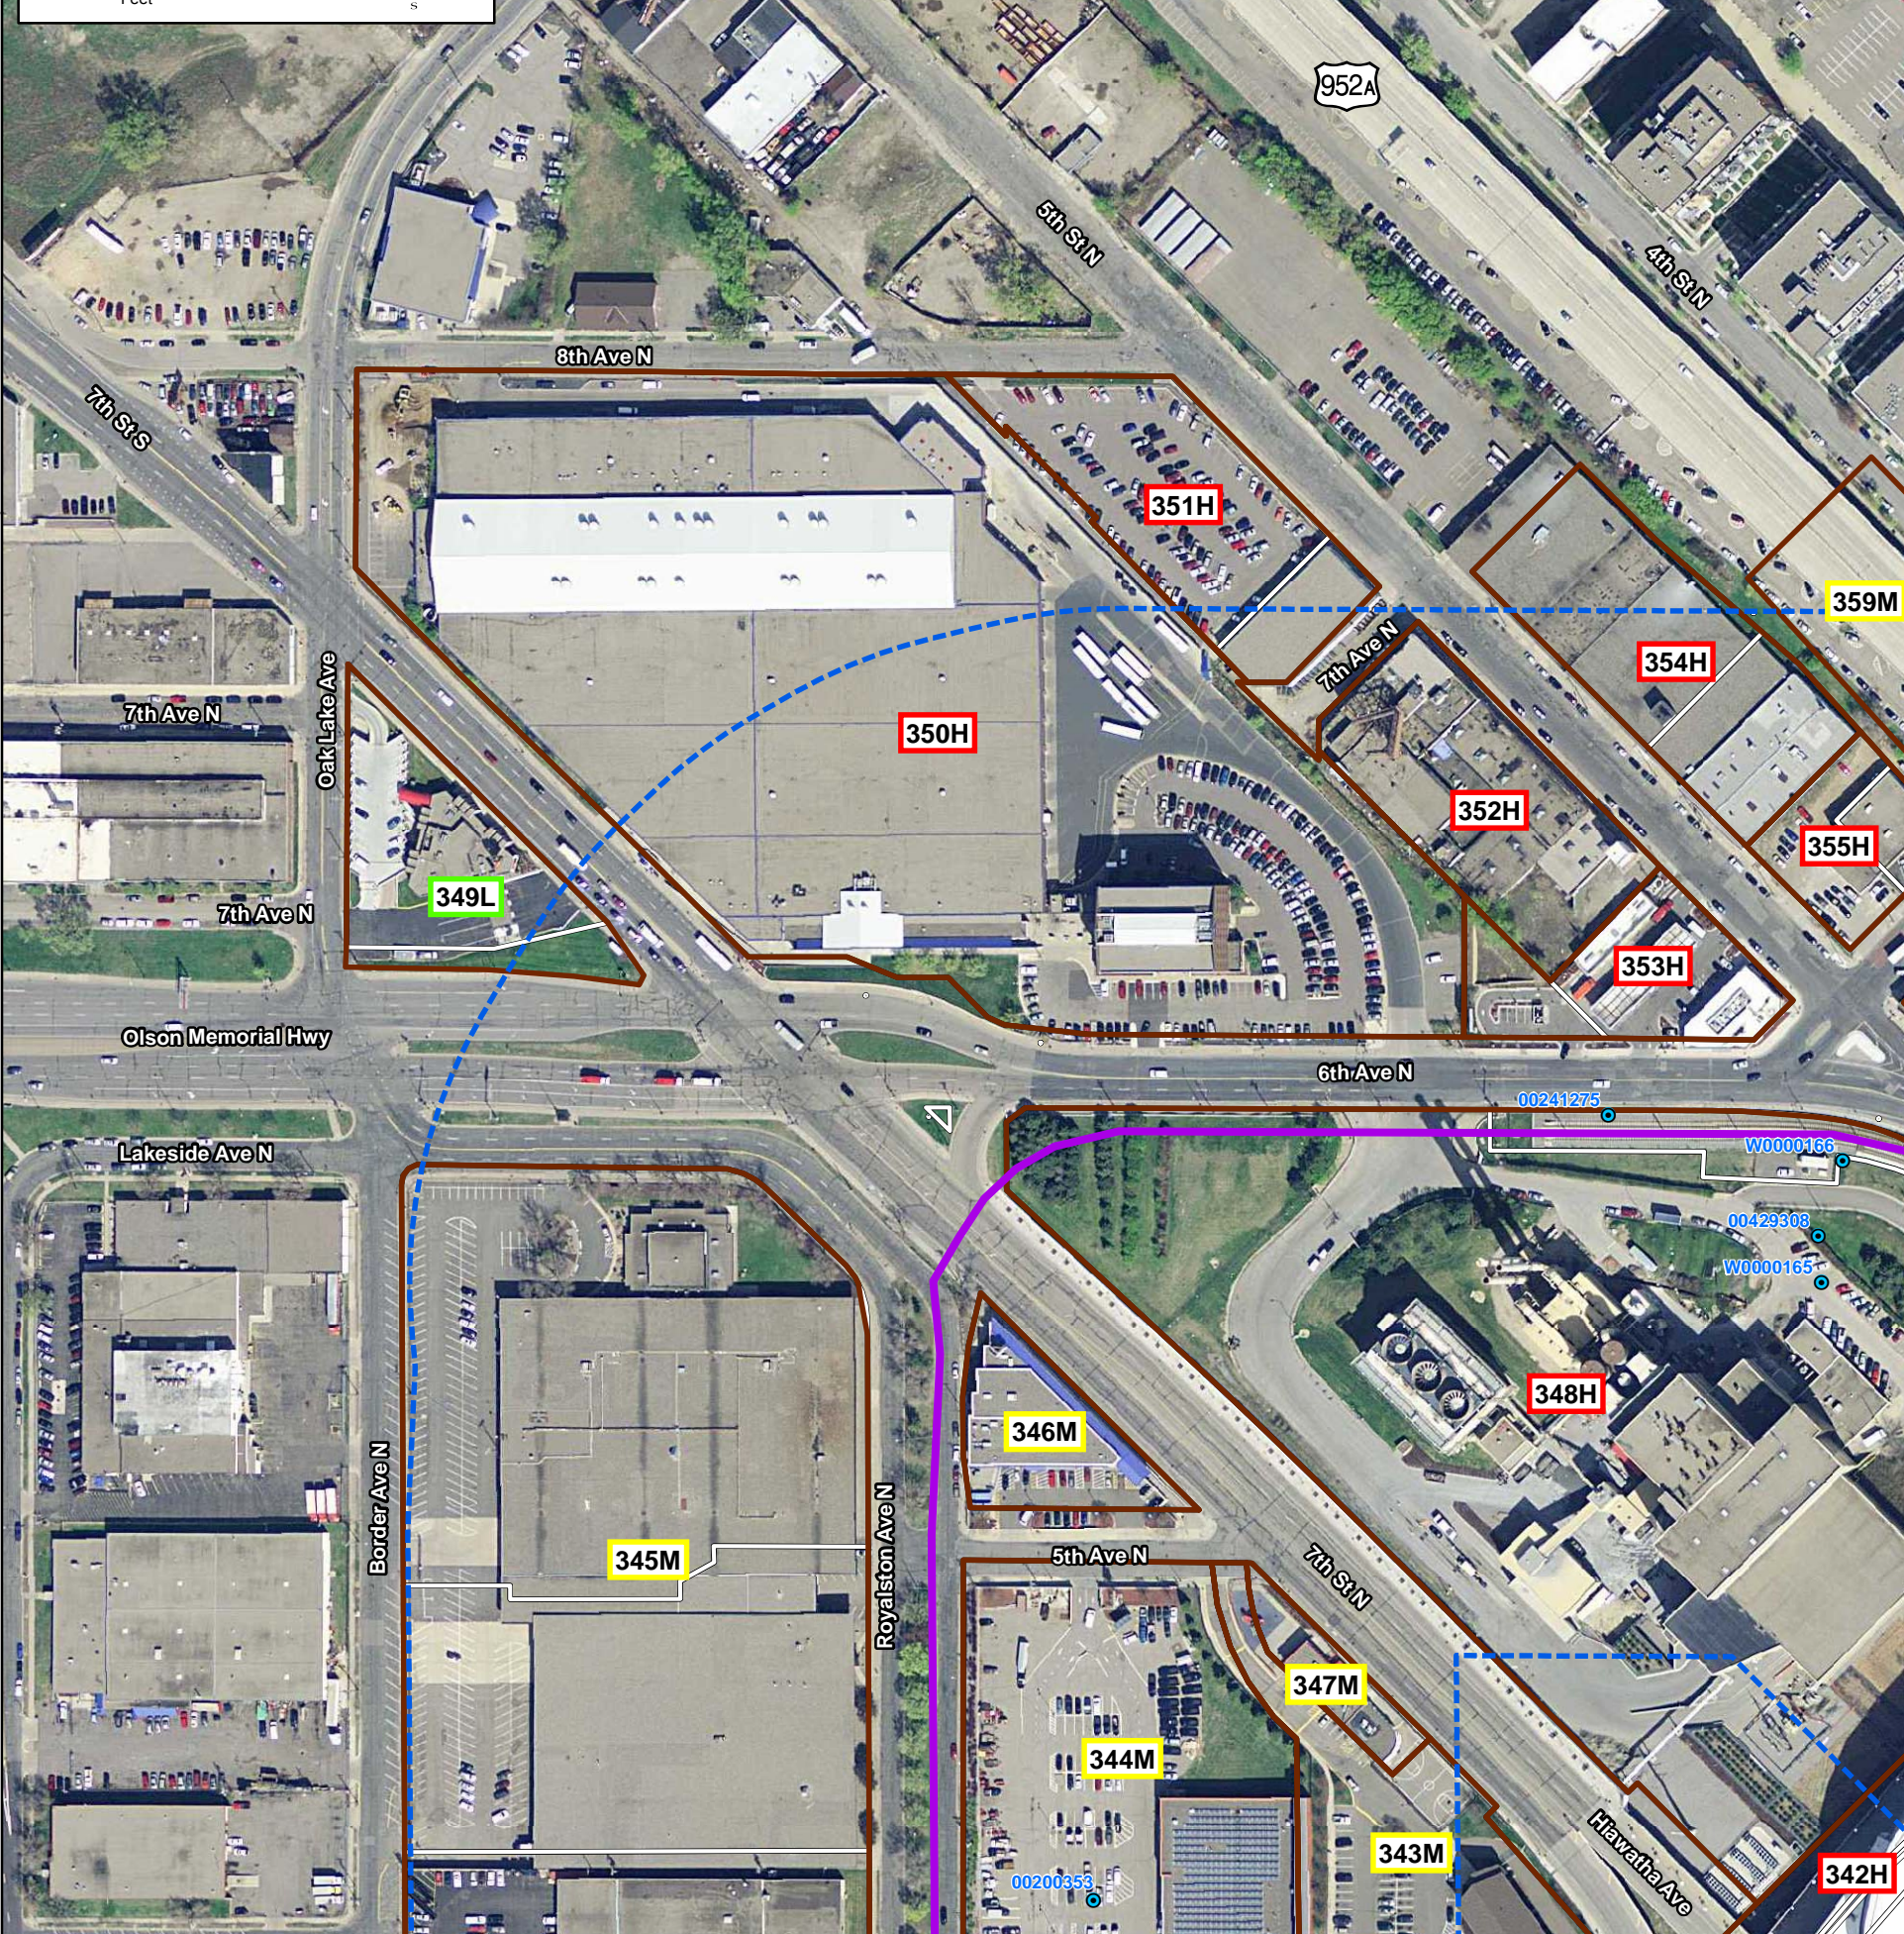
Figure 3-12

SEH ID	Current Use	Rank	Ranking Rationale
342	Target Field, parking, TH 55 overpass, 7th Street, 5th Avenue	High	Inactive VIC, historic rail yard, open/closed LUST, removed USTs, active AST.
343	Mary My Hope Children Center	Medium	Historic rail yard, historic coal yard, closed LUST, removed UST, closed Spills.
344	City of Minneapolis Department of Public Works	Medium	Vehicle maintenance/repair, closed LUST, removed USTs, active ASTs, historic railroad spur tracks and coal yard.
345	City of Minneapolis Traffic Engineering and other industrial/commercial facilities	Medium	Historic commercial/industrial businesses, closed LUST, active USTs, removed and closed in place USTs, closed spill, RCRA SQG/LQG.
346	Sharing & Caring Hands	Medium	Inactive VIC/closed LUST/Spills; Historic auto repair/machine shops/gasoline tanks, removed UST, active RCRA VQG.
347	Mary's Place	Medium	Historic auto repair, printing shop, outdoor storage, RCRA VQG NLR.

348	Hennepin Energy Recovery Center	High	Active landfill/waste to energy incinerator, CERCLIS NFRAP, active/inactive VIC; historical rail yard/industry, vehicle repair; closed LUST, active ASTs, closed Spills, RCRA SQG.
349	Wells Fargo bank	Low	Historic structures with unknown use, stained pavement at drive-through area.
350	Metro Transit	High	Vehicle repair facility, active/closed LUST, active/removed USTs/ASTs, historic industry, auto repair, machine shops, fuel stations, salvage/scrap yards, closed Spills, RCRA SQG.
351	Tubs Inc. recycling and transfer facility, parking lot	High	Recycling/transfer facility; RCRA SQG.
352	Vacant buildings being demolished	High	Active VIC site, auto salvage yard, historic junk yard, closed LUST, active ASTs, removed USTs, petroleum odor/remedial action activities observed, RCRA SQG.
353	Holiday Station and stormwater pond	High	Historic filling station and greasing station, current fuel stations, auto repair, active/closed LUST, active/removed USTs, closed spill, RCRA VQG NLR.

354	Weather-Rite shipping docks, vacant industrial building	High	Inactive VIC, restrictive covenant, historic metal manufacturer and junk yard, closed LUST, USTs closed in place, RCRA VGN NLR, hoists/lifts observed.
355	Fulton Brewery	High	Active VIC/Brownfield, former vehicle repair and filling station, former junkyard, closed LUST, removed USTs, active AST, RCRA SQG NLR.
359	Parking lot and overpass	Medium	Historic manufacturing, junk yard, greenhouse, woodworking shop with varnishing area, stressed vegetation.
