Interceptor Condition Assessment and Rehabilitation Program

Environment Committee

February 11, 2014

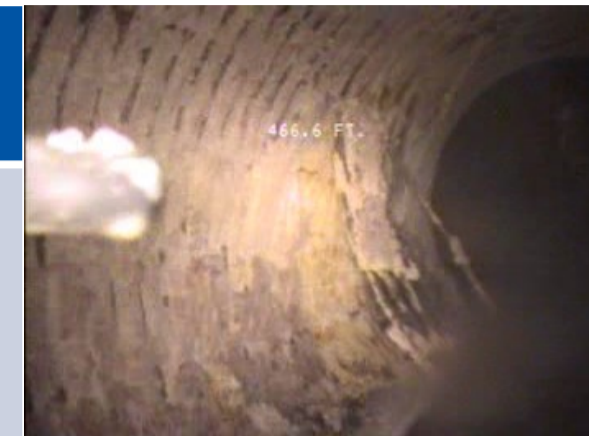
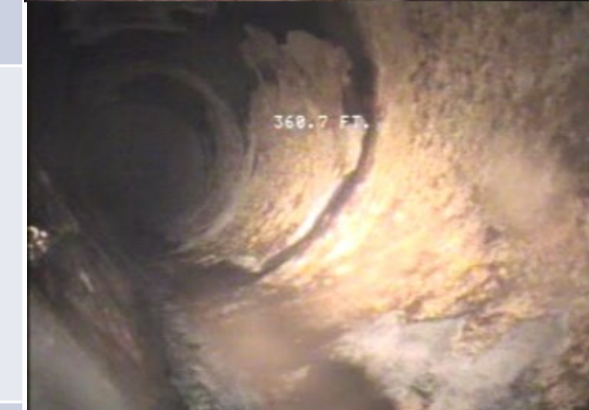
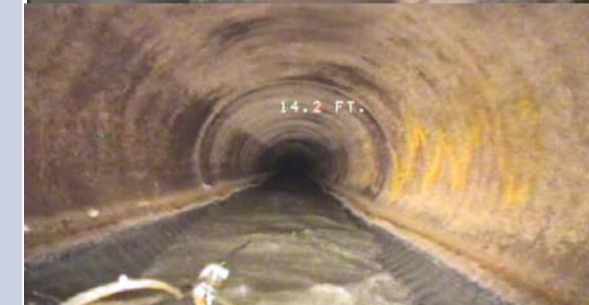
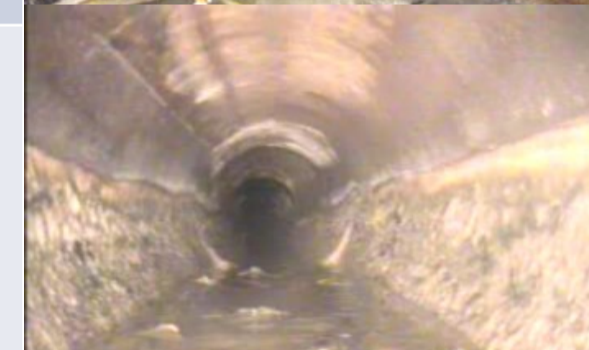
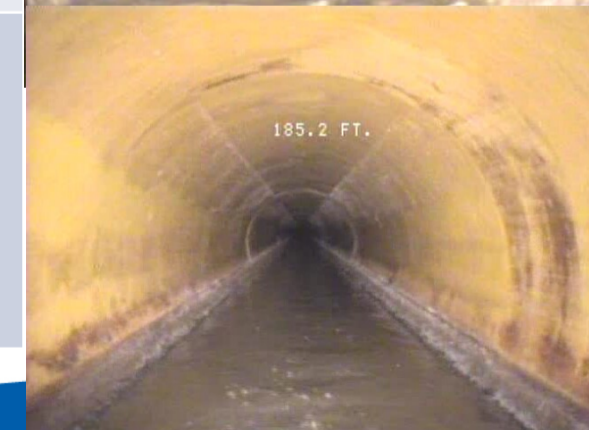
Condition Grading System

Grade	Condition	Rehabilitation
5	Near failure	Immediate Attention
4	Poor	Repair within 10 years
3	Fair	Re-inspect in 5 years
2	Good	Re-inspect in 10 years
1	Excellent	Re-inspect in 10 years
