Business Item 2014-199

Ratification of Declaration of Emergency for Repair of Interceptor 7113

Environment Committee: August 12, 2014

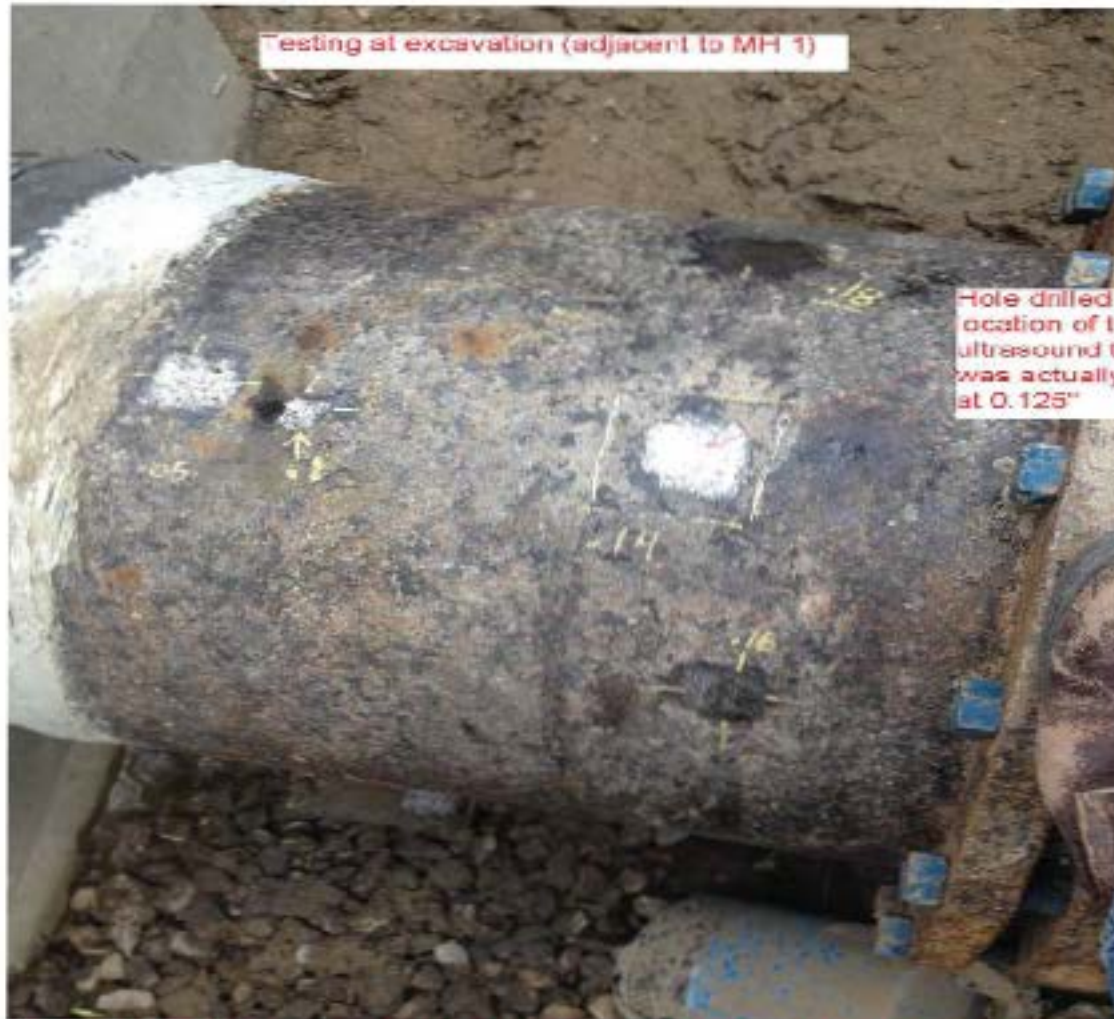
Testing at excavation (adjacent to MH 1)

Hole drilled in the location of the 0.14" ultrasound test location was actually measured at 0.125"

Additionally, the 20" DIP, CL 52 spool piece pipe at Magney's trailer was measured to verify accuracy of ultrasound. It measured 0.44" and 0.45" where factory is 0.42". Also, the coupon from Phase 2 (SJ Louis) conveyance which was on the DIP portion measured 0.51" in thickness while the ultrasound gave readings ranging from 0.52" to 0.54".
