Declaration of Emergency for Repair of Rosemount Interceptor 7112 and 9208

Environment Committee: July 23, 2019

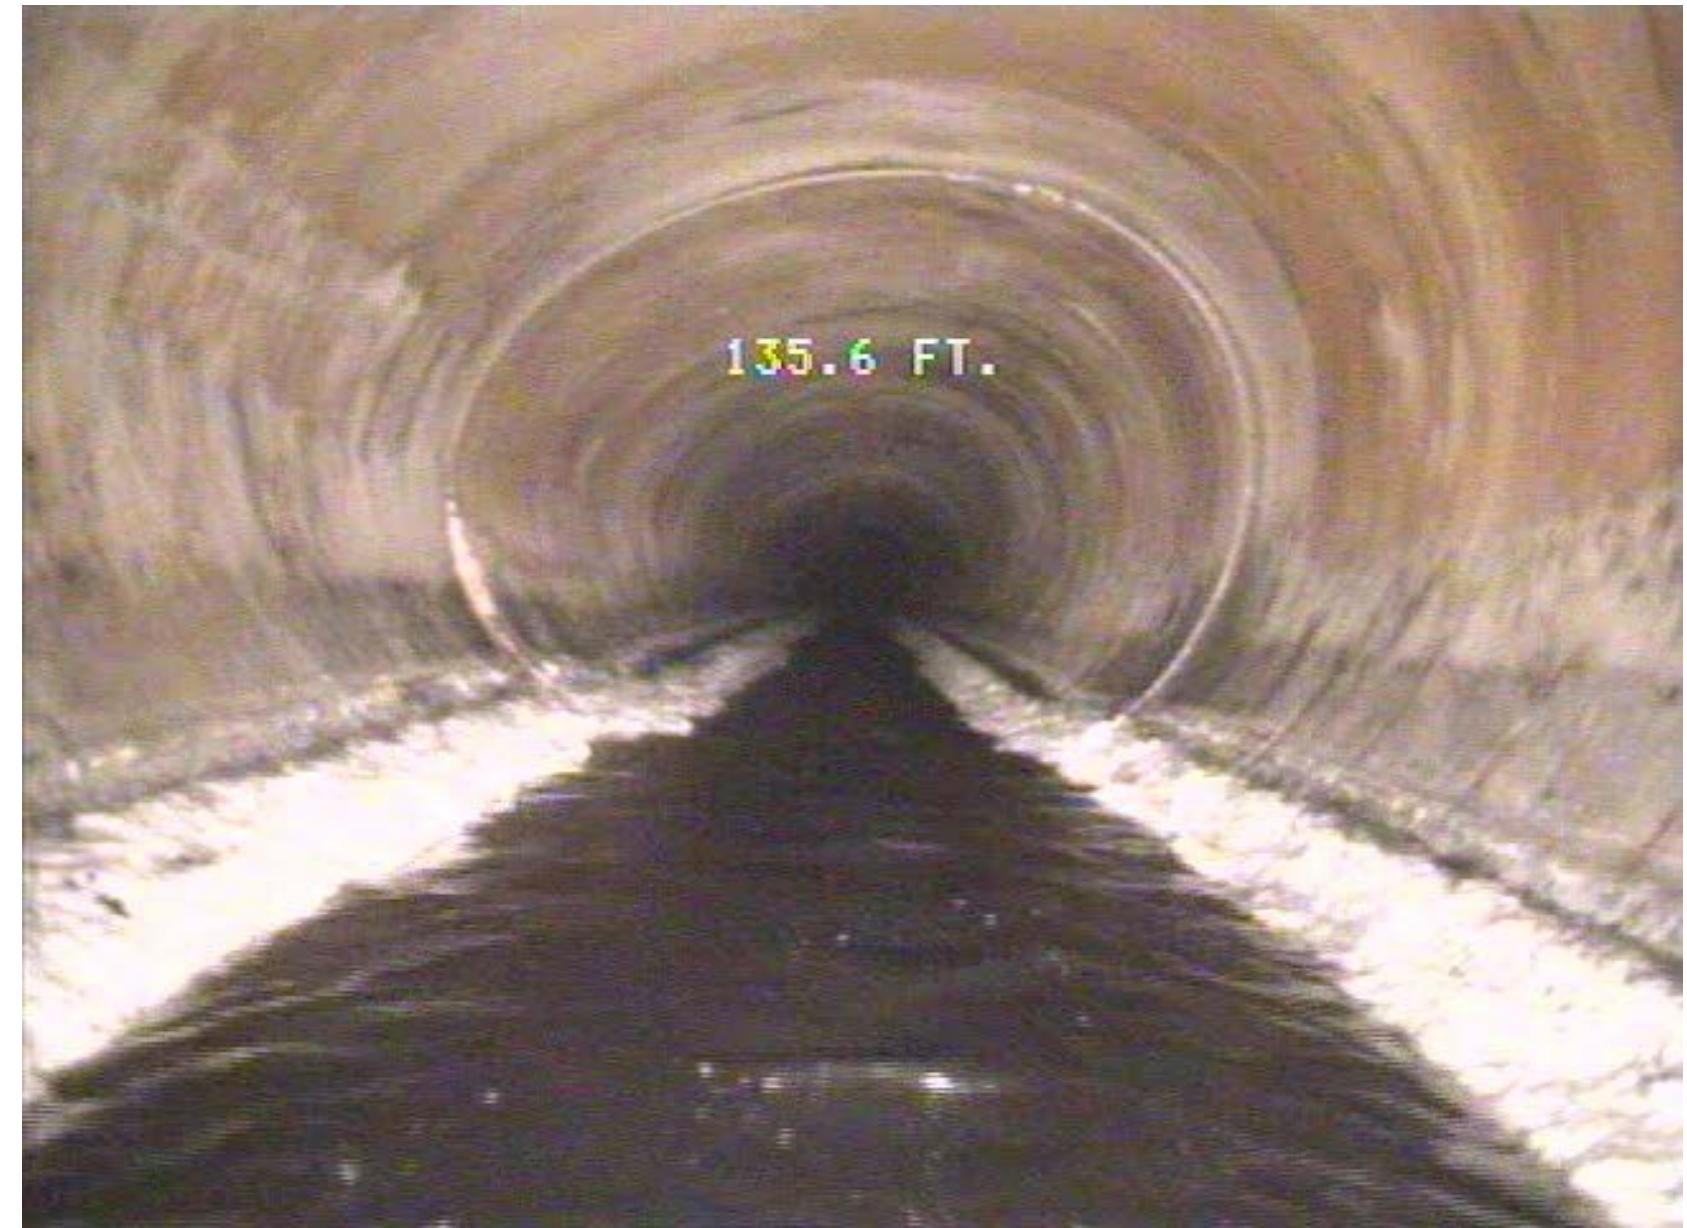
- Interceptor 9208 constructed in 2008
- Provides service for Rosemount
- Emergency declared March 11, 2019
- Excavation began April 1, 2019
- Pipe installed and backfilled April 8, 2019
