# Information Item: Minneapolis Pipe-In-Pipe Repairs

Environment Committee

May 10, 2022

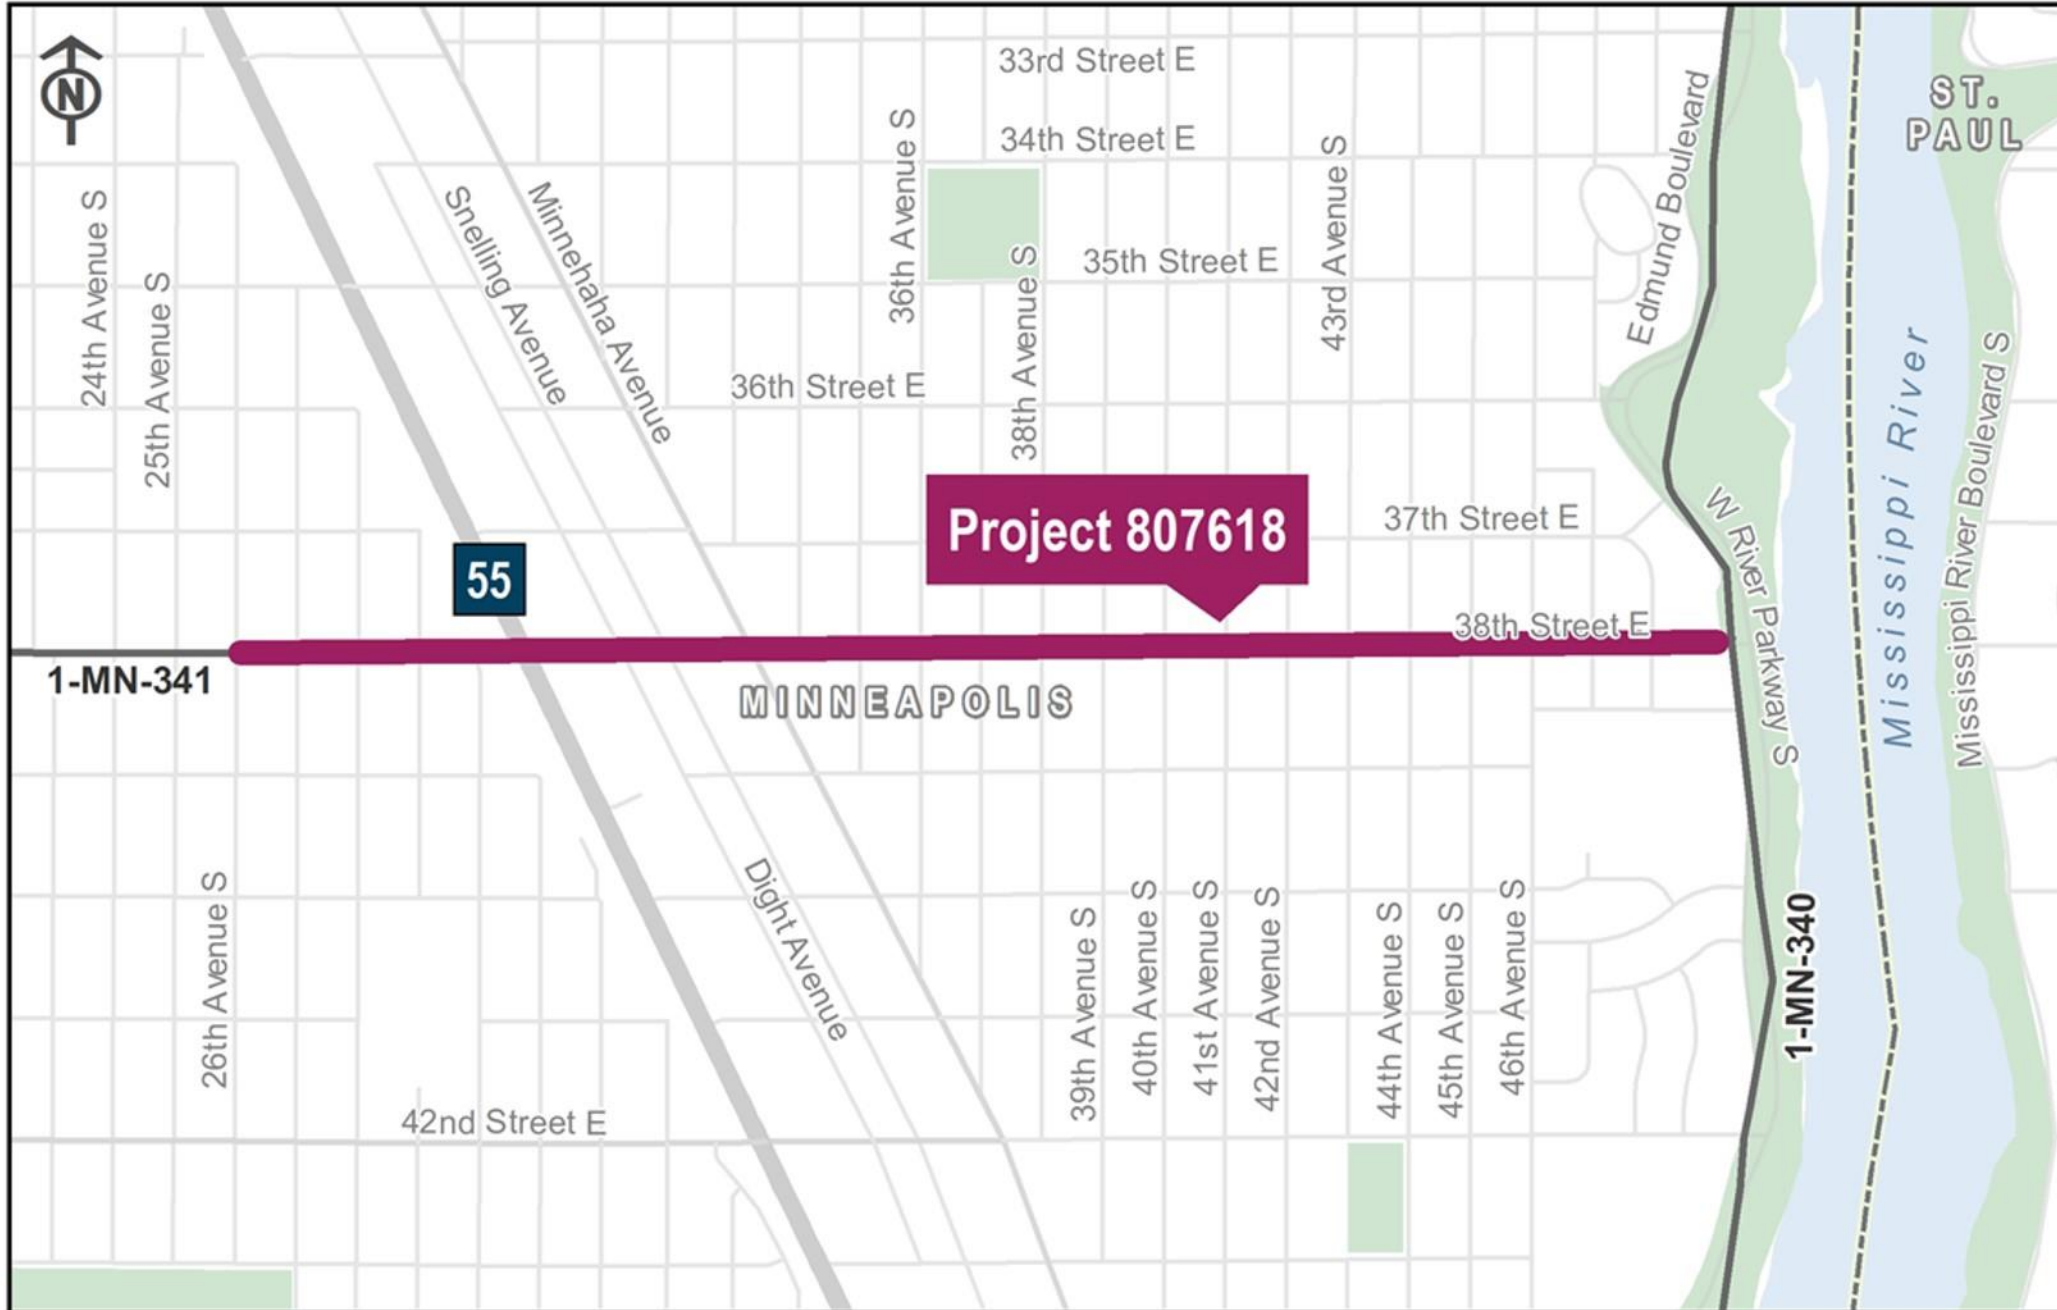
## 1-MN-341:

- 111-inch combined sewer built 1911
- 62 by 31-inch pipe-in-pipe section constructed in 1986
- Includes a regulator constructed at 26<sup>th</sup> Avenue S
- 2-year construction for the rehabilitation of the pipe-in-pipe section started in 2021

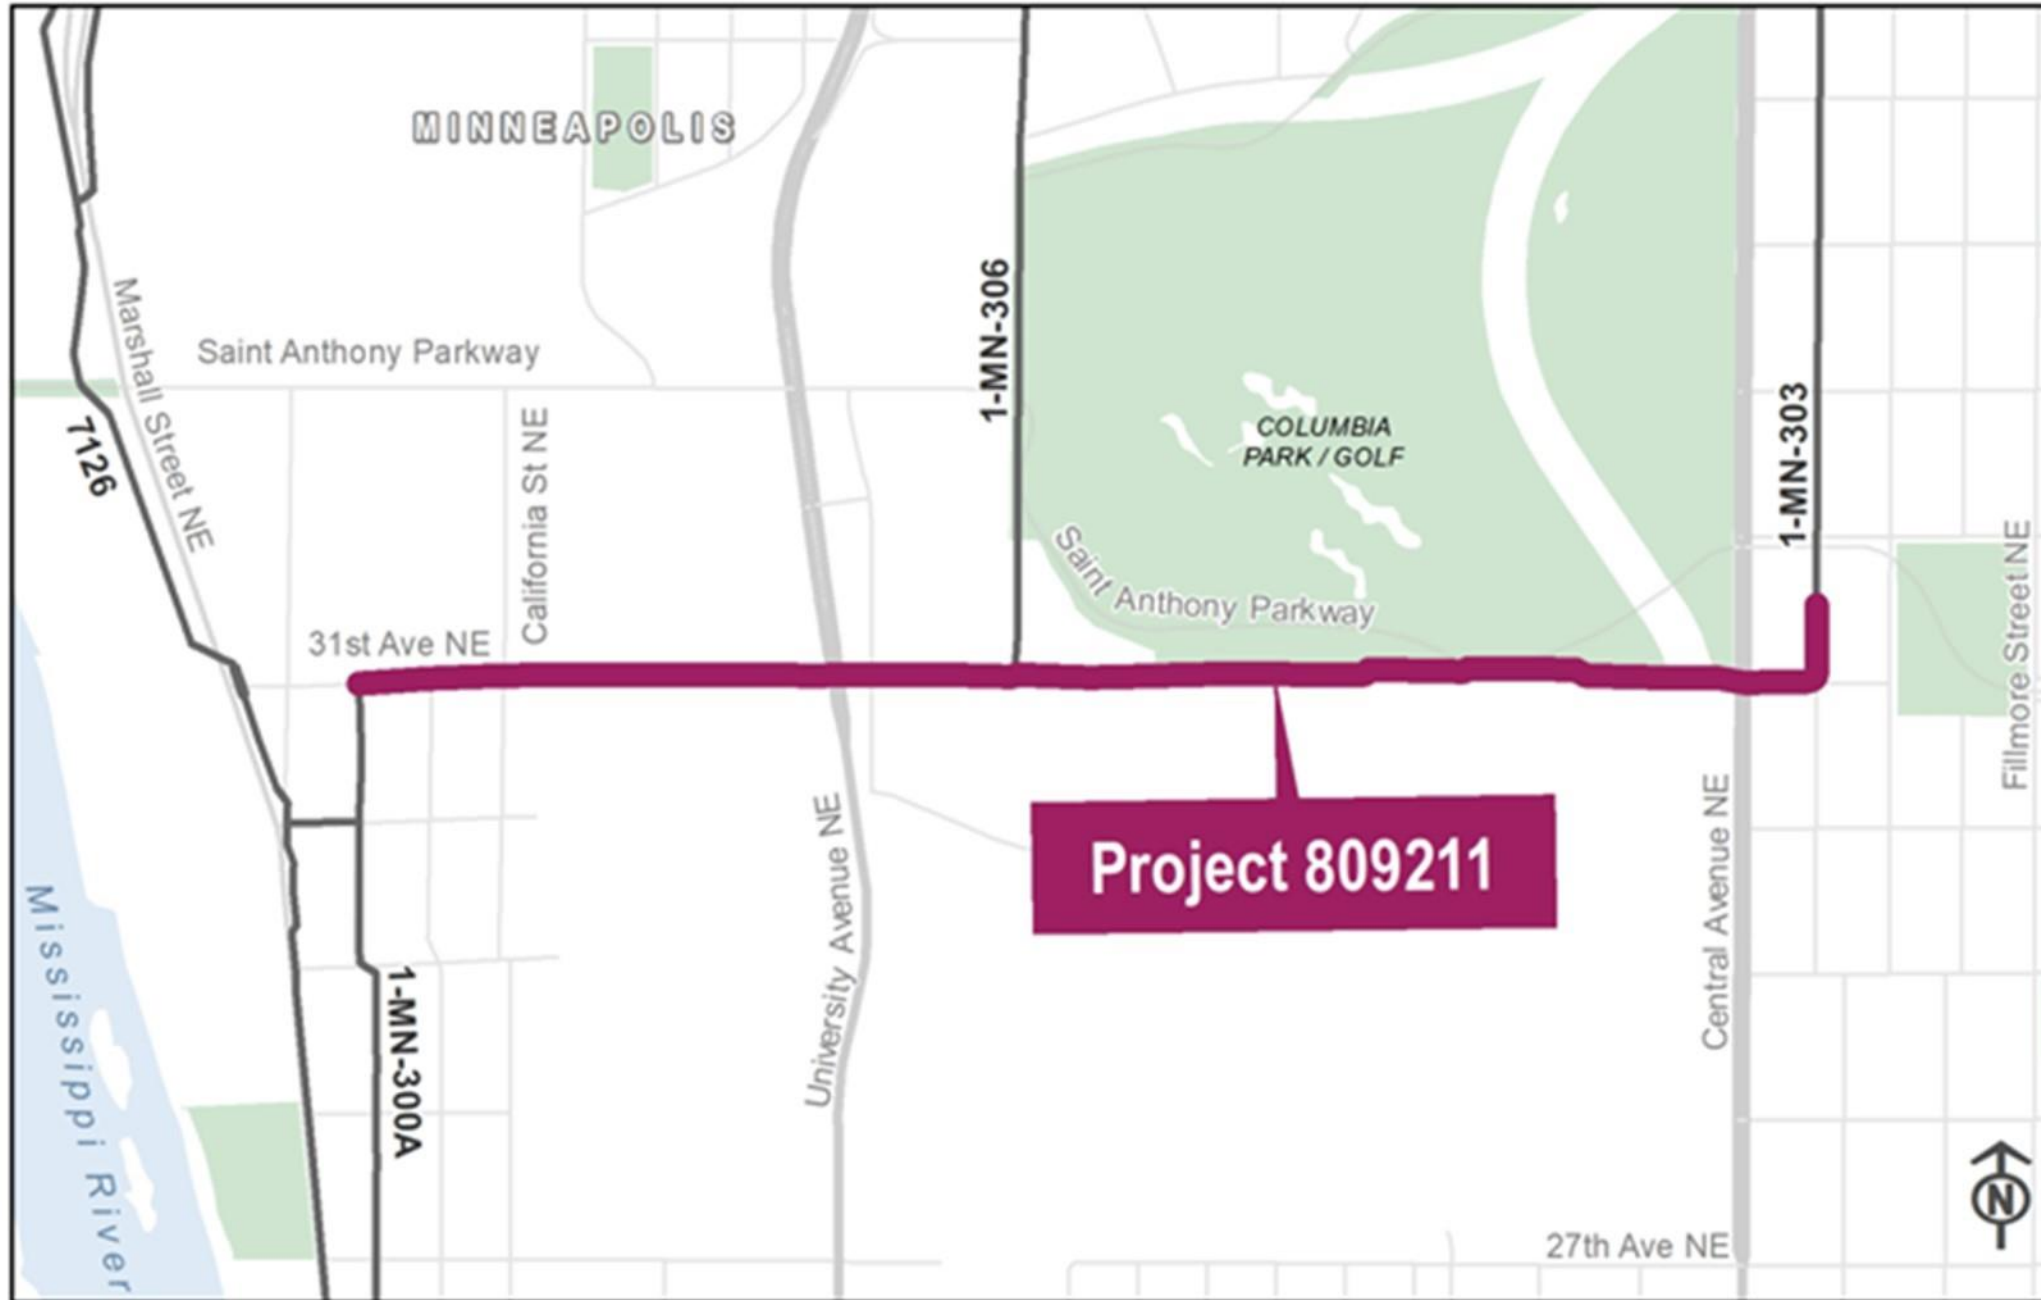
## 1-MN-303:

- 102” Combined sewer built 1920s
- 53 by 27-inch pipe-in-pipe section constructed in 1965
- Project is in design phase
- Severity of the deficiencies and capacity issues will require a different approach
