Business Item 2024-229

Ratification of Procurement After the Fact for Service Water Hydrant Repair and City Water Main

Environment Committee: October 22, 2024

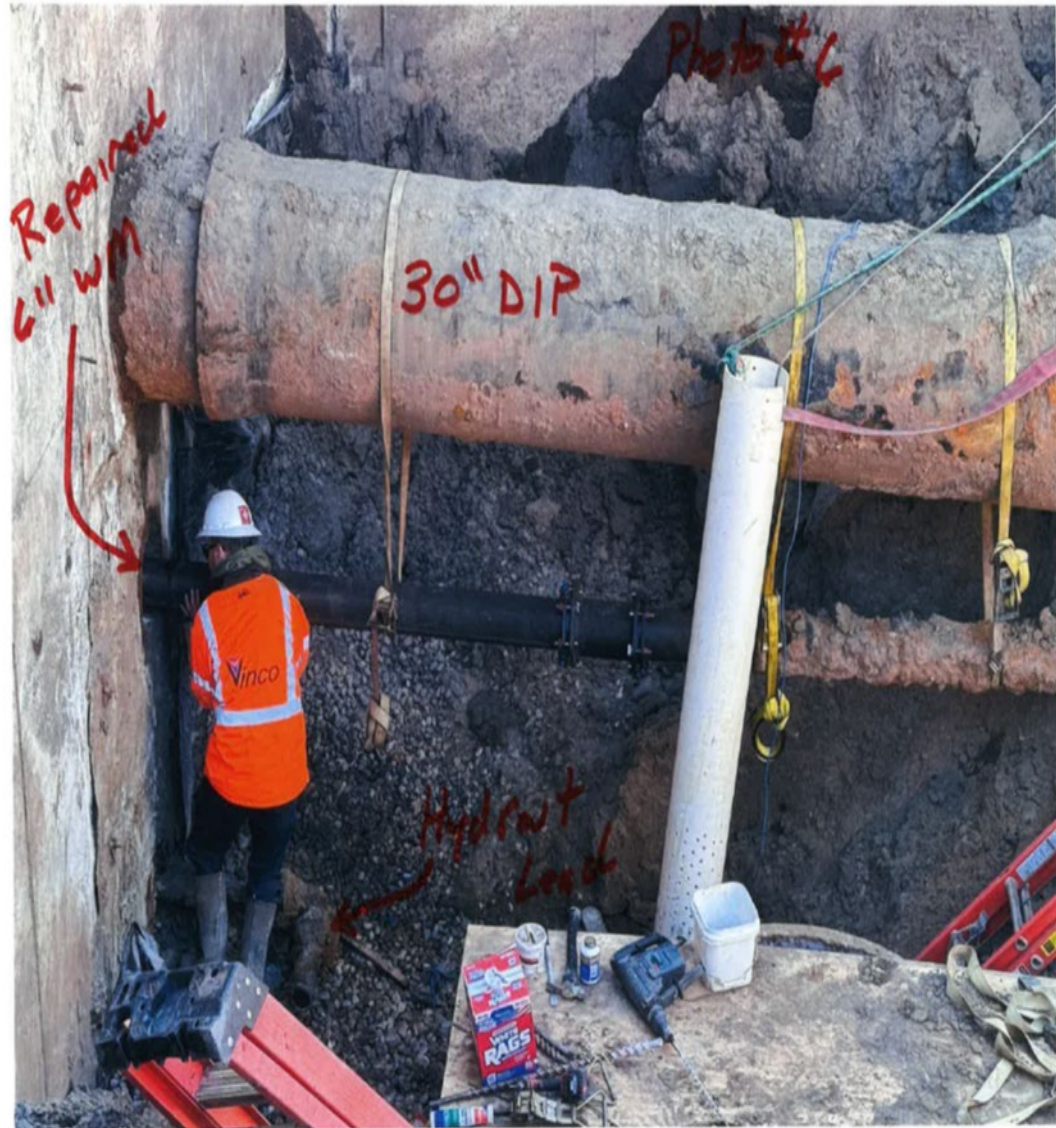
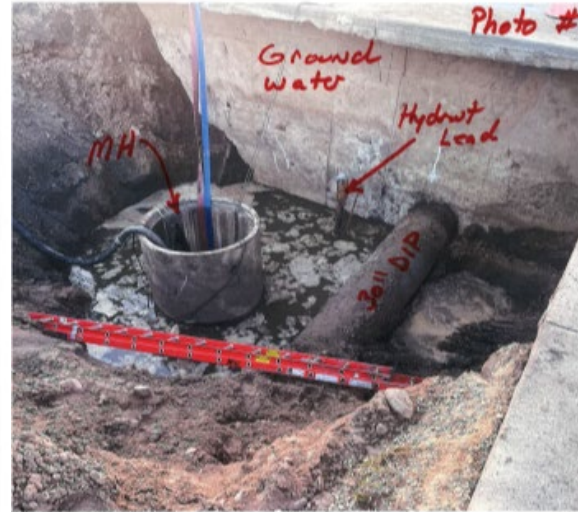
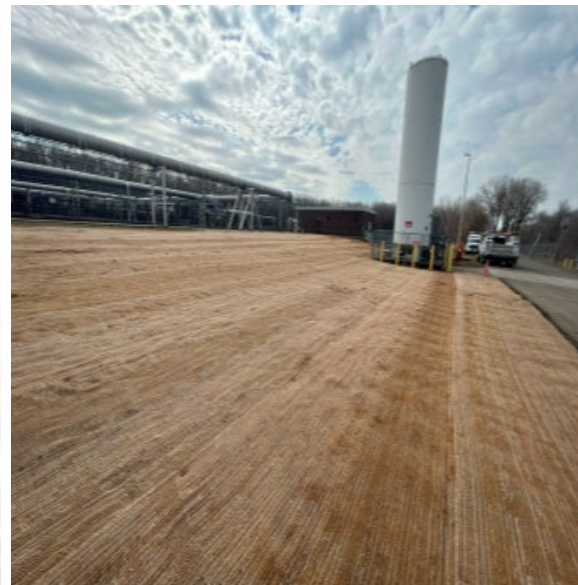
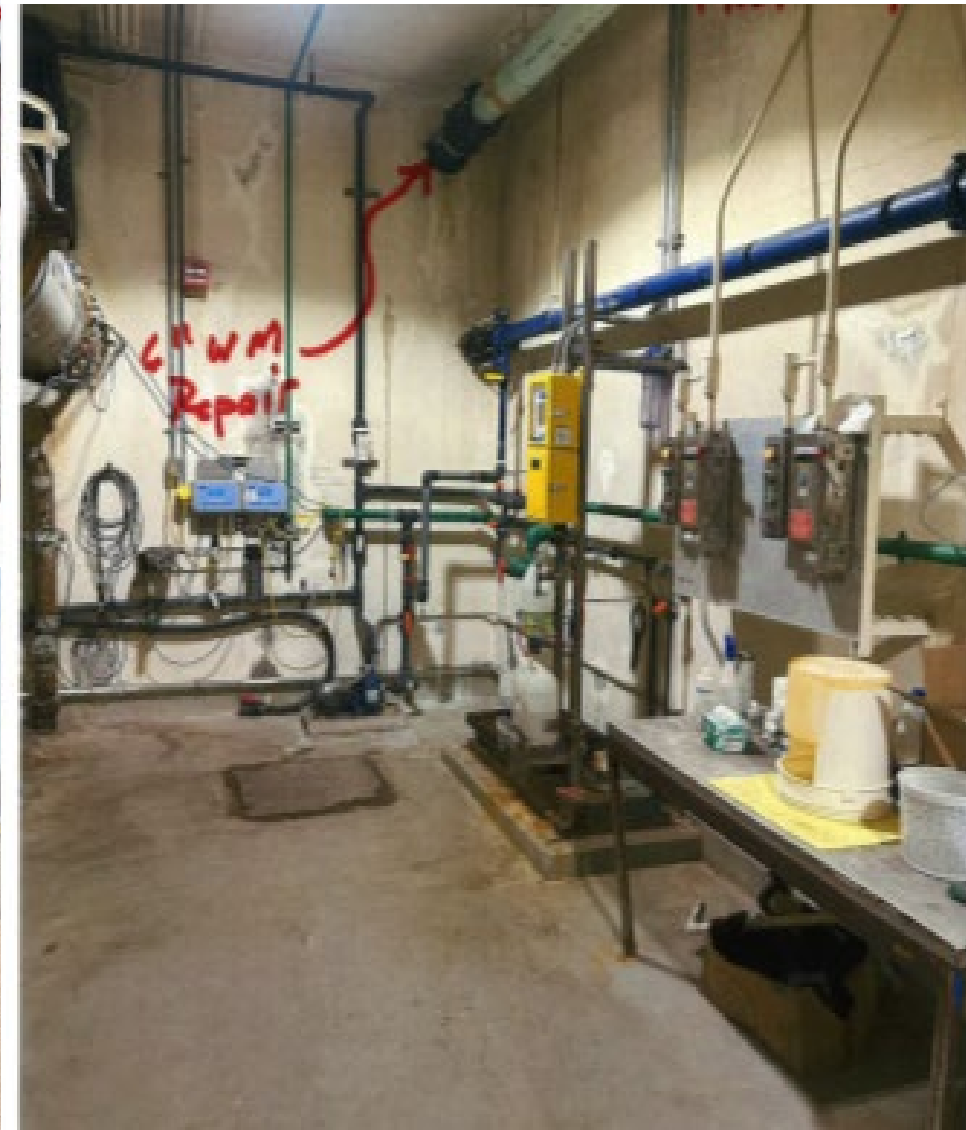
Additional Supporting Photos

- Locates were scheduled and only identified the 3" yard hydrant line. Locates did not detect 30" (Ductile Iron Pipe) DIP, 2 – 2" conduits running parallel under sidewalk, or the 6" city water main located directly under the 30" DIP
- Once excavation started, water filled the hole almost immediately
- Large pumps were supplied by the contractor but were not able to keep up with the flow of water. At this point it was decided to utilize plant groundwater pumps to pump water from the site
- The plant pumps were able to pump down the excavation site and the utilities were uncovered and discovered that the city water main was cracked and rotted at the tank wall

- As the excavation deepened, it also grew in width to prevent engulfment of crew. Safety was a high priority on this job as wet soil continued to collapse in on the hole
- Larger excavation equipment was needed to reach the depth of where the repairs were needed to be made
- A 48" diameter manhole access needed to be unstacked for the backhoe to reach the city water pipe
- For future excavations, utilities tape was laid over piping at required heights and plant drawing are being updated
