ACTION TRANSMITTAL No. 2013-34

SUBJECT: Scope Change Request for Bridge No. 9 over the Mississippi River at the University of Minnesota

CITY OF MINNEAPOLIS PROJECT NO. SP 141-090-038
BRIDGE NO. 9 OVER MISSISSIPPI RIVER AND WEST RIVER PARKWAY

Attachment J – Condition Study Report: Bridge No. 9 Pedestrian Bridge Over Mississippi River

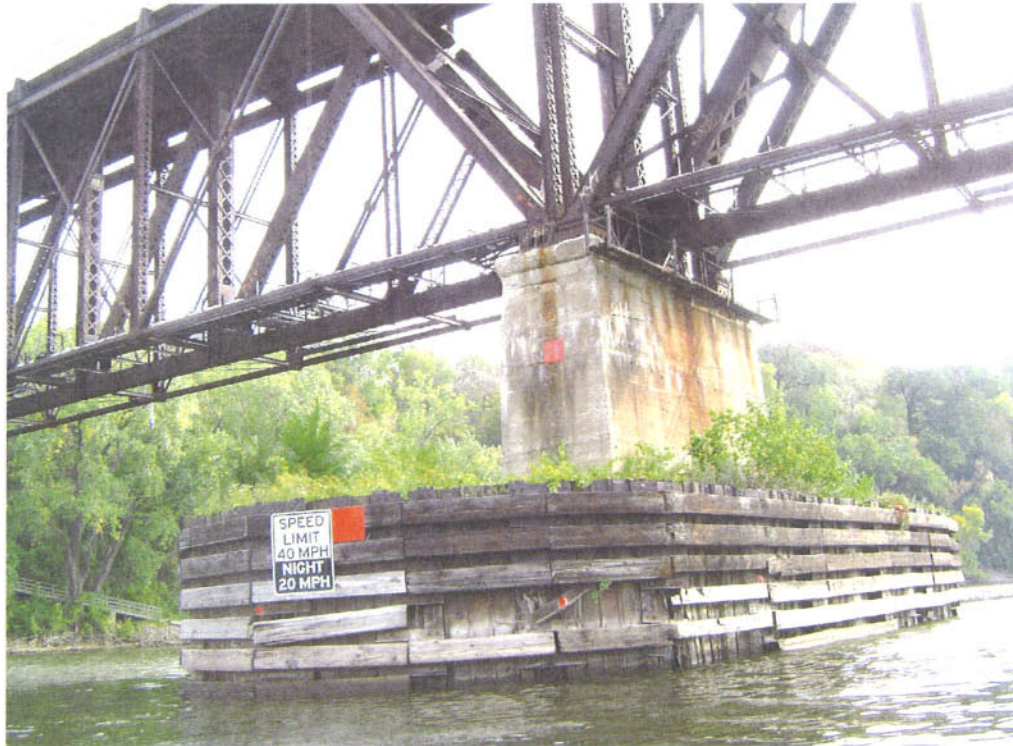
Looking Towards River Pier Fender of Bridge No. 9

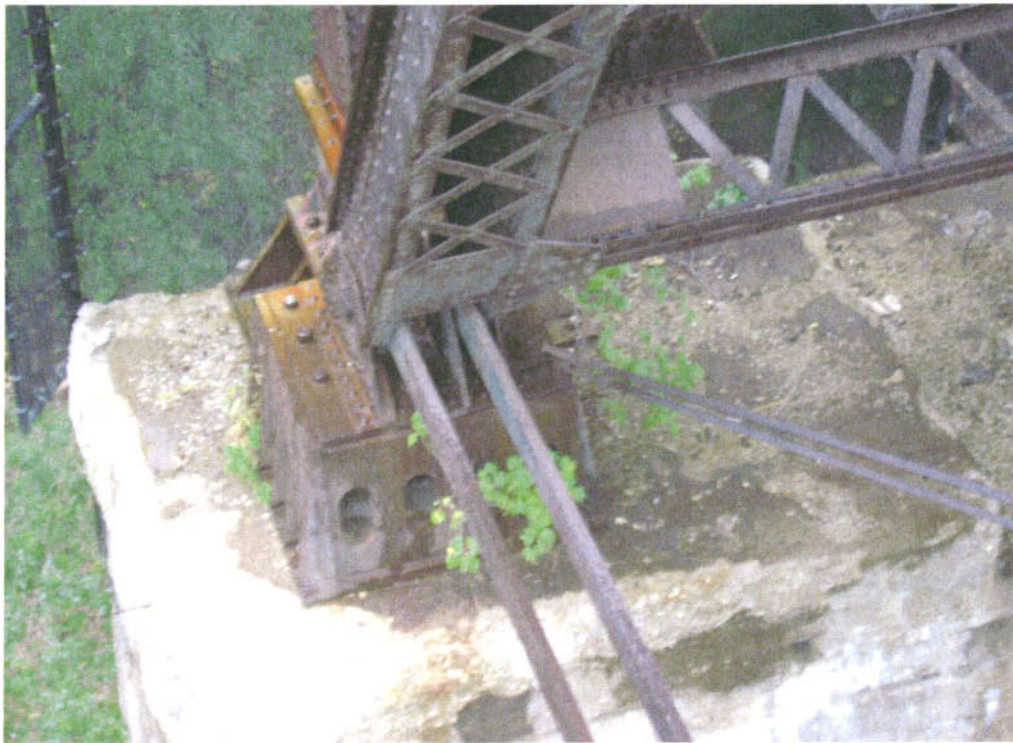
Truss Bearing of Bridge No. 9

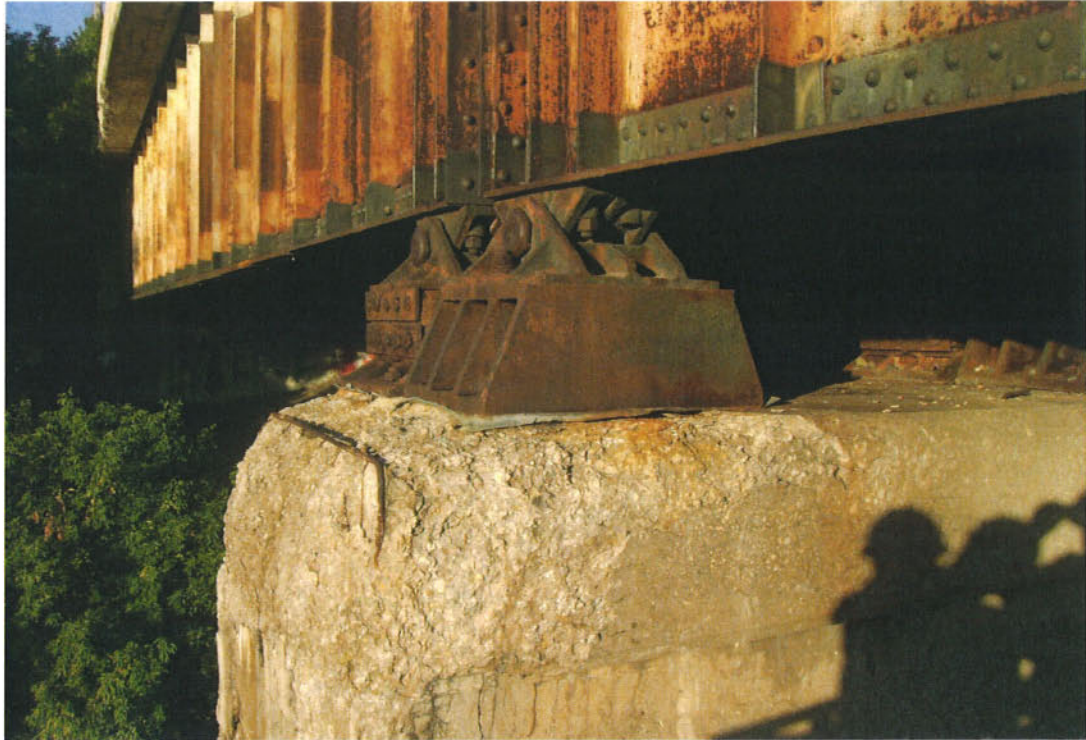
Looking Towards West Approach Span Bearings at Pier 7 of Bridge No. 9

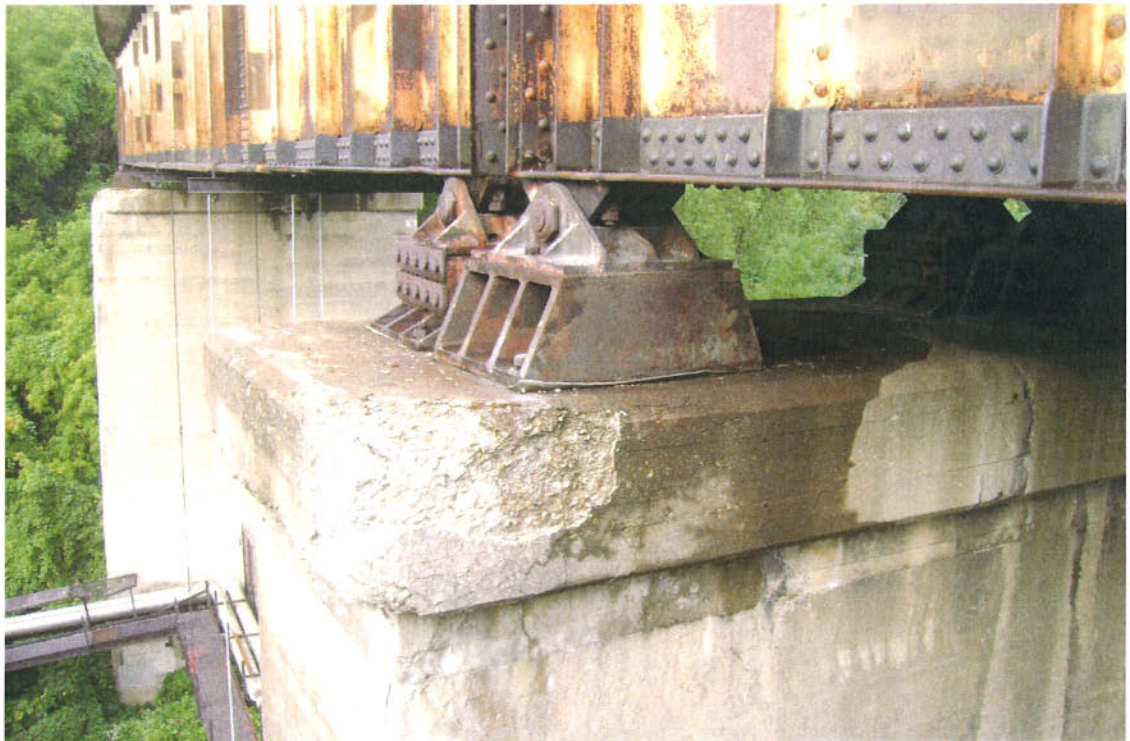
Looking Towards West Approach Bearings at Pier 6 of Bridge No. 9

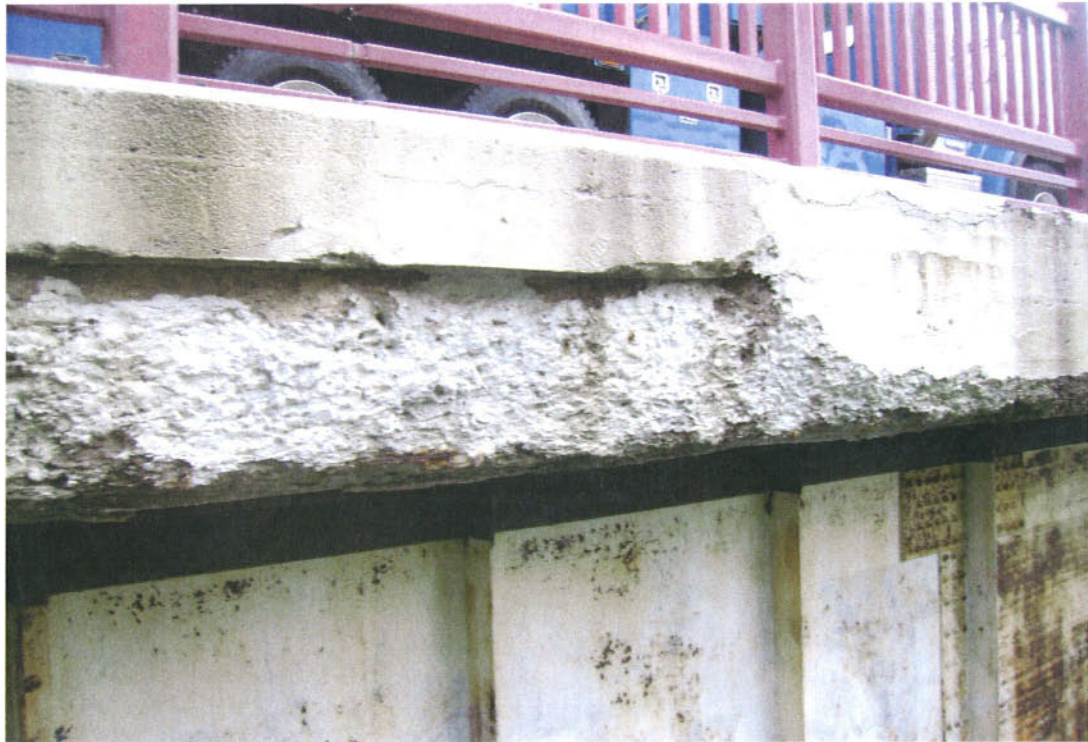
Looking Towards South Deck Edge in End Span of Bridge No. 9

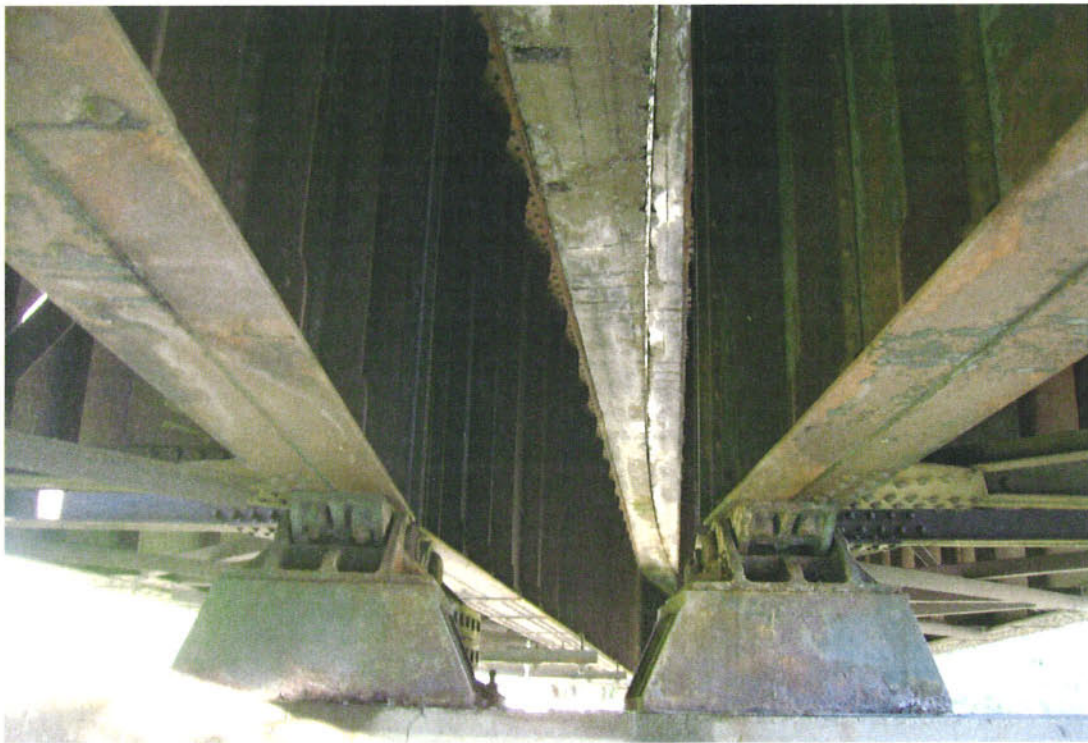
Center Deck Joint at West Approach Span of Bridge No. 9

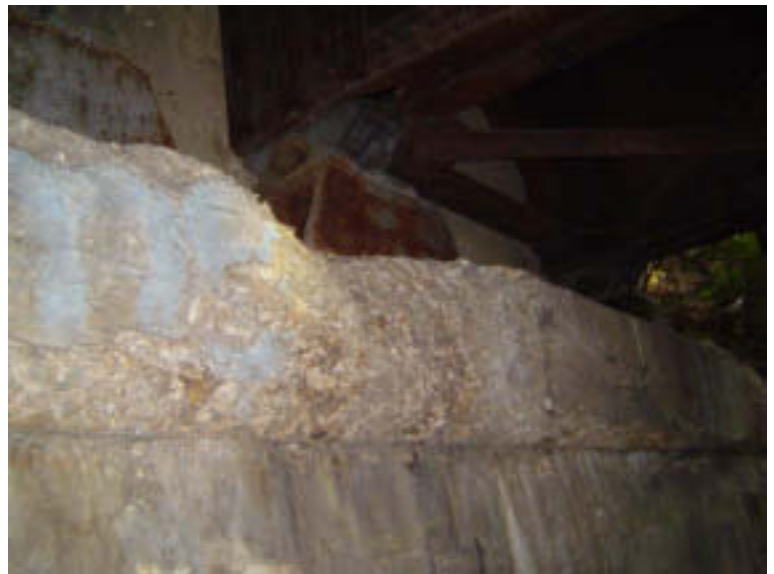
Abutment 1: Abutment Seat

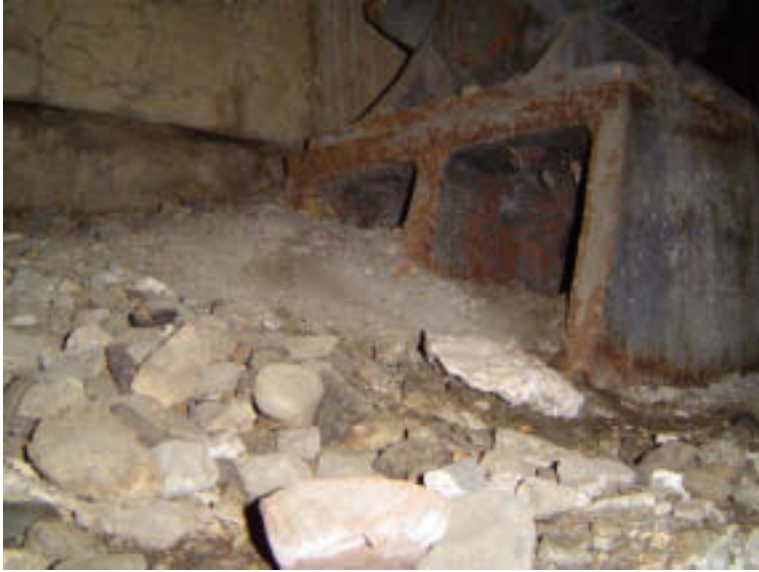
Abutment 1: Abutment Seat

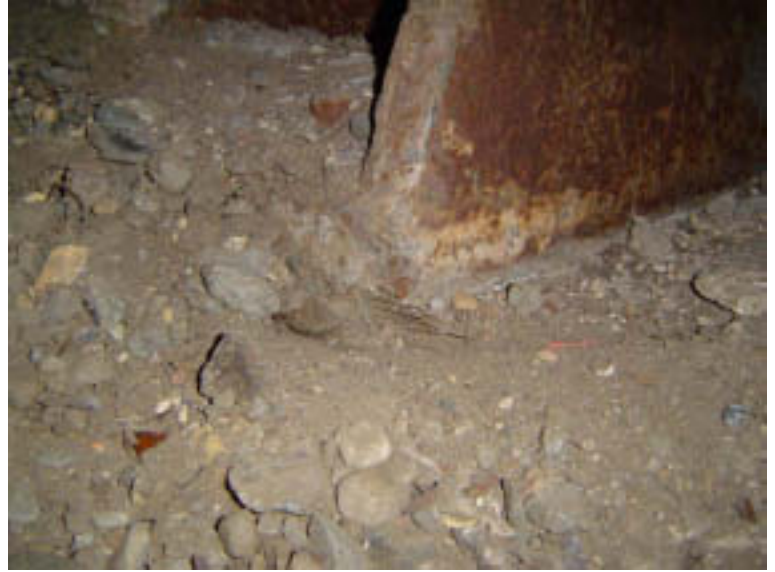
Abutment 1: Abutment Seat

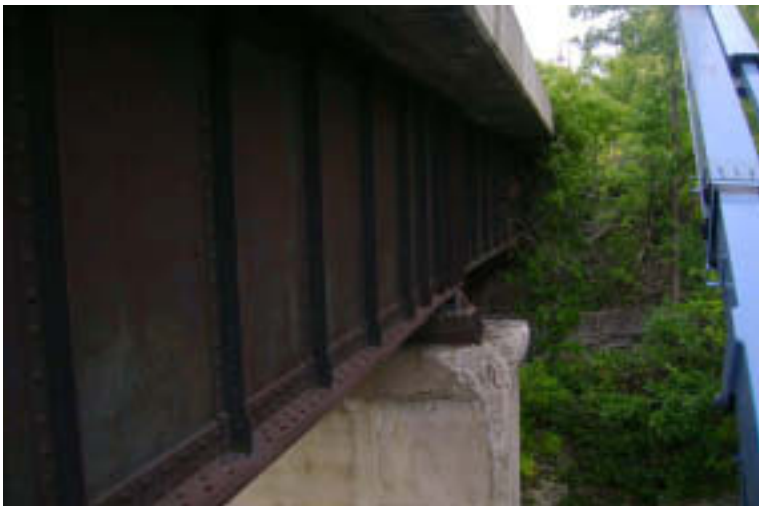
- The concrete surfaces at the ends of the caps for Piers 2 to 7 are deteriorated due to weathering and scaling. Reinforcing bars are exposed at a few pier locations. However, the concrete surfaces under the bearings are not affected to date.

Pier 2: Pier Cap

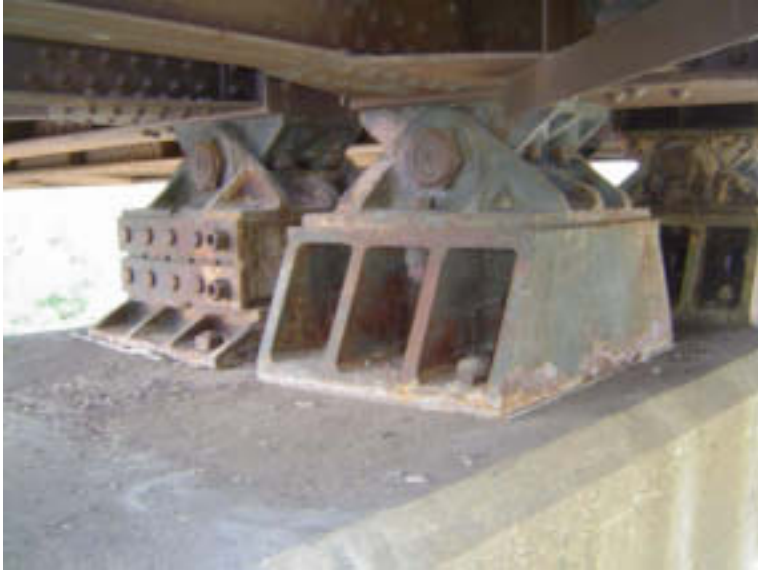
Pier 6: Pier Cap Deterioration

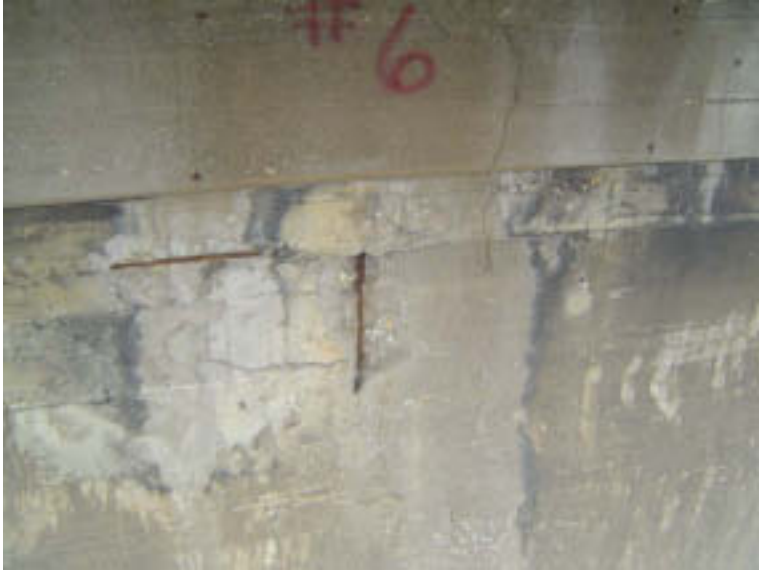
Pier 6: Exposed Reinforcement Below Cap

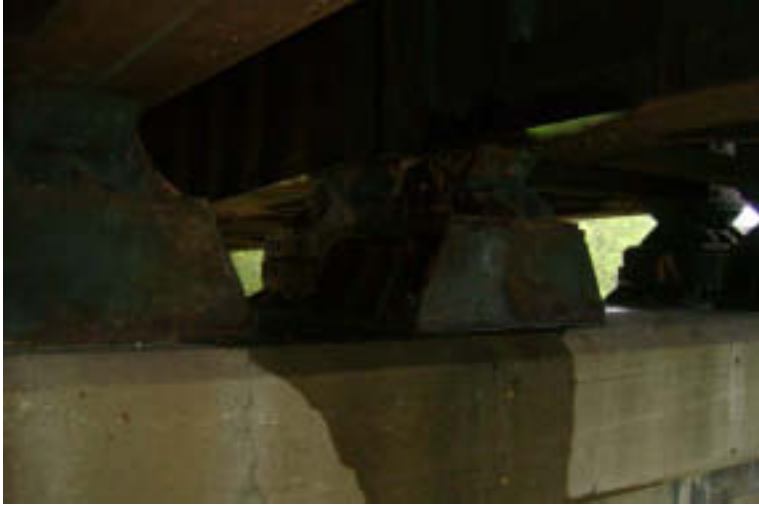
Pier 6: Pier Cap and Bearing

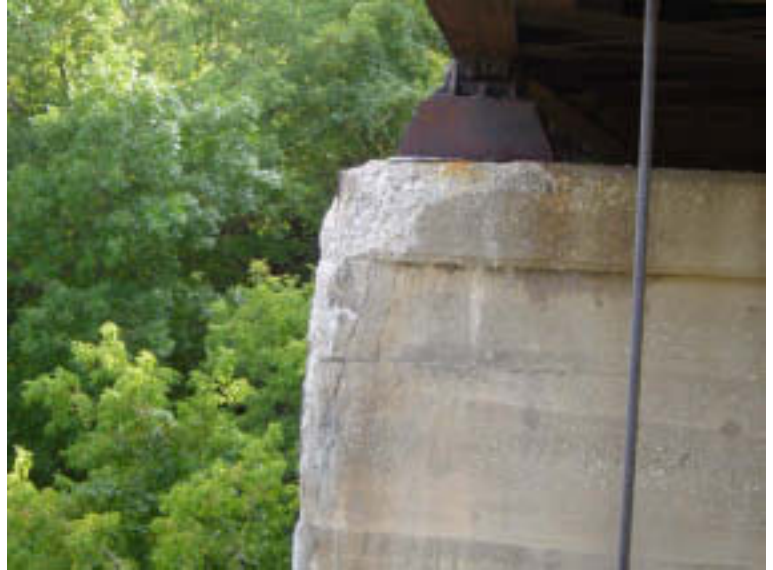
Pier 6: Drainage on to Pier from Deck

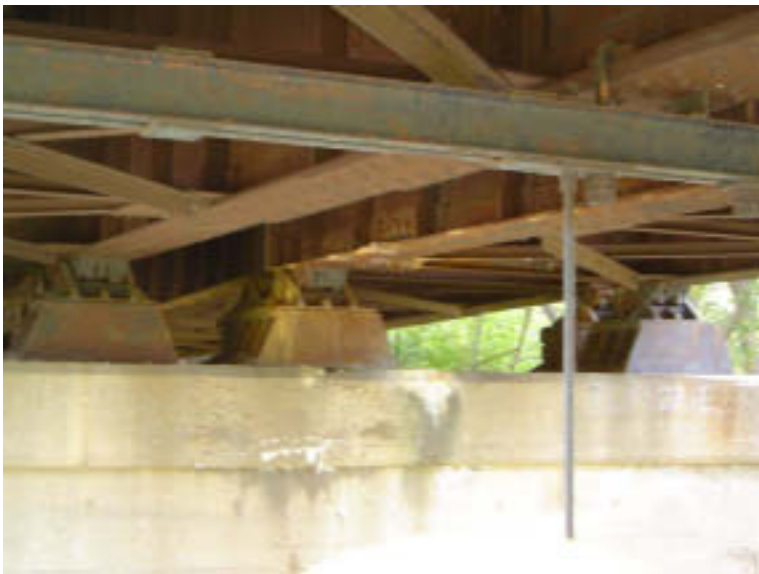
Pier 7: Pier Cap

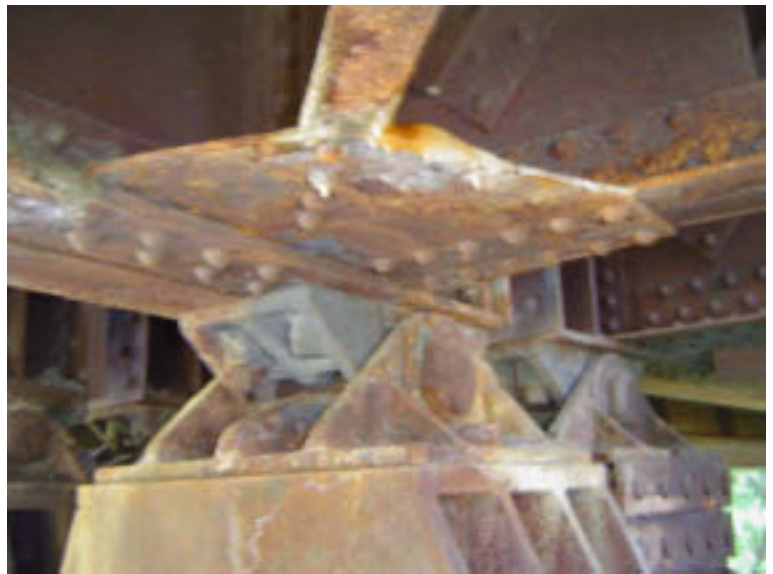
Pier 7: Pier Cap

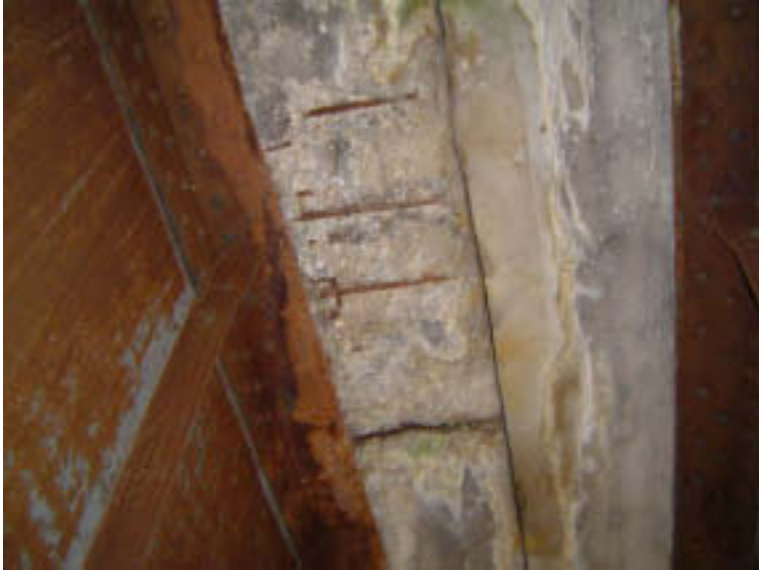
Span 2: Soffit

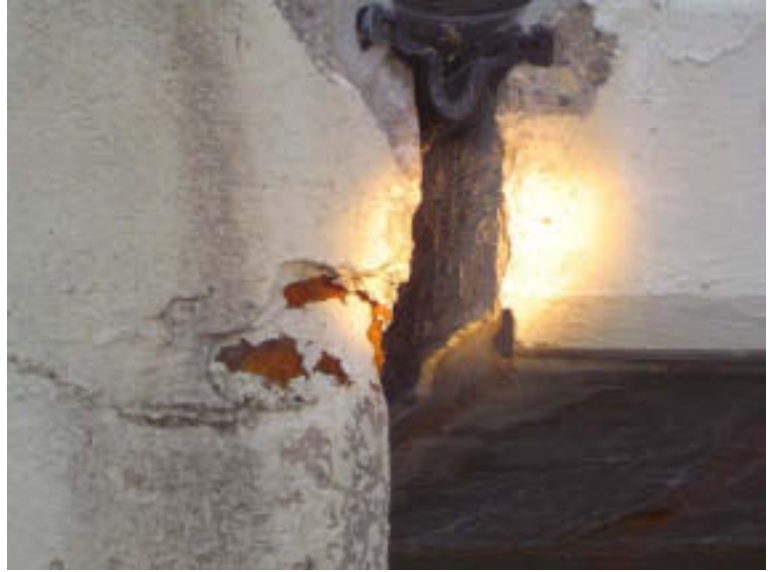
Span 2: Exposed Reinforcement

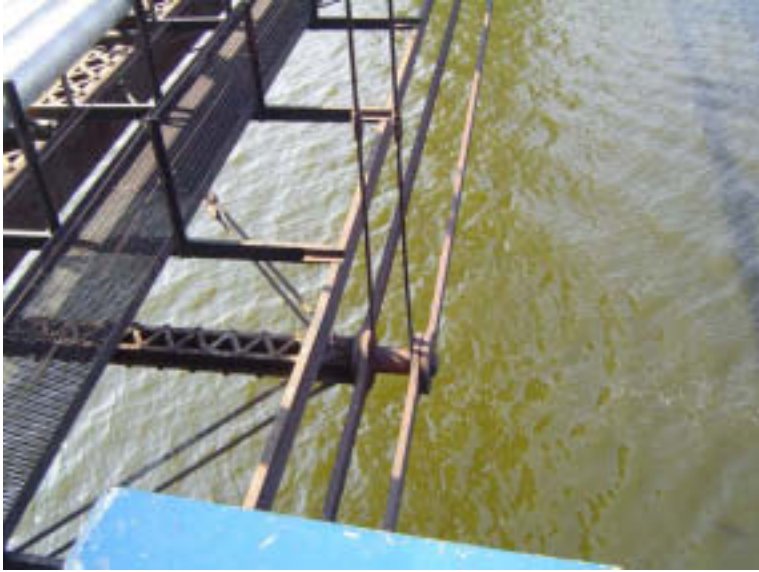
Span 2: Staining from Drainage

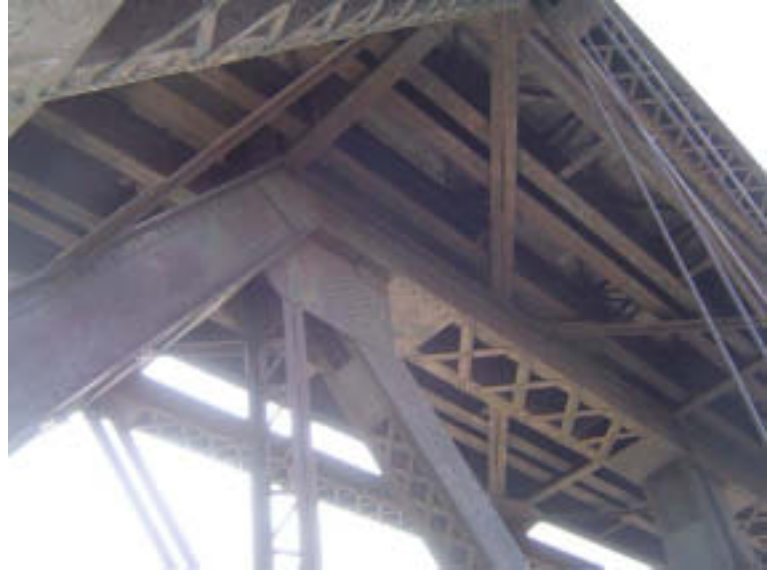
Span 3: Bottom Chords

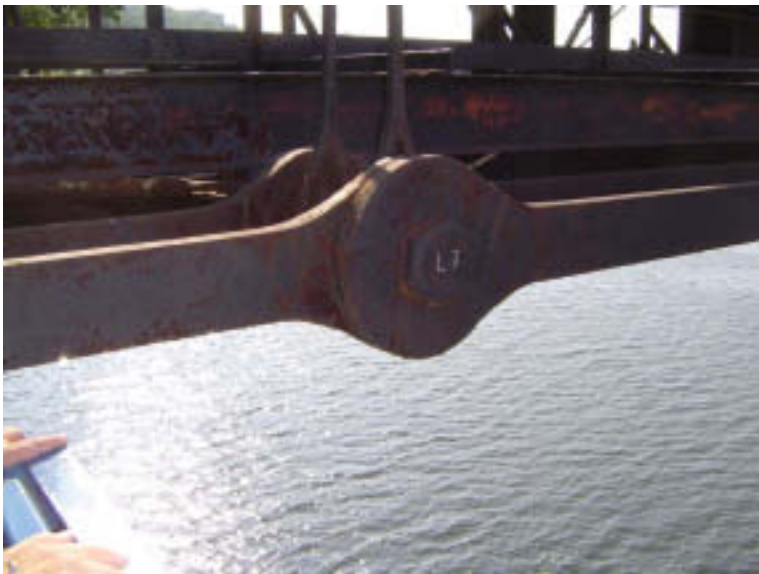
Span 3: Upper Chords

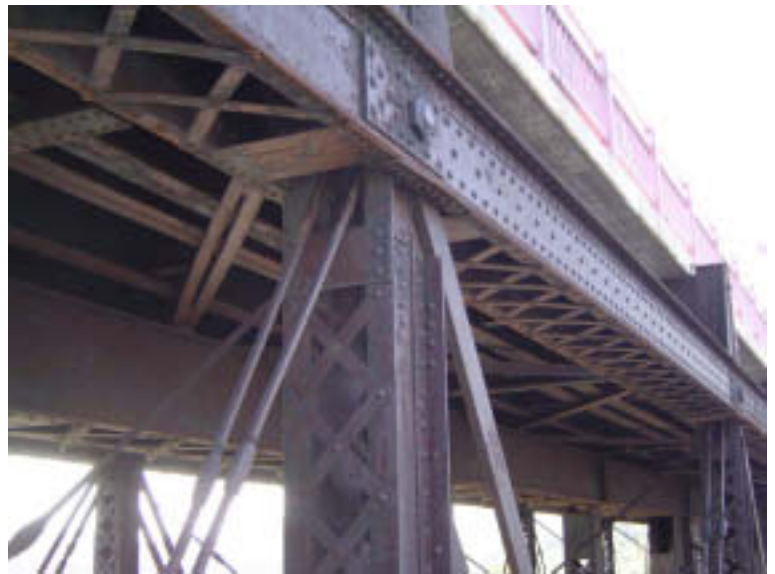
Span 3: Bottom Chords

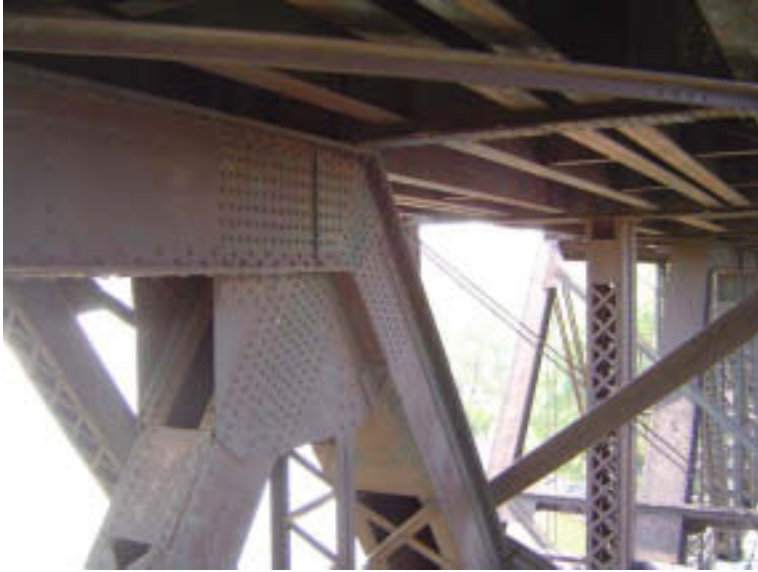
Span 3: Top Chords and Vertical Members

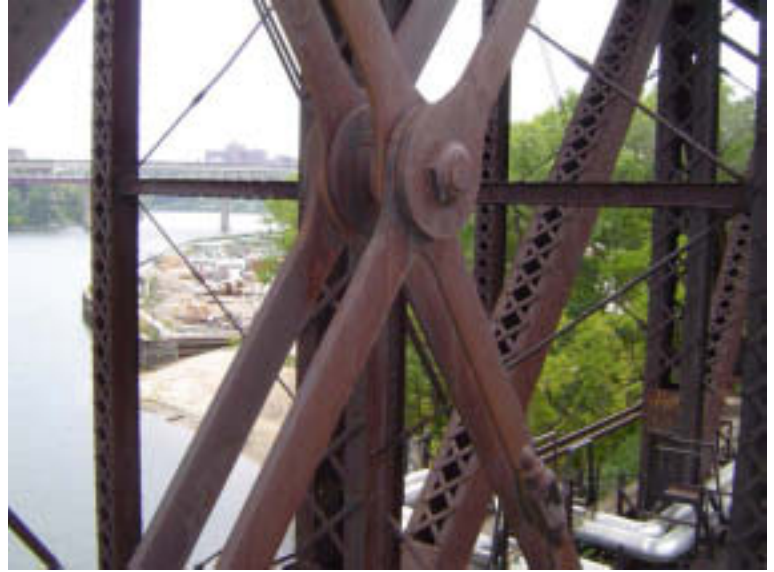
Span 3: Center Truss

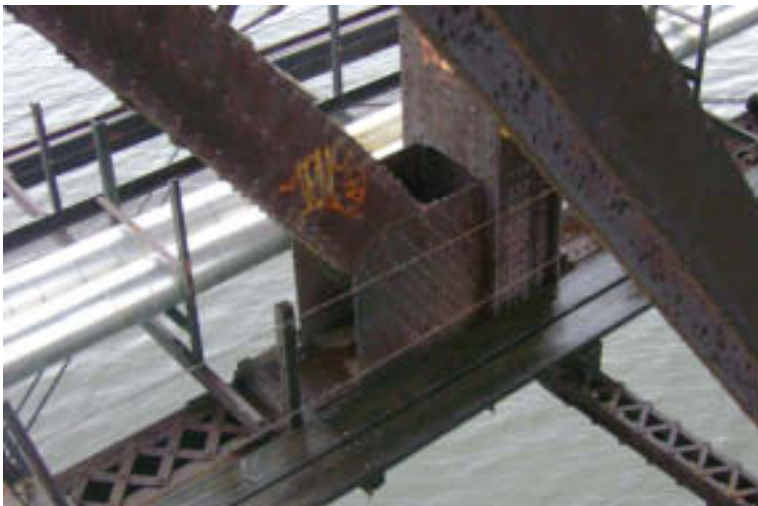
Span 3: Outside Truss Bracing

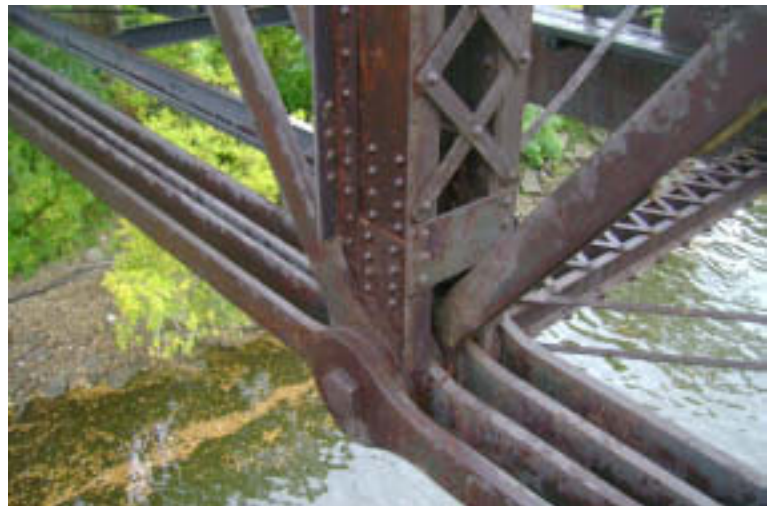
Span 3: Center Truss L1

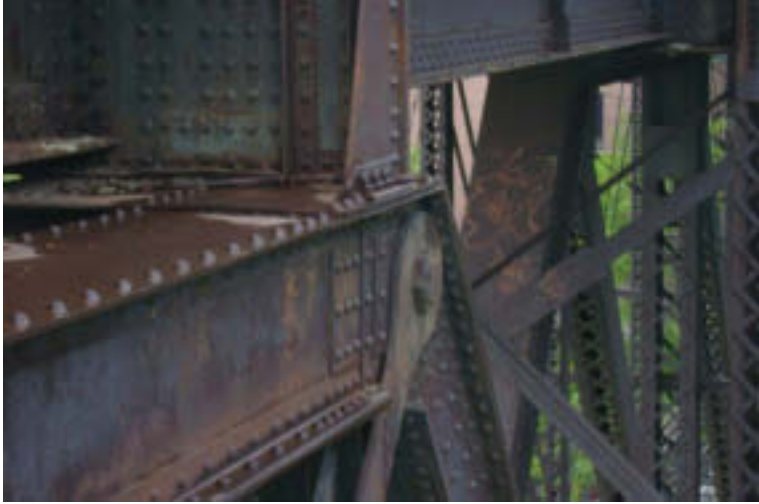
Span 3: Outside Truss L1

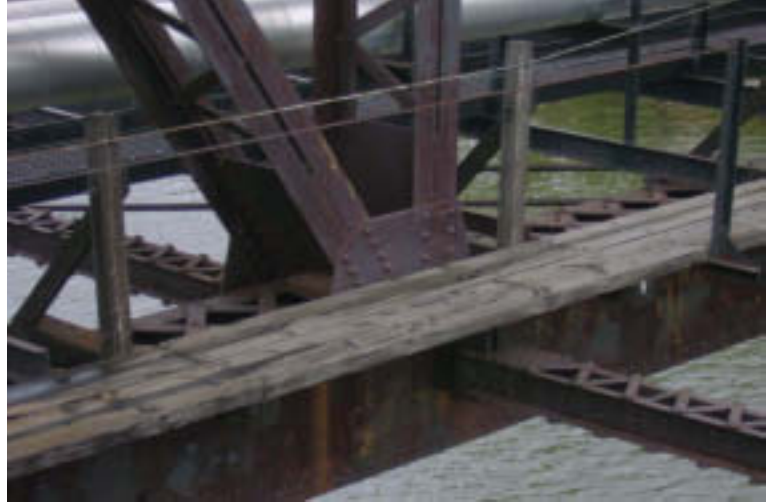
Span 3: Upper Chord

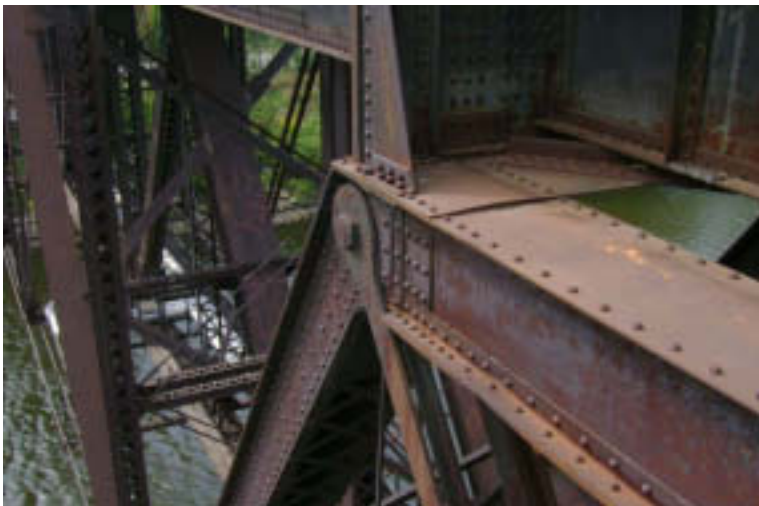
Span 3: Center Truss Lower Connection

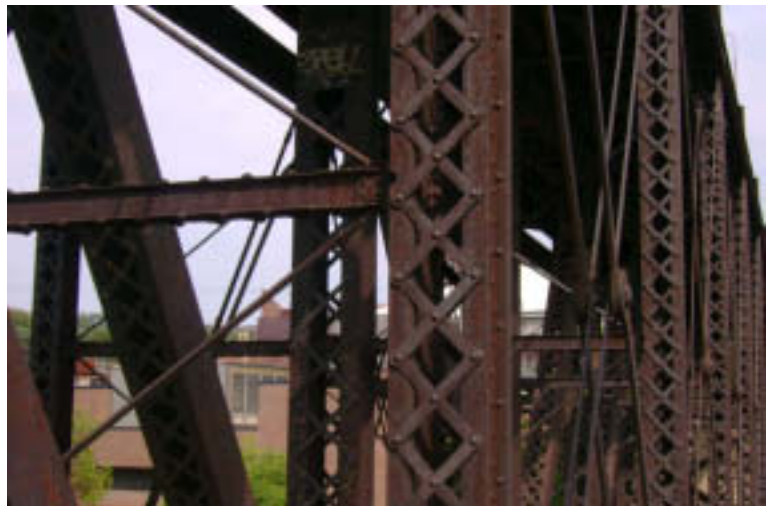
Span 3: Upper Chord and Floor Beam

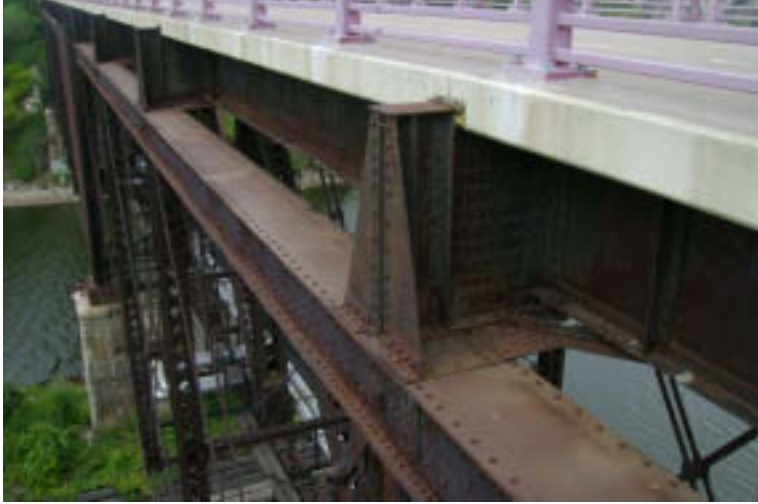
Span 3: Vertical Members

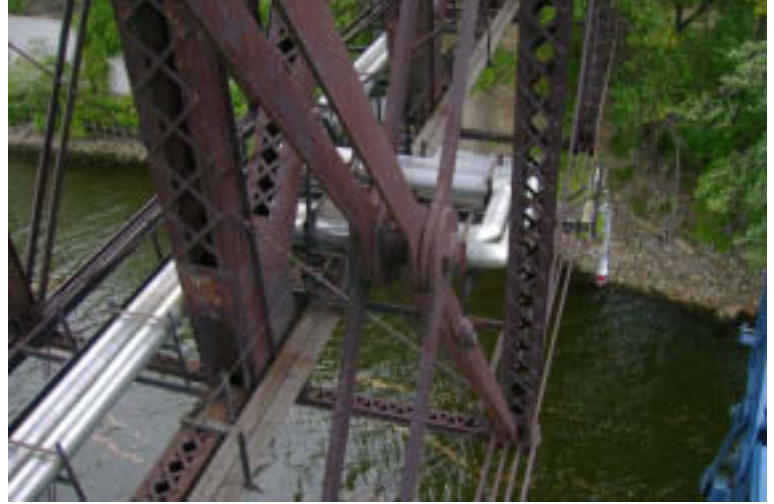
Span 3: Upper Chords

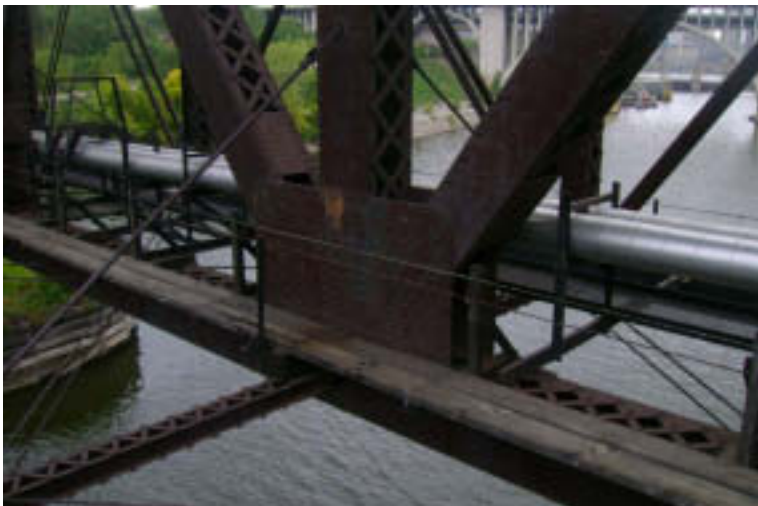
Span 3: Lower Chords

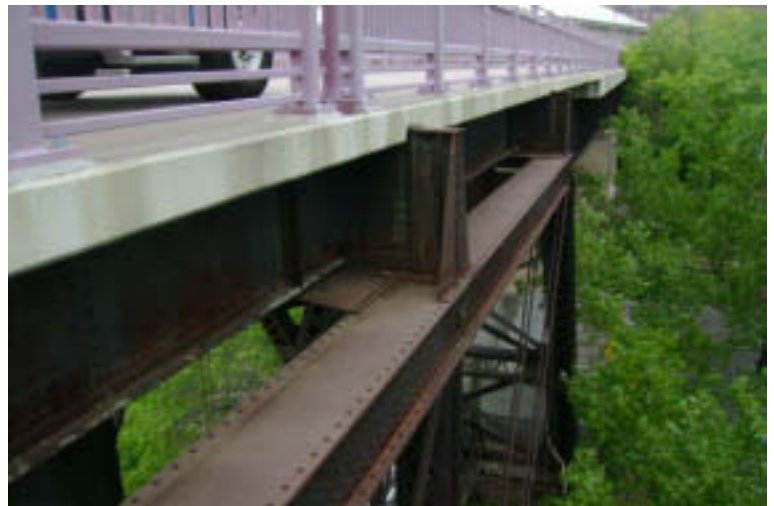
Span 3: Center Truss Lower Connection

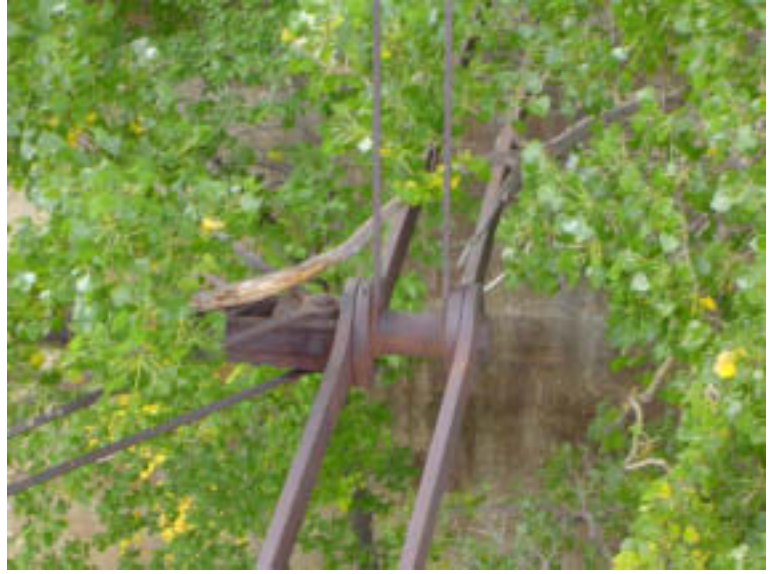
Span 3: Lower Chords

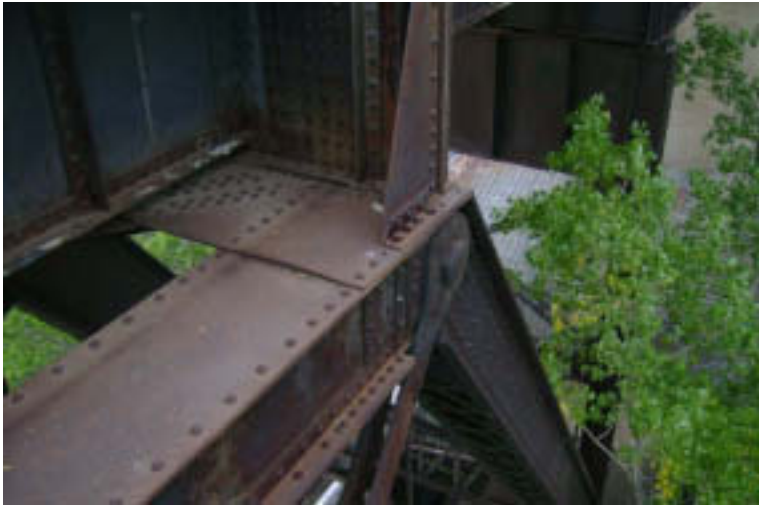
Span 3: Lower Chords

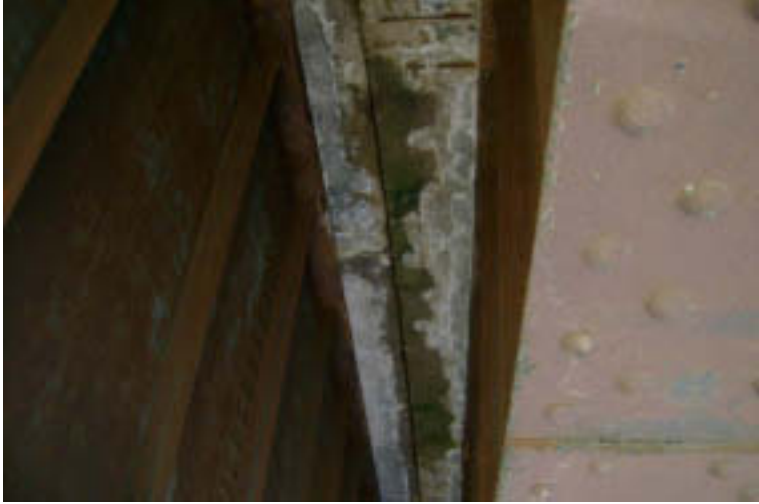
Span 4: Center Truss

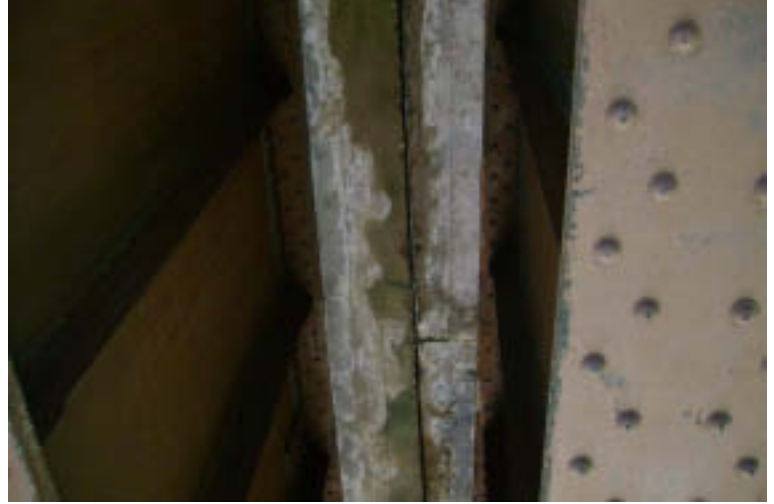
Span 5: Center Line of Deck

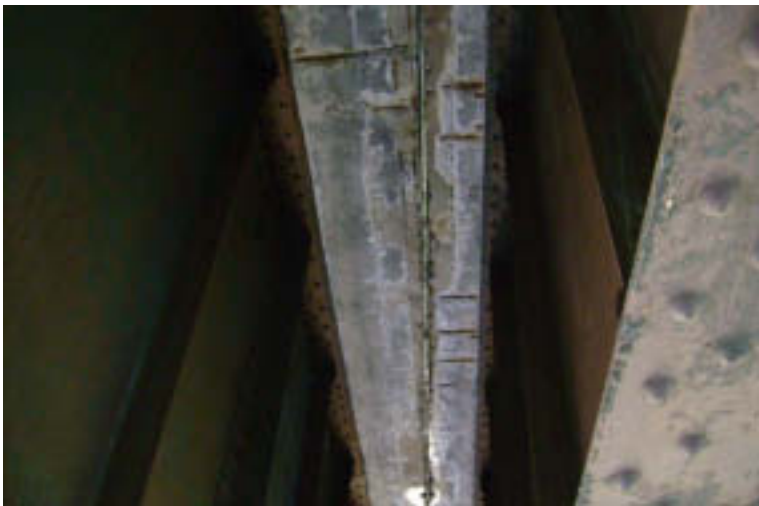
Span 5: Center Line of Deck

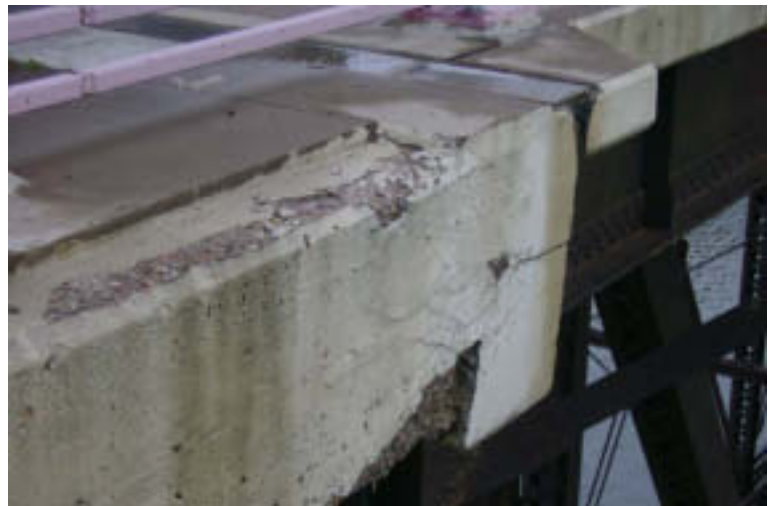
Span 5: Deck and Girder at the Expansion

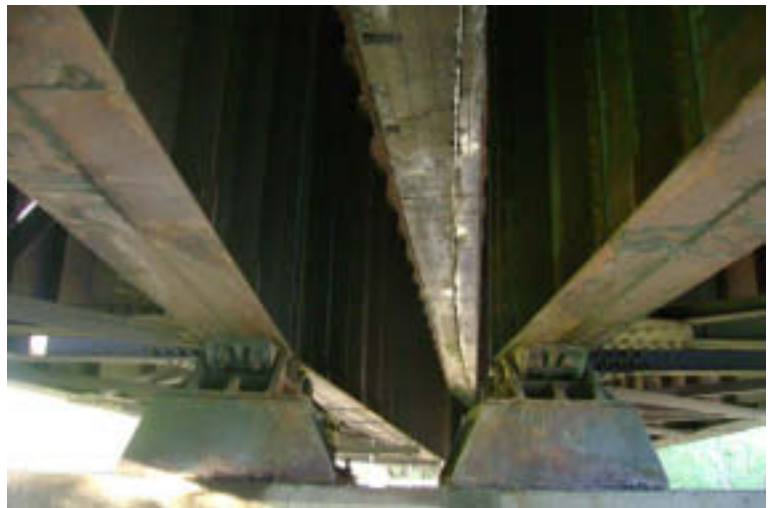
Span 6: Deck Expose Reinforcement

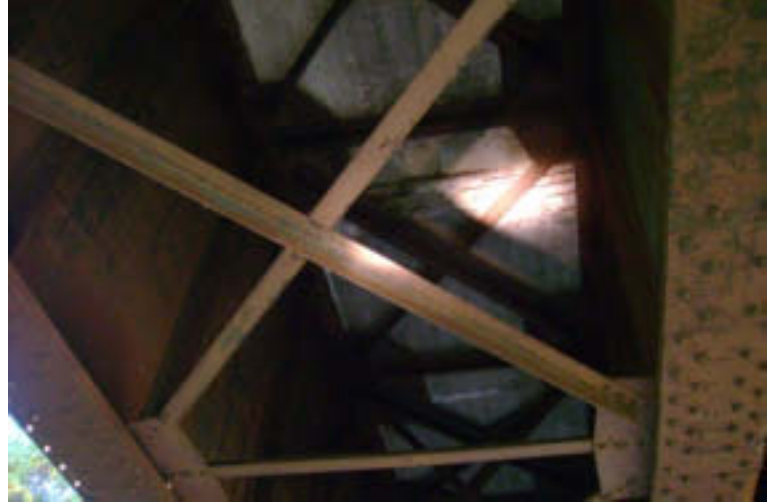
Span 7: Deck Weathering

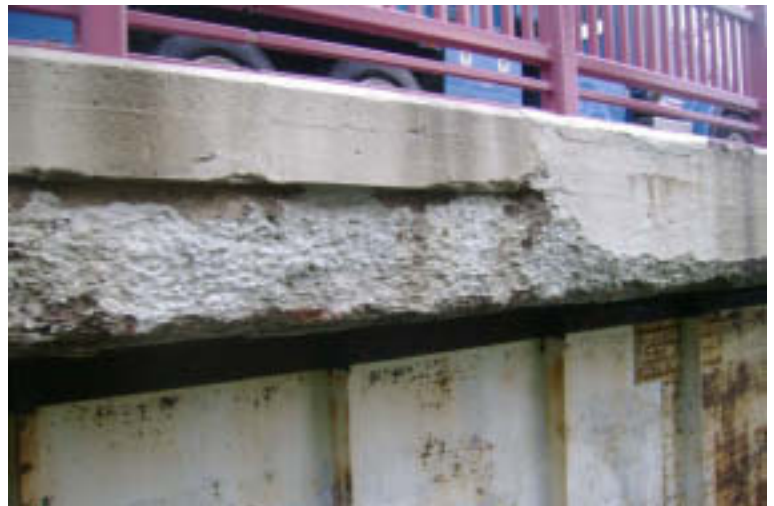
Span 7: Center of the Deck

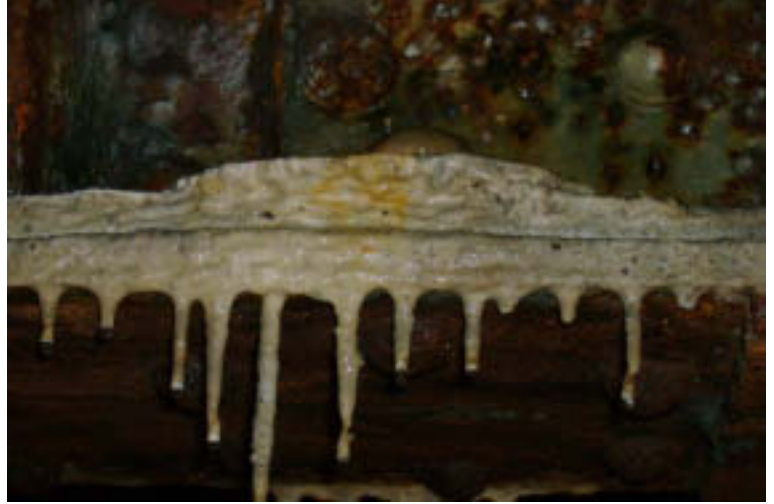
Span 7: Deck

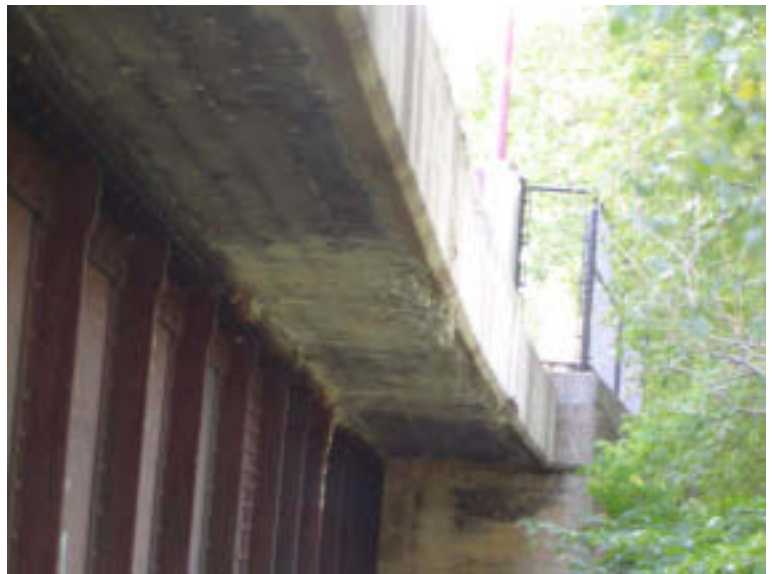
Span 7: Joint near Pier 7

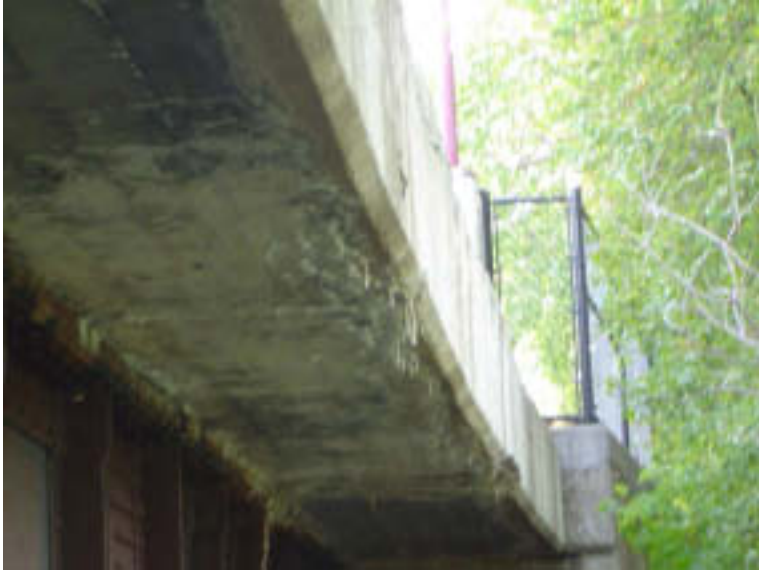
Span 7: Calcium Carbonate Built Up

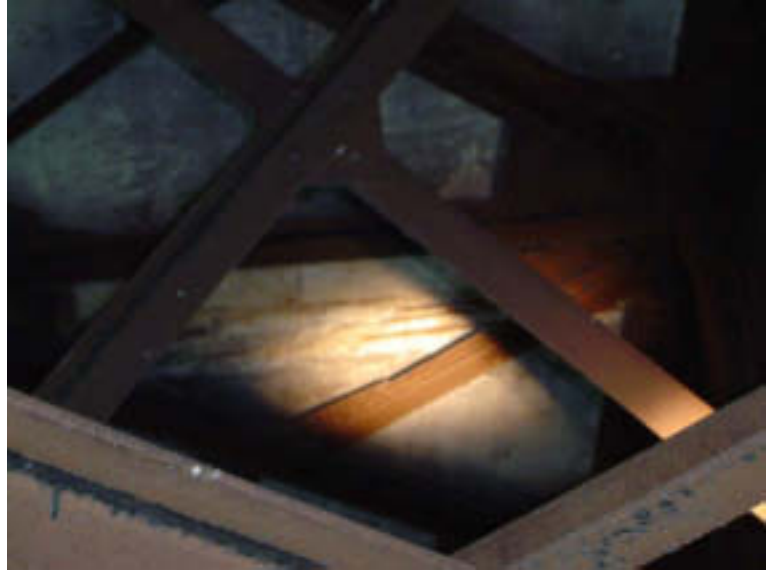
Span 7: Calcium Carbonate Built Up

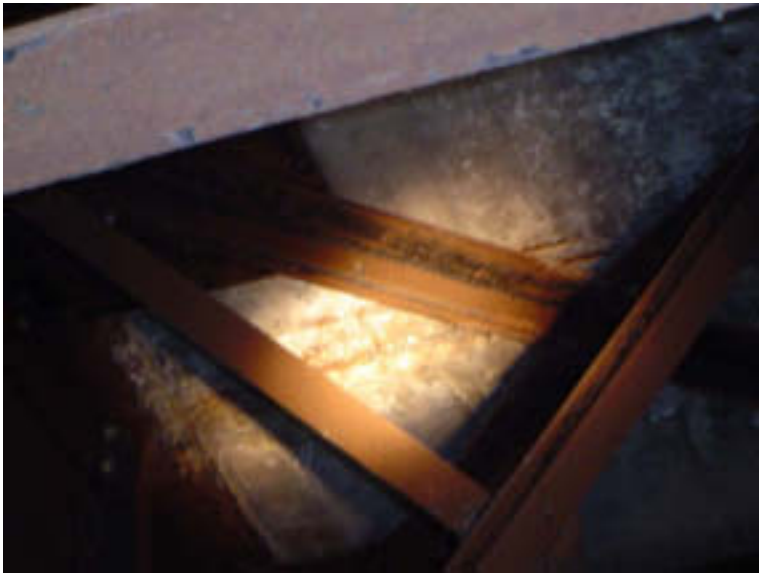
Span 7: Expose Reinforcement
