ACTION TRANSMITTAL No. 2013-34

SUBJECT: Scope Change Request for Bridge No. 9 over the Mississippi River at the University of Minnesota

CITY OF MINNEAPOLIS PROJECT NO. SP 141-090-038
BRIDGE NO. 9 OVER MISSISSIPPI RIVER AND WEST RIVER PARKWAY

Attachment J – Condition Study Report: Bridge No. 9 Pedestrian Bridge Over Mississippi River

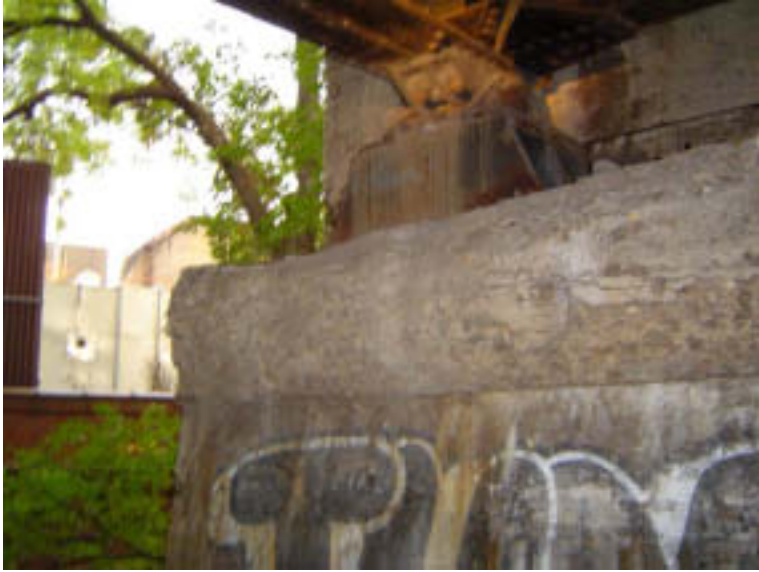
Abutment 1: North Side Bearing

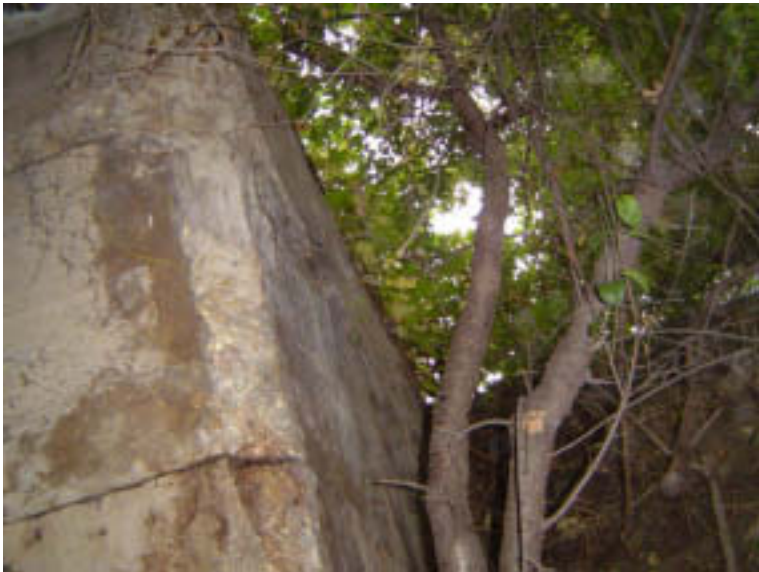
Abutment 1: South Wingwall

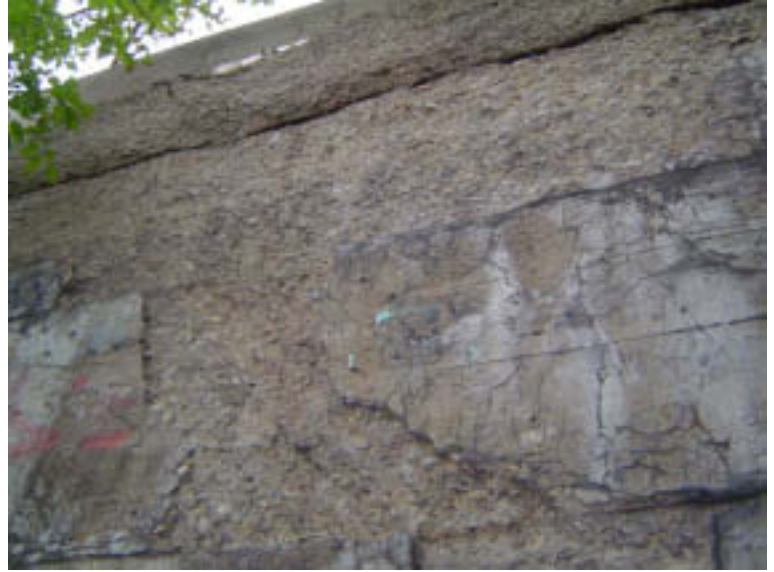
Abutment 1: North Wingwall

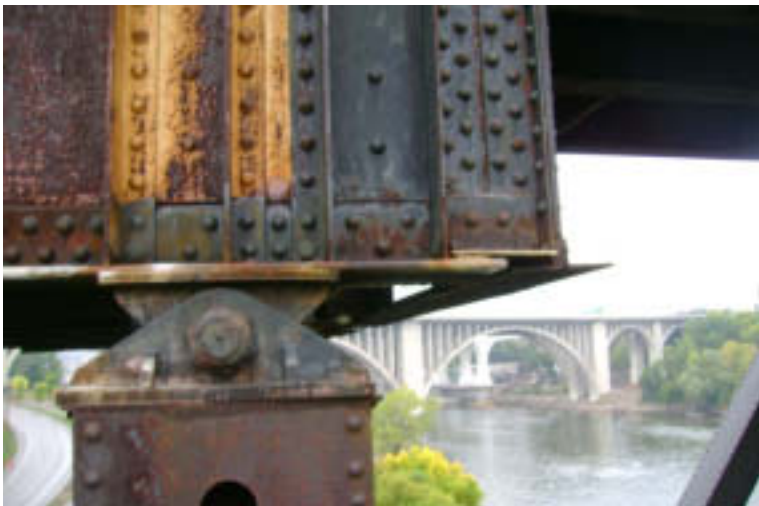
Pier 5: Steel Cap Calcium Carbonate Built Up

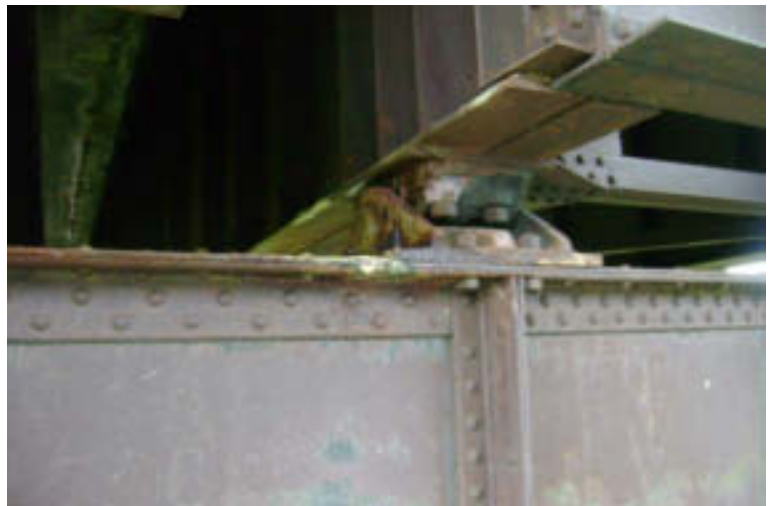
Pier 5: Steel Cap Calcium Carbonate Built Up

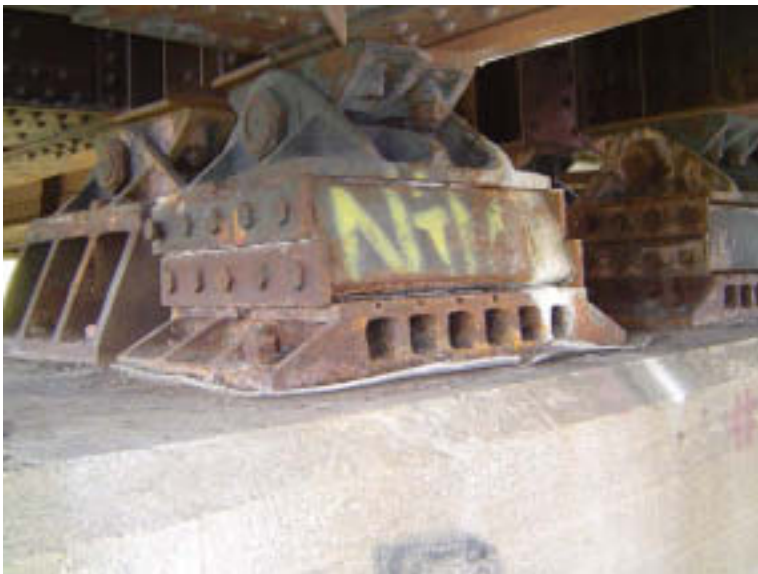
Pier 6: Bearing and Calcium Carbonate

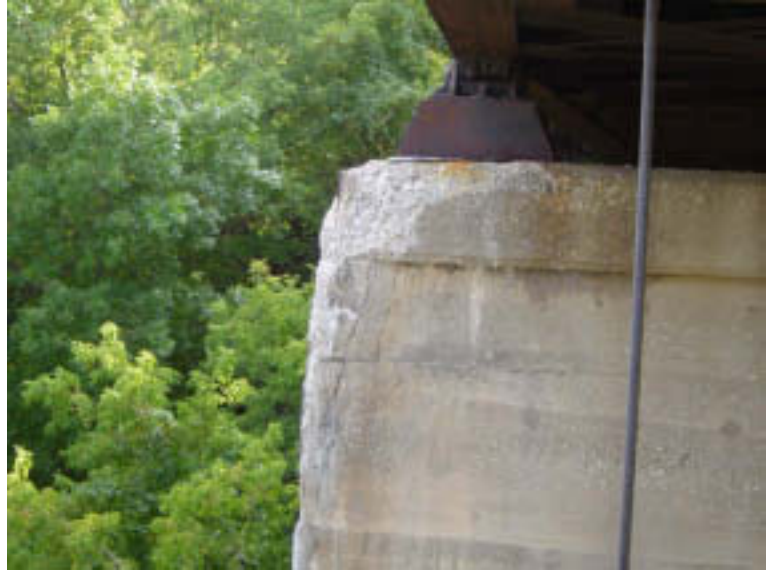
Pier 6: Drainage on to Pier from Deck

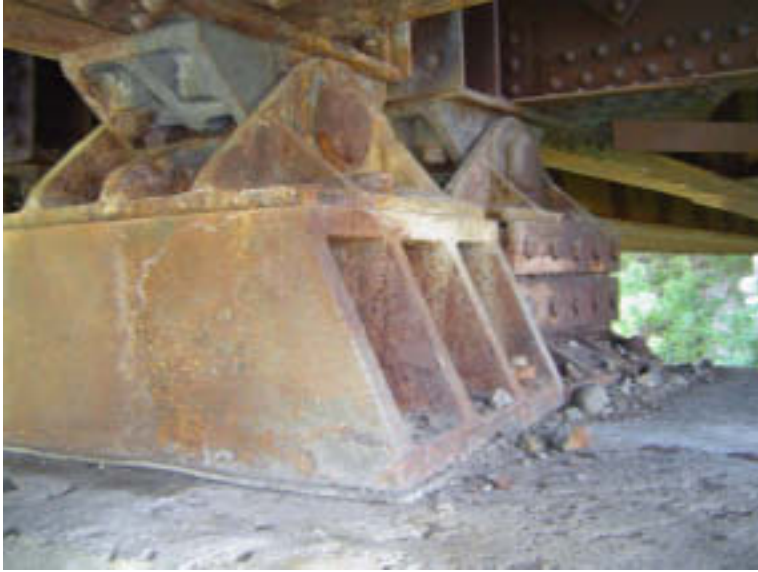
Pier 7: Bearing Calcium Carbonate

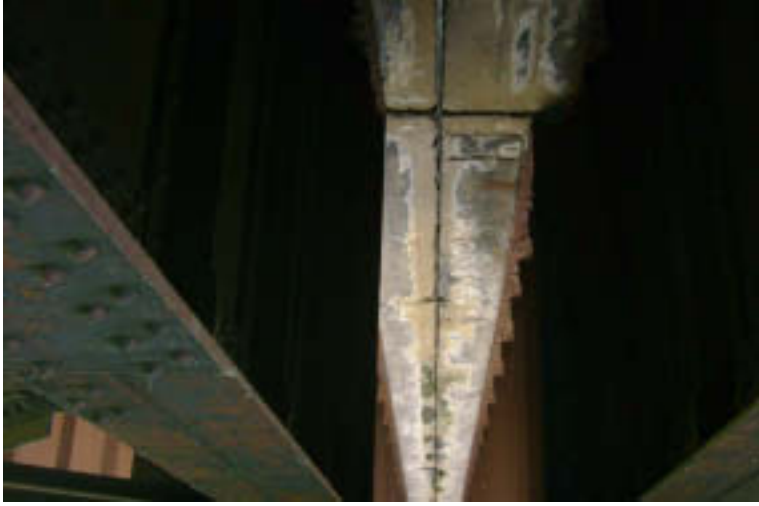
Span 1: Exposed Reinforcement

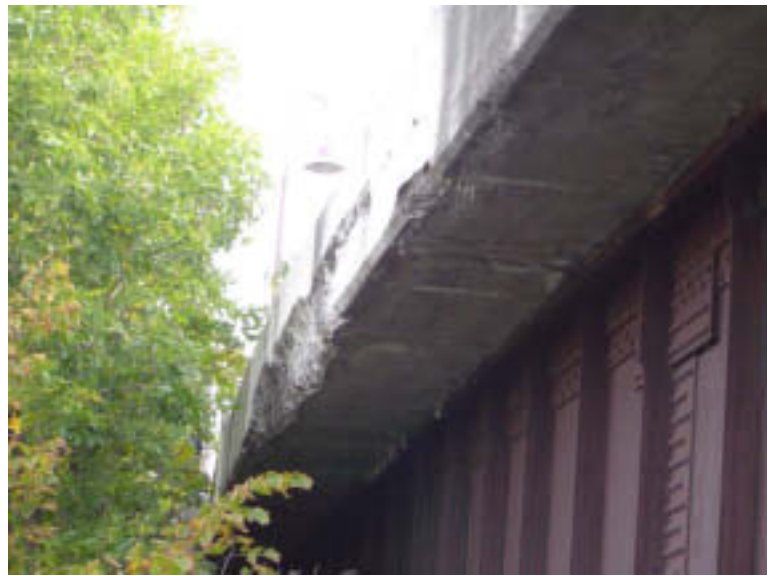
Span 1: Soffit Exposed Reinforcement

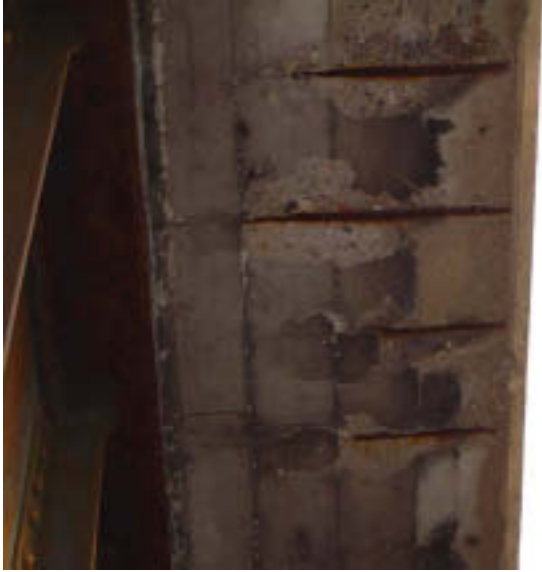
Span 1: Soffit Exposed Reinforcement

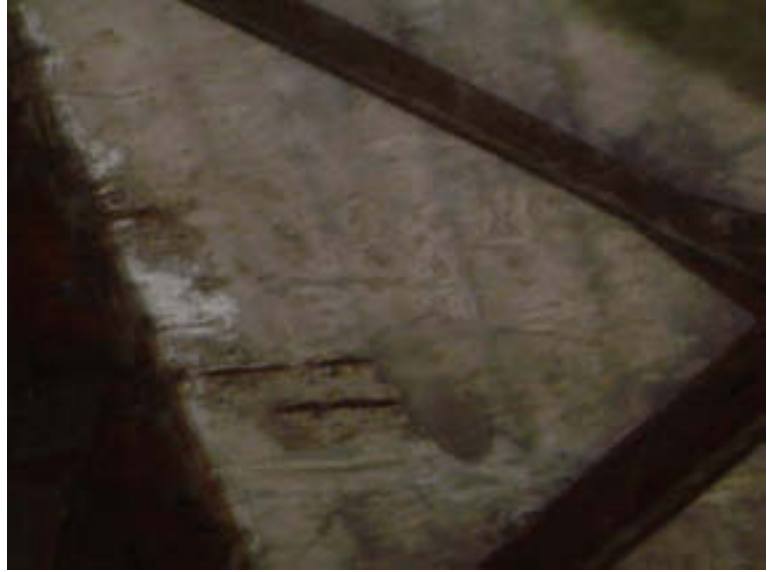
Span 1: Soffit Exposed Reinforcement

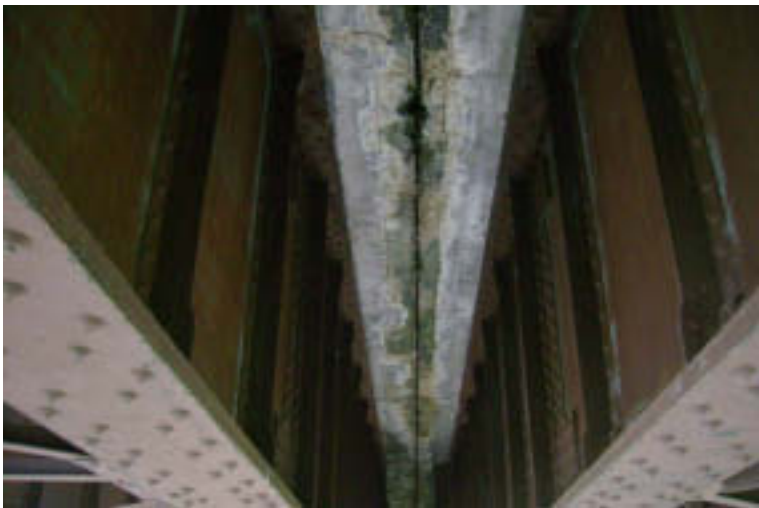
Span 2: Exposed Reinforcement

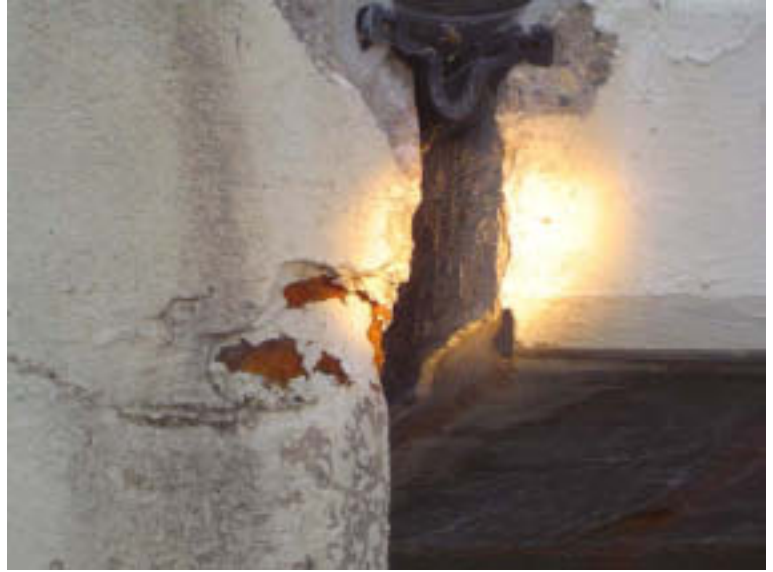
Span 2: Exposed Reinforcement

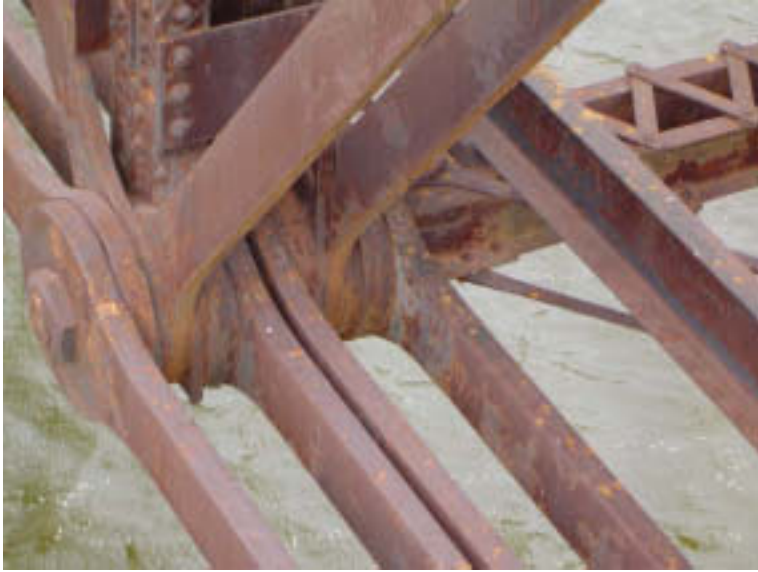
Span 4: Vertical Members

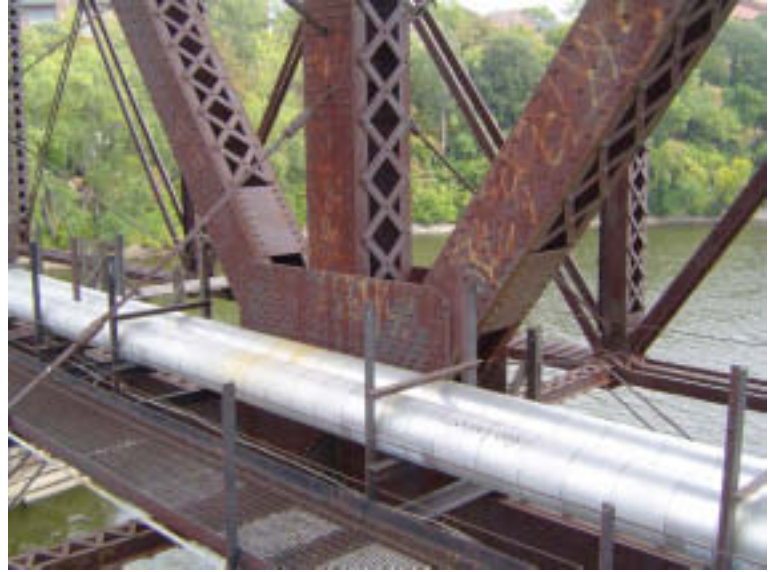
Span 4: Lower Chord Connection

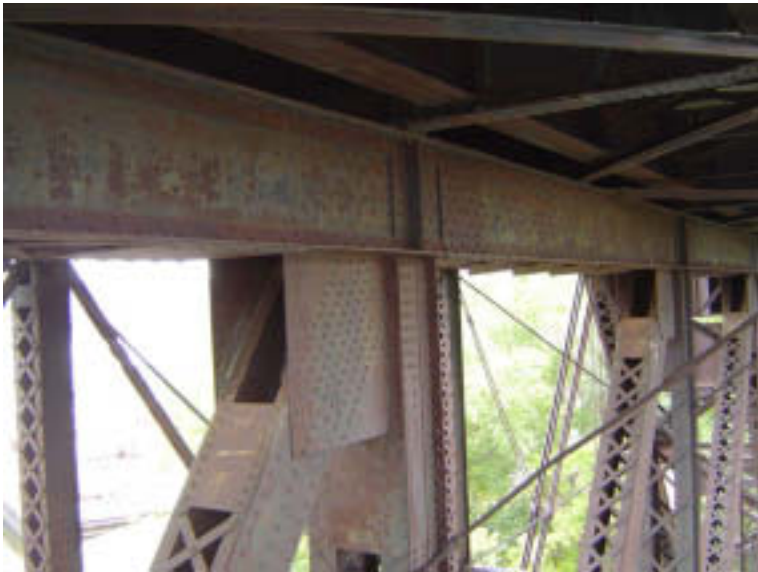
Span 4: Center Truss Lower Connection

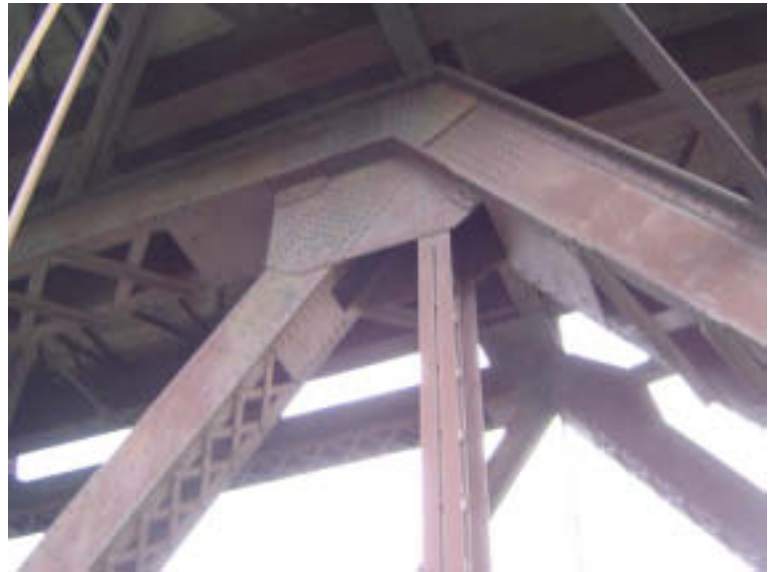
Span 4: Center Truss Upper Connection

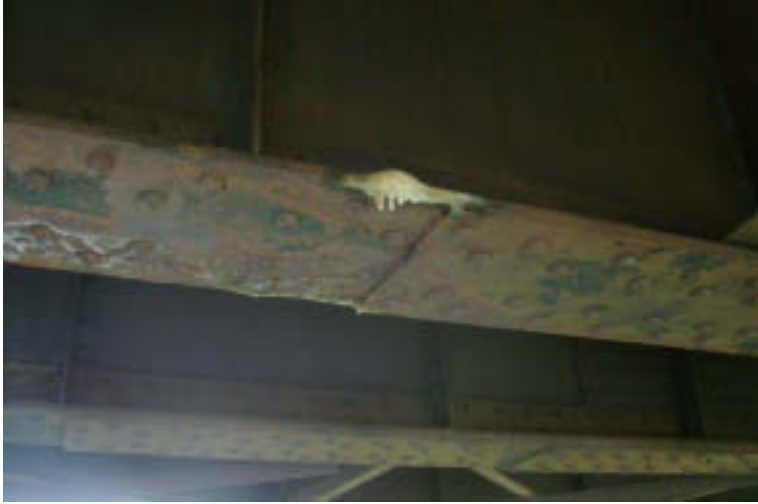
Span 5: Calcium Carbonate Dripping

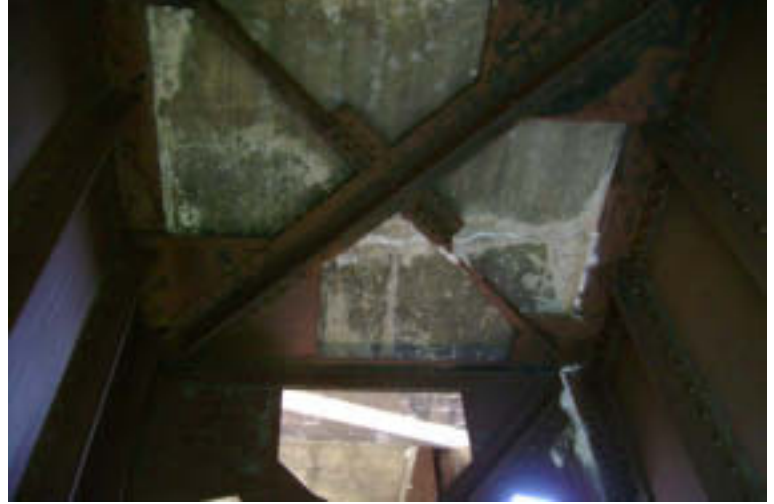
Span 5: Calcium Carbonate Build Up

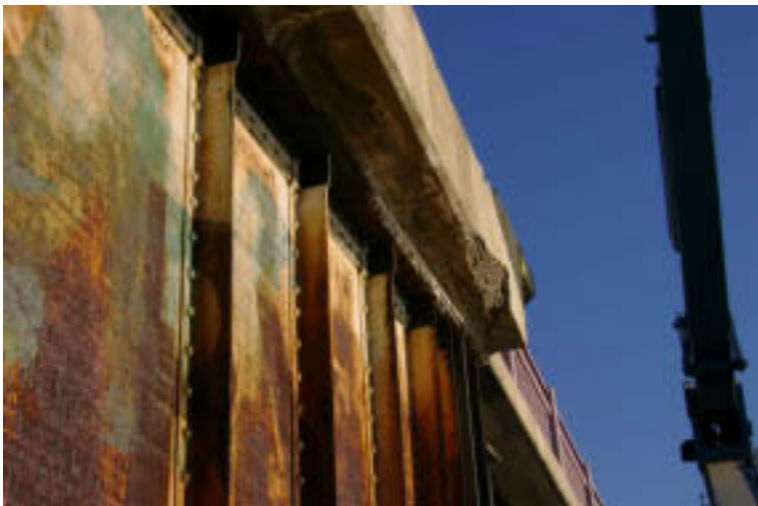
Span 5: Calcium Carbonate Dripping from Deck to Girders

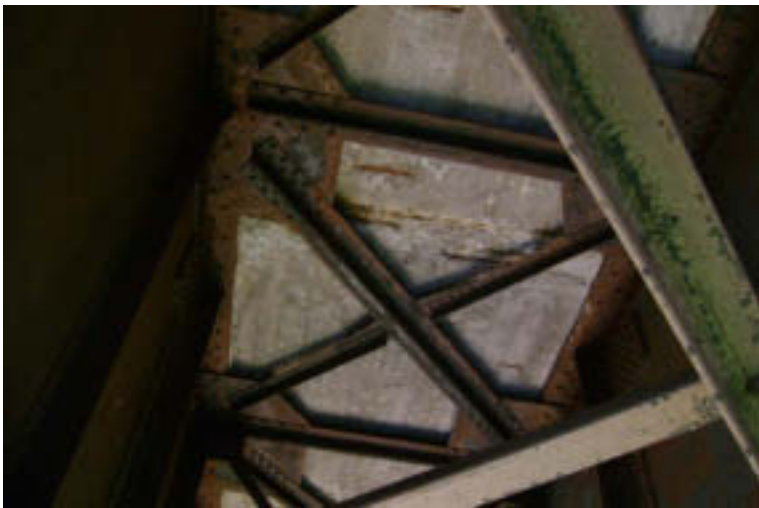
Span 5: Calcium Carbonate Built

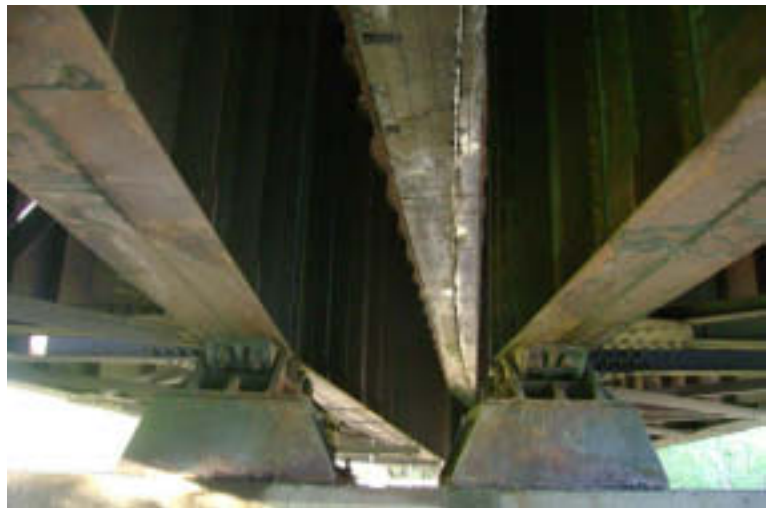
Span 6: Deck Expose Reinforcement

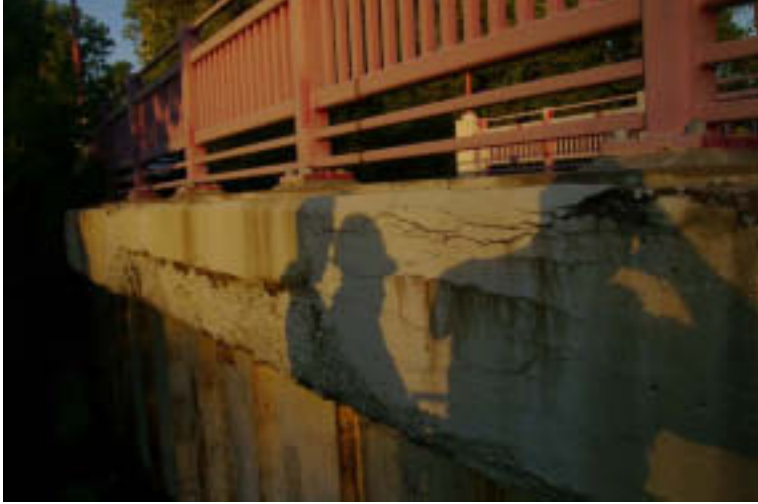
Span 6: Deck Expose Reinforcement

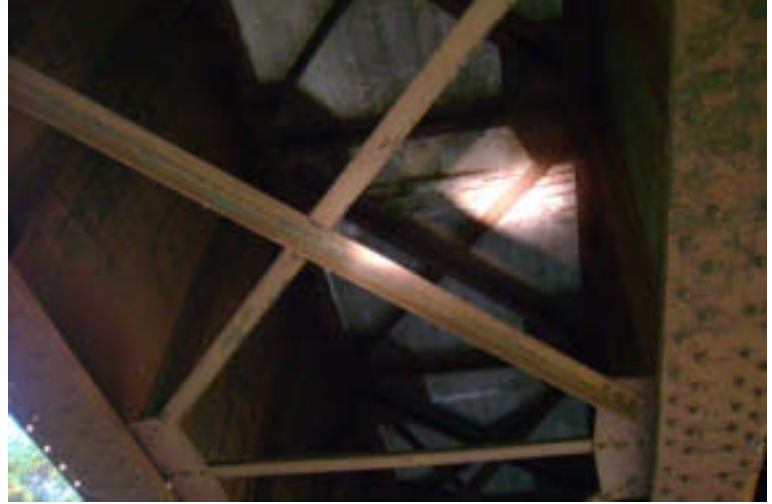
Span 7: Deck Weathering

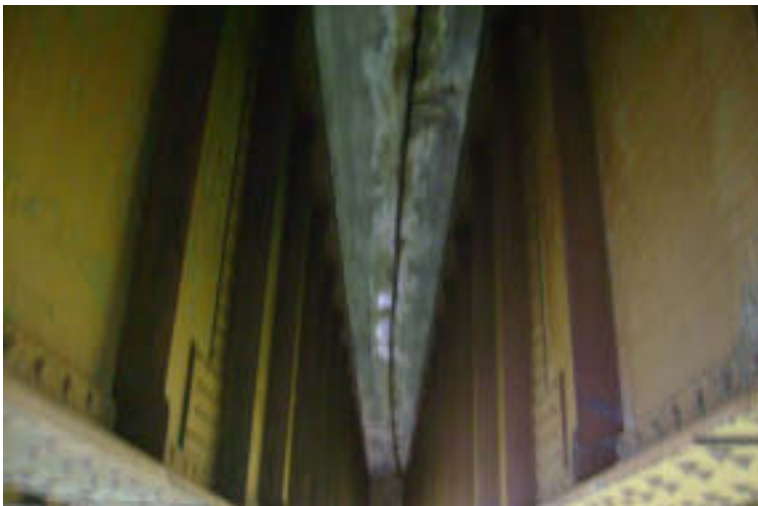
Span 7: Deck Exposed Reinforcement

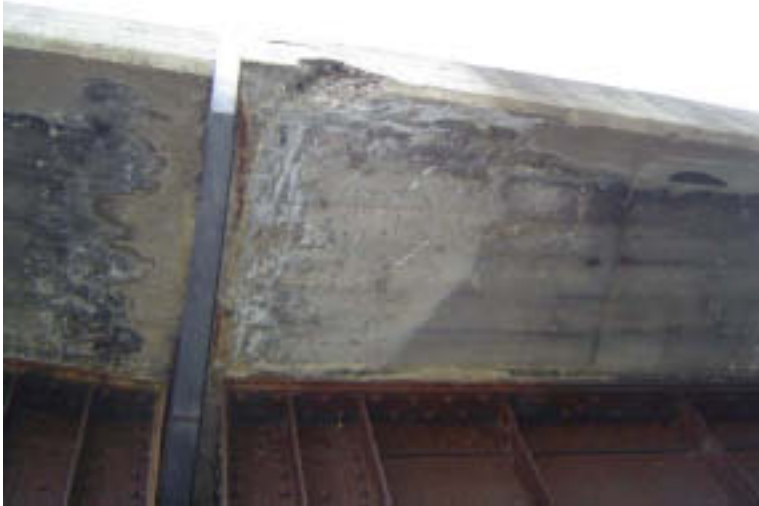
Span 7: Calcium Carbonate Built Up

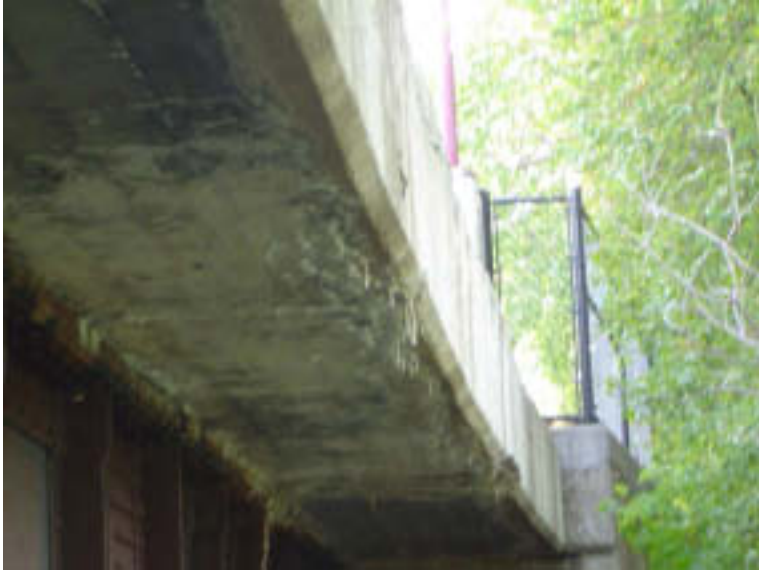
Span 7: Calcium Carbonate Built Up

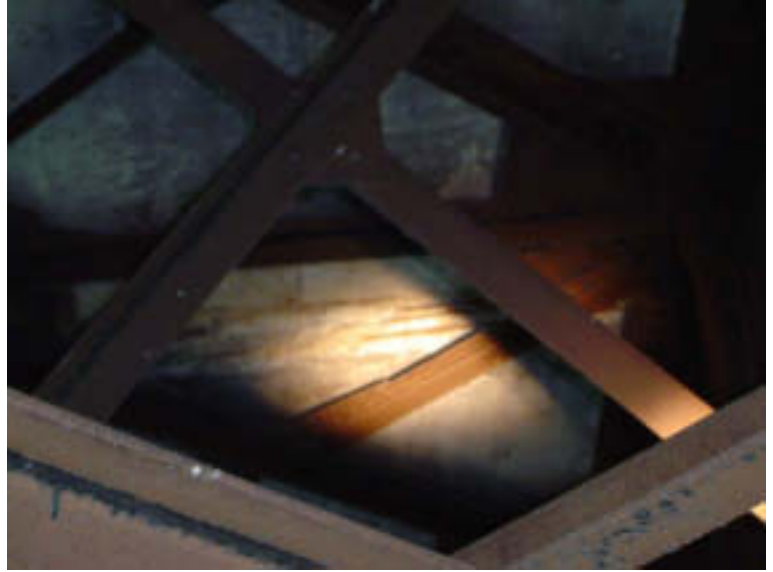
Span 7: Calcium Carbonate Built Up

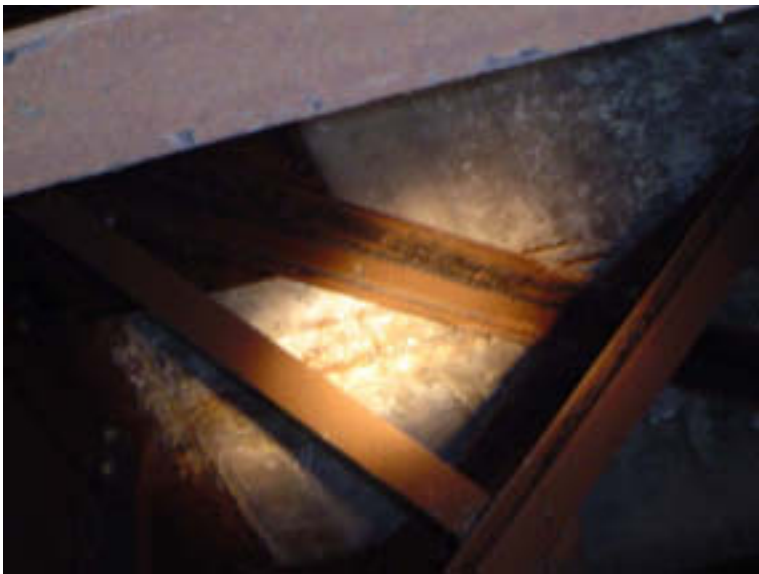
Span 7: Expose Reinforcement

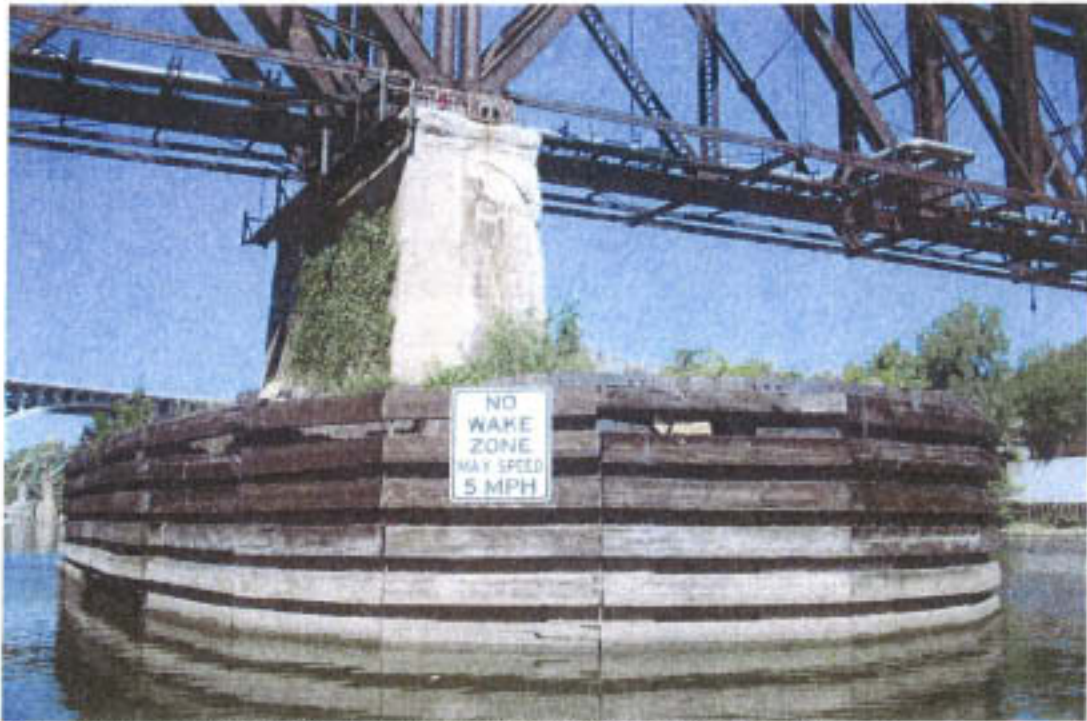
Photograph 1. View of Downstream End of Pier 4, Looking North.
