04849 - CSAH 81 (West Broadway Avenue/Bottineau Boulevard) Bridge Replacement over Lowry Avenue/Oakdale Avenue and Victory Memorial Drive/Theodore Wirth Parkway

Regional Solicitation - Roadways Including Multimodal Elements

CSAH 81 (W Broadway Ave/Bottineau Blvd) - Bridge Replacement Project

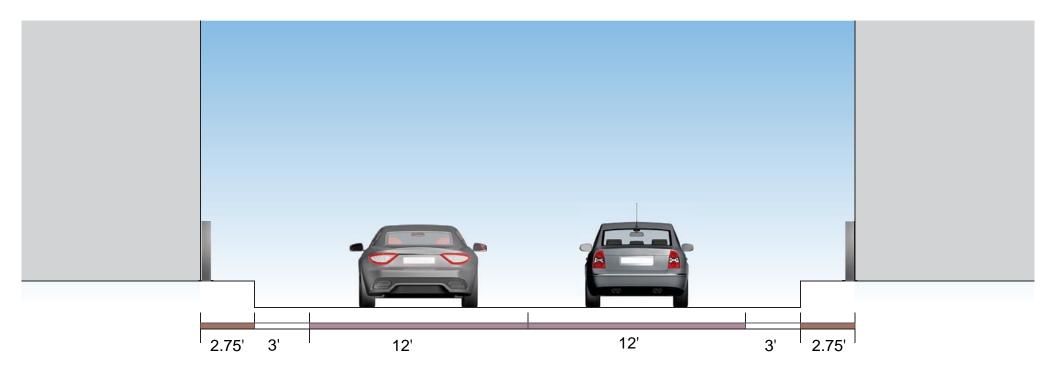
Existing Typical Cross Section

Total Width: 35.5 ft

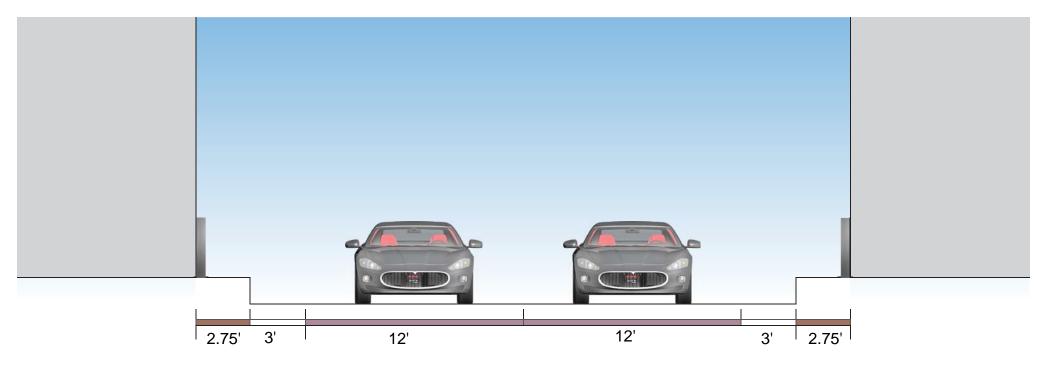
Existing Typical Cross Section

CSAH 081 (Bottineau Boulevard) - Southbound Bridge

Total Width: 35.5 ft

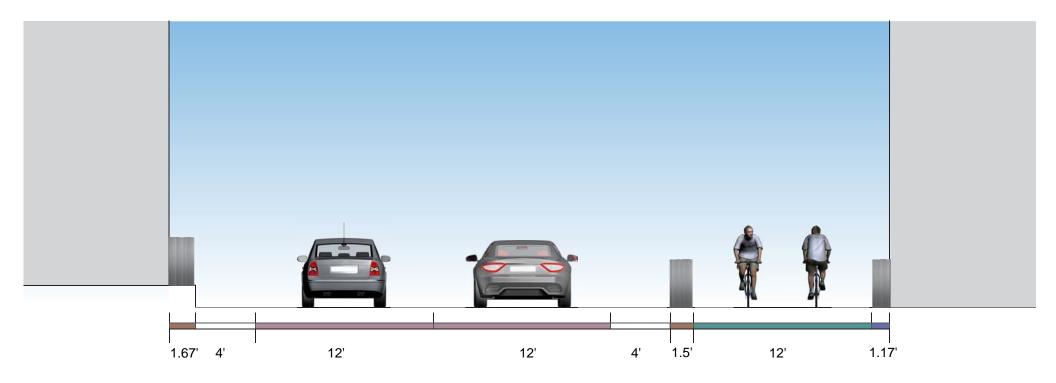
Proposed Typical Cross Section

CSAH 081 (Bottineau Boulevard) - Northbound Bridge

Total Width: 48.34 ft

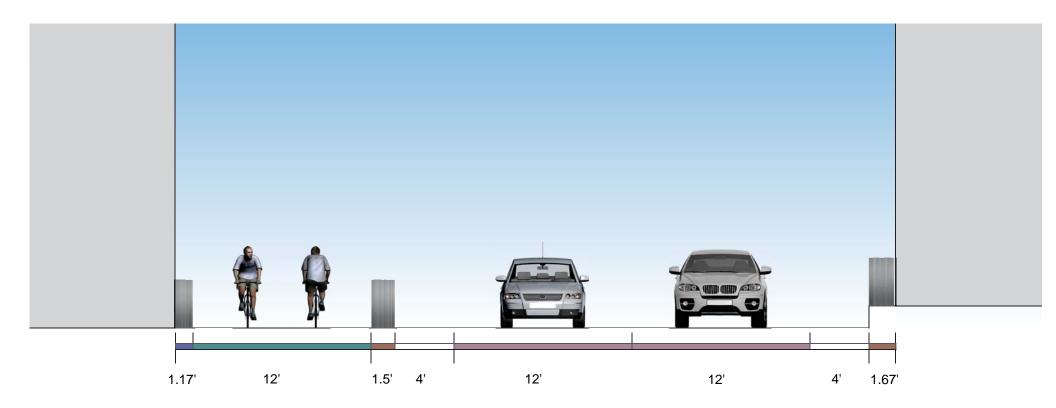
Proposed Typical Cross Section

CSAH 081 (Bottineau Boulevard) - Southbound Bridge

Total Width: 48.34 ft
