10356 - 2018 Bridges

10910 - Lexington Parkway (CSAH 51) Replacement of Bridges 5583 and 7276

Regional Solicitation - Roadways Including Multimodal Elements

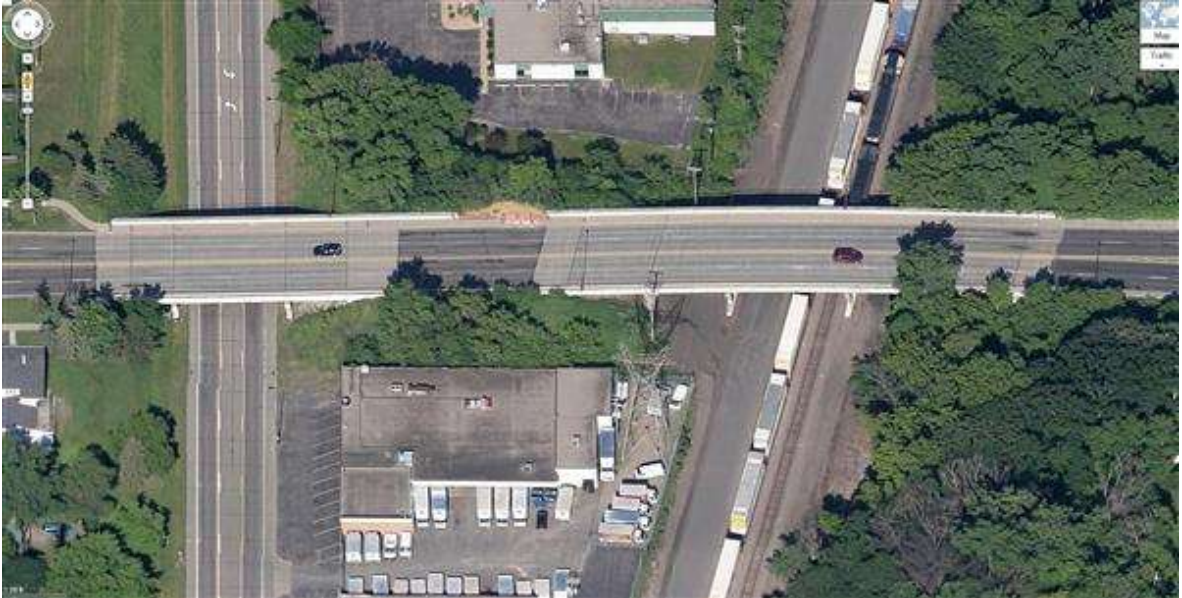
**2017 ROUTINE
BRIDGE INSPECTION REPORT**

**BRIDGE # 5583
CSAH 51(LEX PKWY) over BNSF RR**

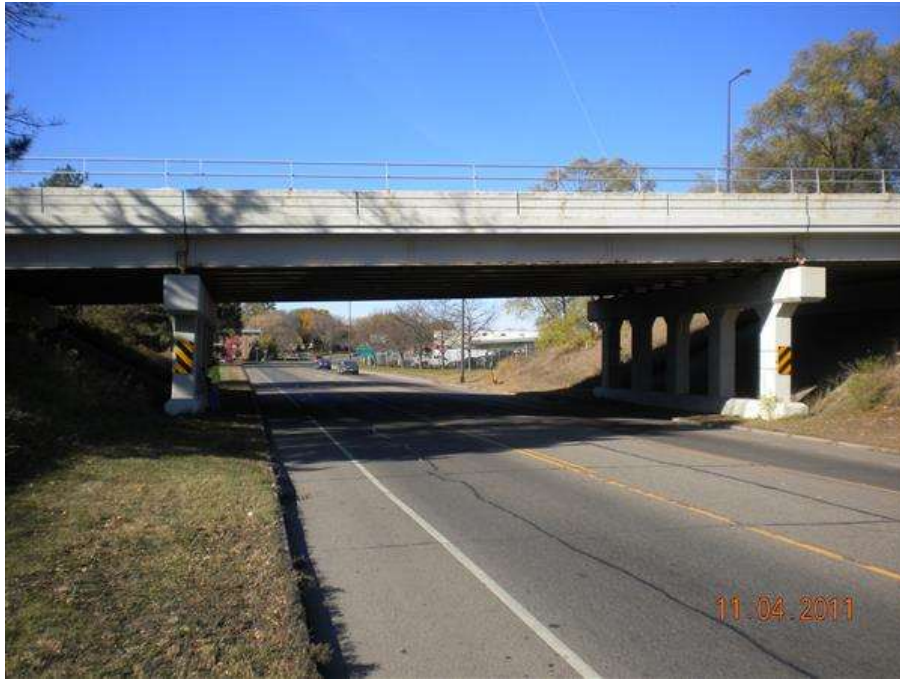
**2017 ROUTINE
BRIDGE INSPECTION REPORT**

**BRIDGE # 7276
CSAH 51(LEX PKWY) over CSAH 33(PIERCE BUTLER)**
