December 9, 2022

Over the past month, crews continued cleaning the sanitary sewer interceptor. Crews also repaired the small portion of pipe that required open cut excavation work. Recently, manhole rehabilitation and cured-in-place pipe (CIPP) lining work began throughout the project area. This work is anticipated to continue over the next couple of weeks. During this work, there will be heavier truck traffic on the trail. **Please exercise caution when traveling through the area and follow any posted detour or closure signage.**

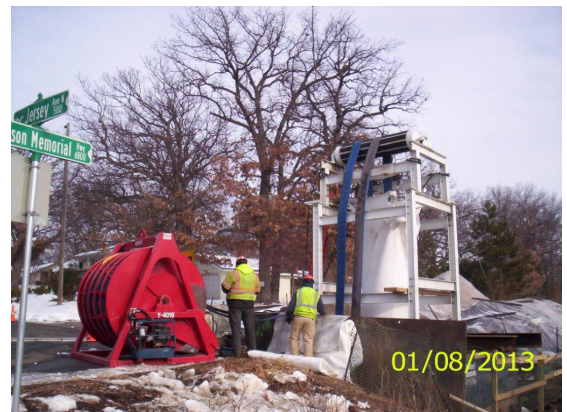
Example of CIPP inversion process.

Rehabilitation of the sewer pipes and structures will be done by inserting a liner into the existing pipes to form a new pipe or structure. Water is then used to extend and expand the liner, and then hot water or steam is added until the heat-activated resin in the liner hardens and forms a new pipe inside the existing pipe.
