ACTION TRANSMITTAL No. 2013-34

SUBJECT: Scope Change Request for Bridge No. 9 over the Mississippi River at the University of Minnesota

CITY OF MINNEAPOLIS PROJECT NO. SP 141-090-038
BRIDGE NO. 9 OVER MISSISSIPPI RIVER AND WEST RIVER PARKWAY

Attachment J – Condition Study Report: Bridge No. 9 Pedestrian Bridge Over Mississippi River

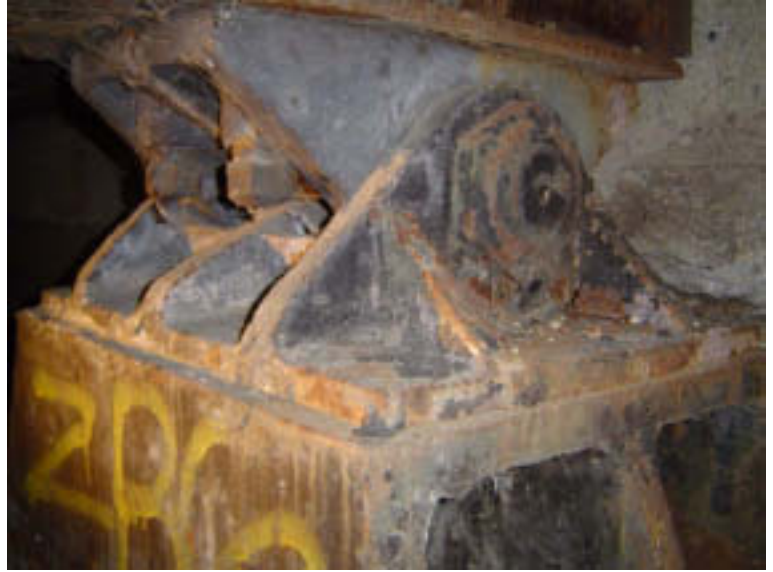
Abutment 1: Bearing

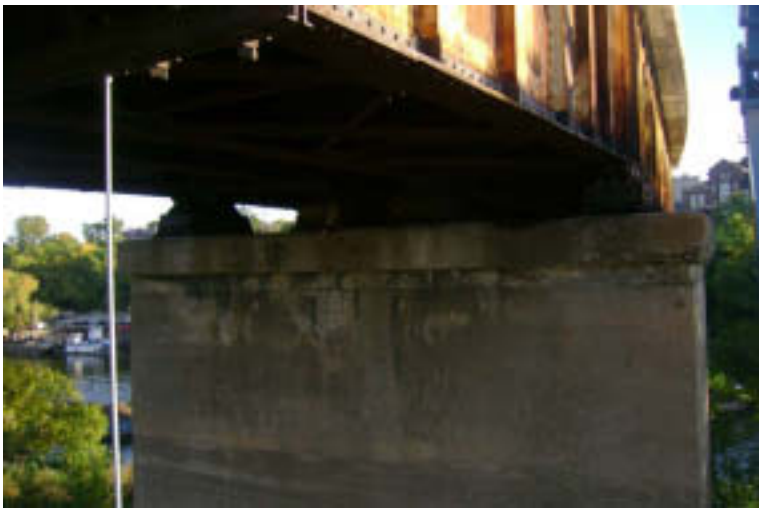
Pier 6: Bearing and Calcium Carbonate

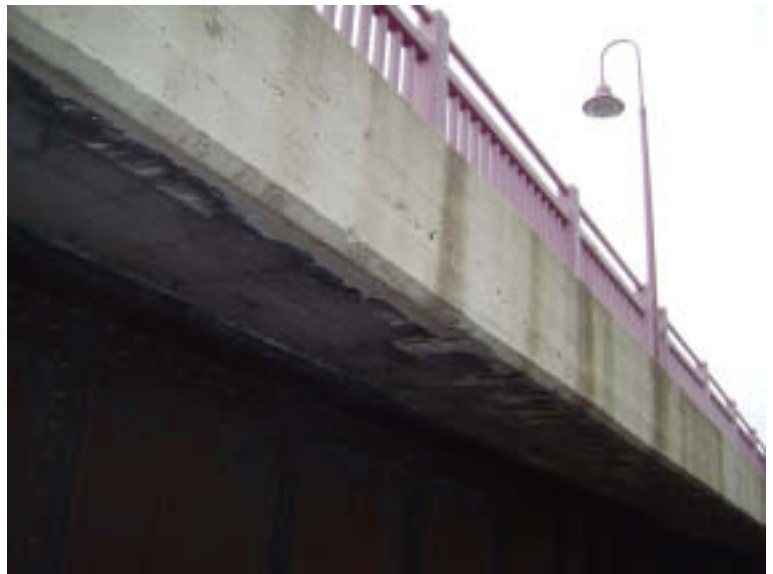
Span 2: Under Side Center of Deck

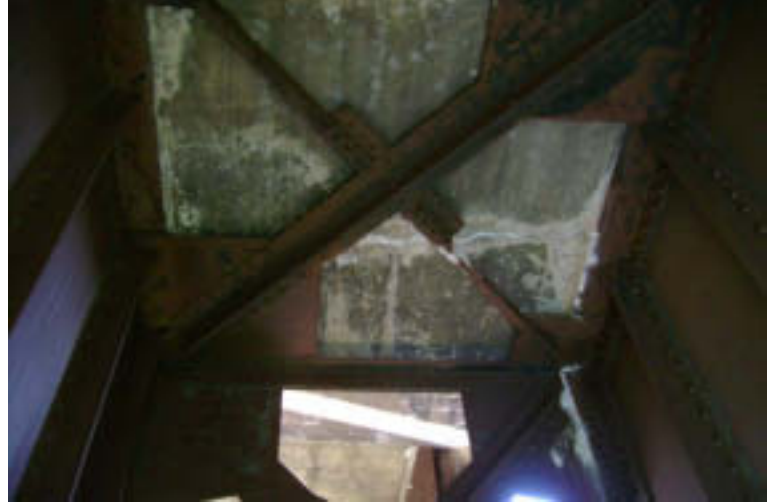
Span 5: Calcium Carbonate Build Up

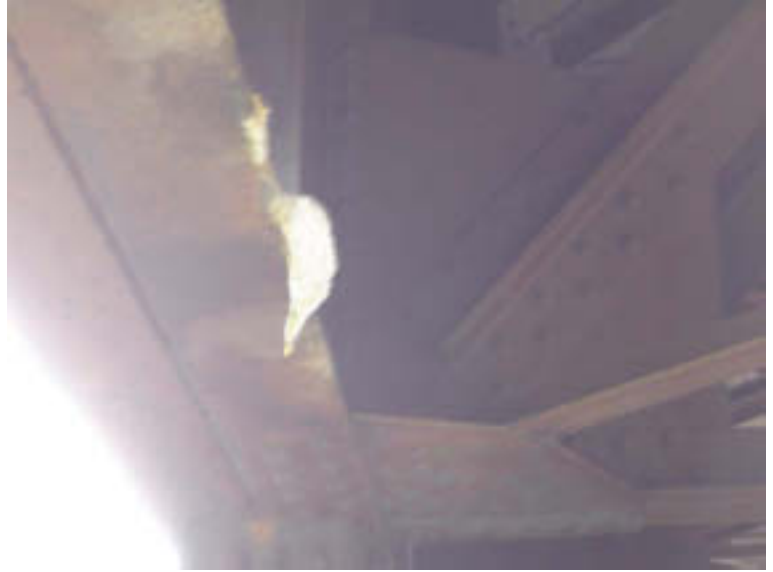
Span 5: Calcium Carbonate Built
