ACTION TRANSMITTAL No. 2013-34

SUBJECT: Scope Change Request for Bridge No. 9 over the Mississippi River at the University of Minnesota

CITY OF MINNEAPOLIS PROJECT NO. SP 141-090-038
BRIDGE NO. 9 OVER MISSISSIPPI RIVER AND WEST RIVER PARKWAY

Attachment J – Condition Study Report: Bridge No. 9 Pedestrian Bridge Over Mississippi River

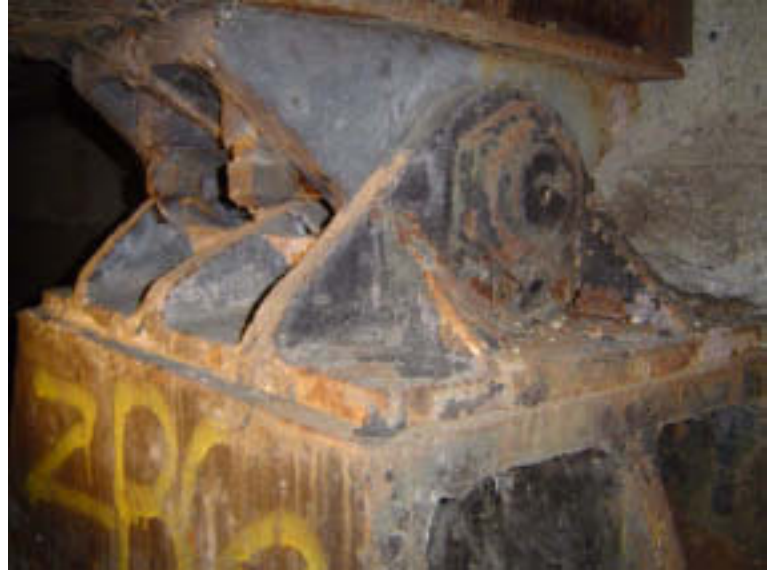
Abutment 1: Bearing

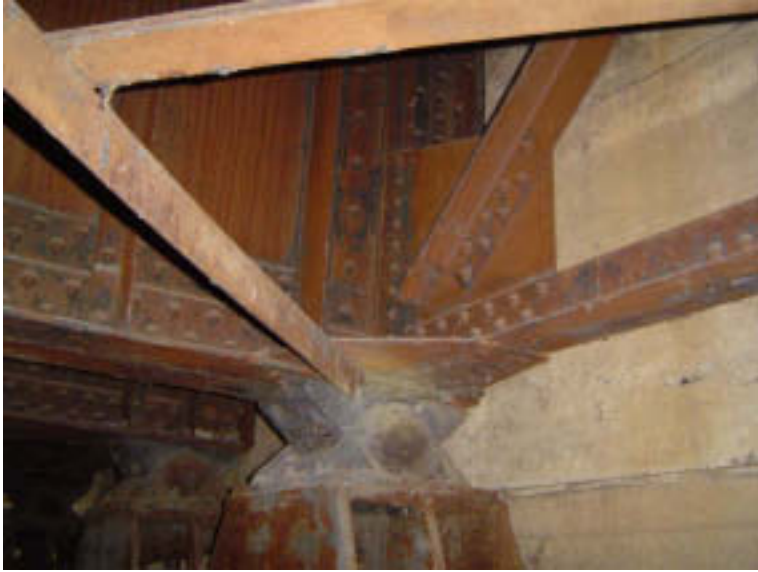
Abutment 1: Bearing

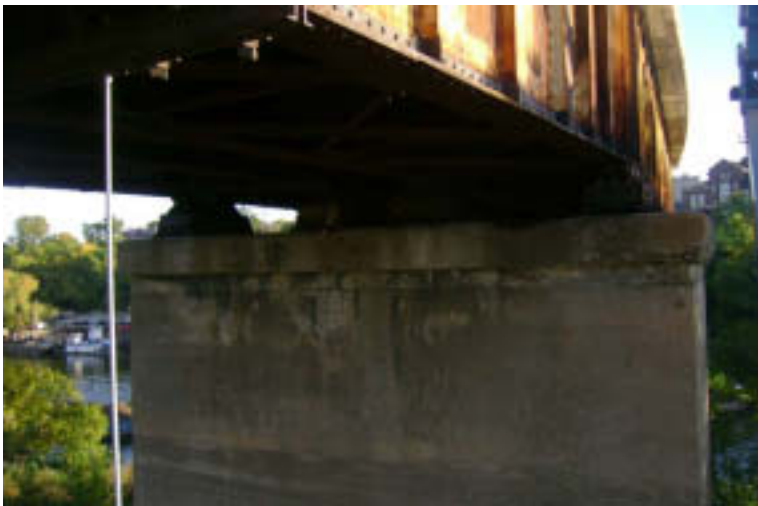
Pier 6: Bearing and Calcium Carbonate

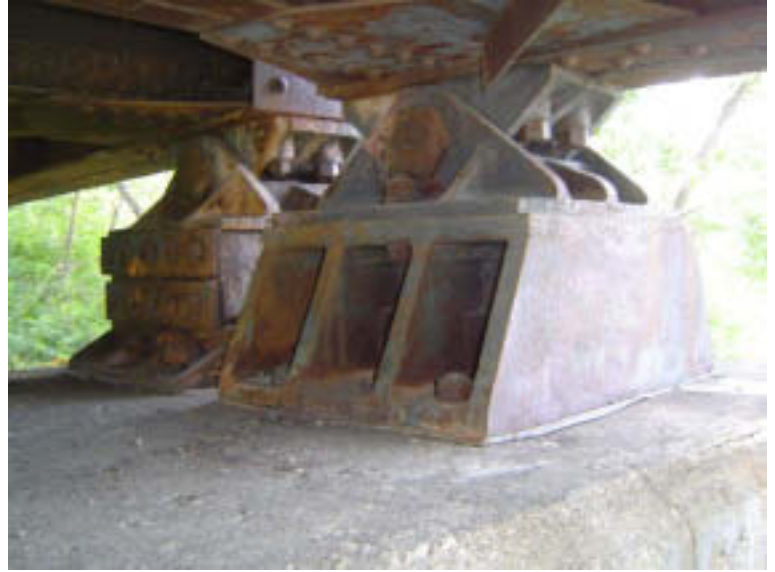
Pier 7: Bearing Calcium Carbonate

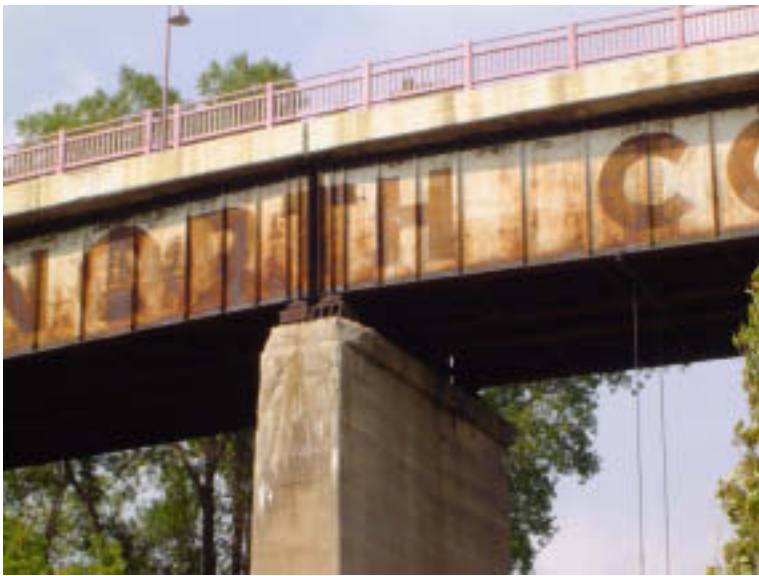
Pier 7: Pier Cap Deterioration

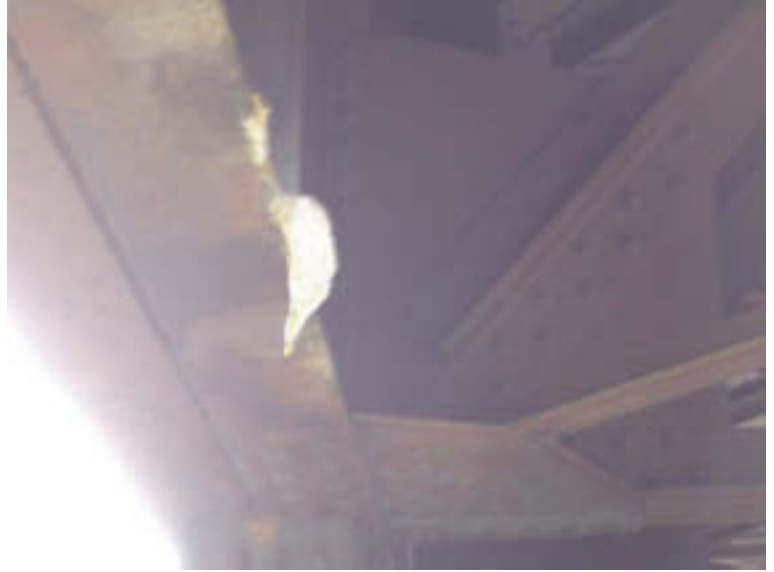
Span 5: Calcium Carbonate Built
